4. CASE 20.122, 20 JOHN STREET, Menzies Sweet and James Rhodes House, 1823 (COLLEGE HILL)

Federal; double house; 2-1/2 stories; clapboard; gable roof; 6 bay facade with double doorway flanked by pilasters and sidelights and carved fan decoration above; rear extension.

Proposal: The scope of work proposed consists of Major Alterations and includes:

- The applicant is requesting the removal of the of the existing dormer and the installation of a skylight, front (south) elevation.

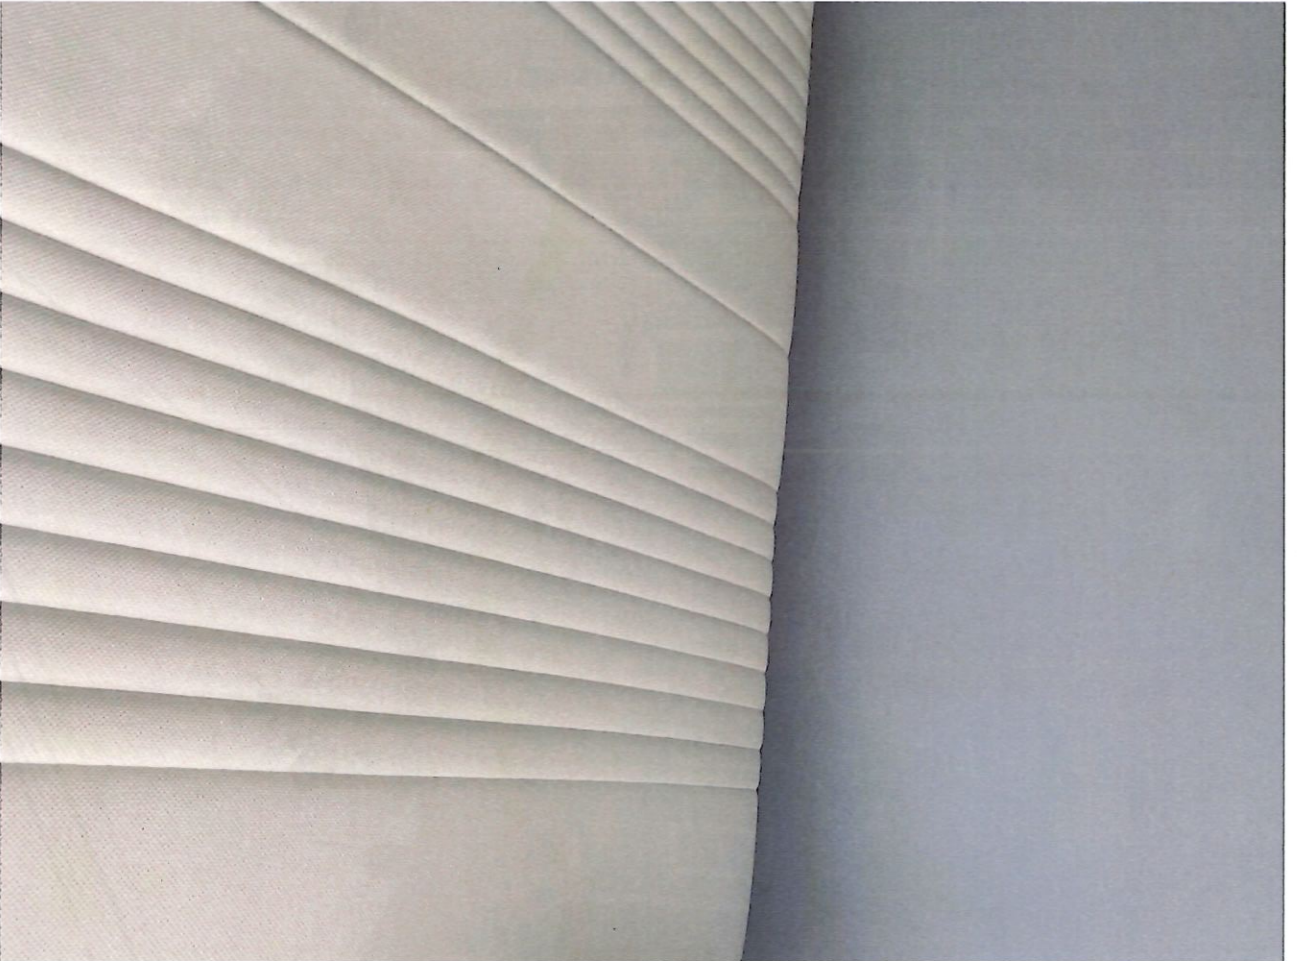
Ceiling repair, window, front floor

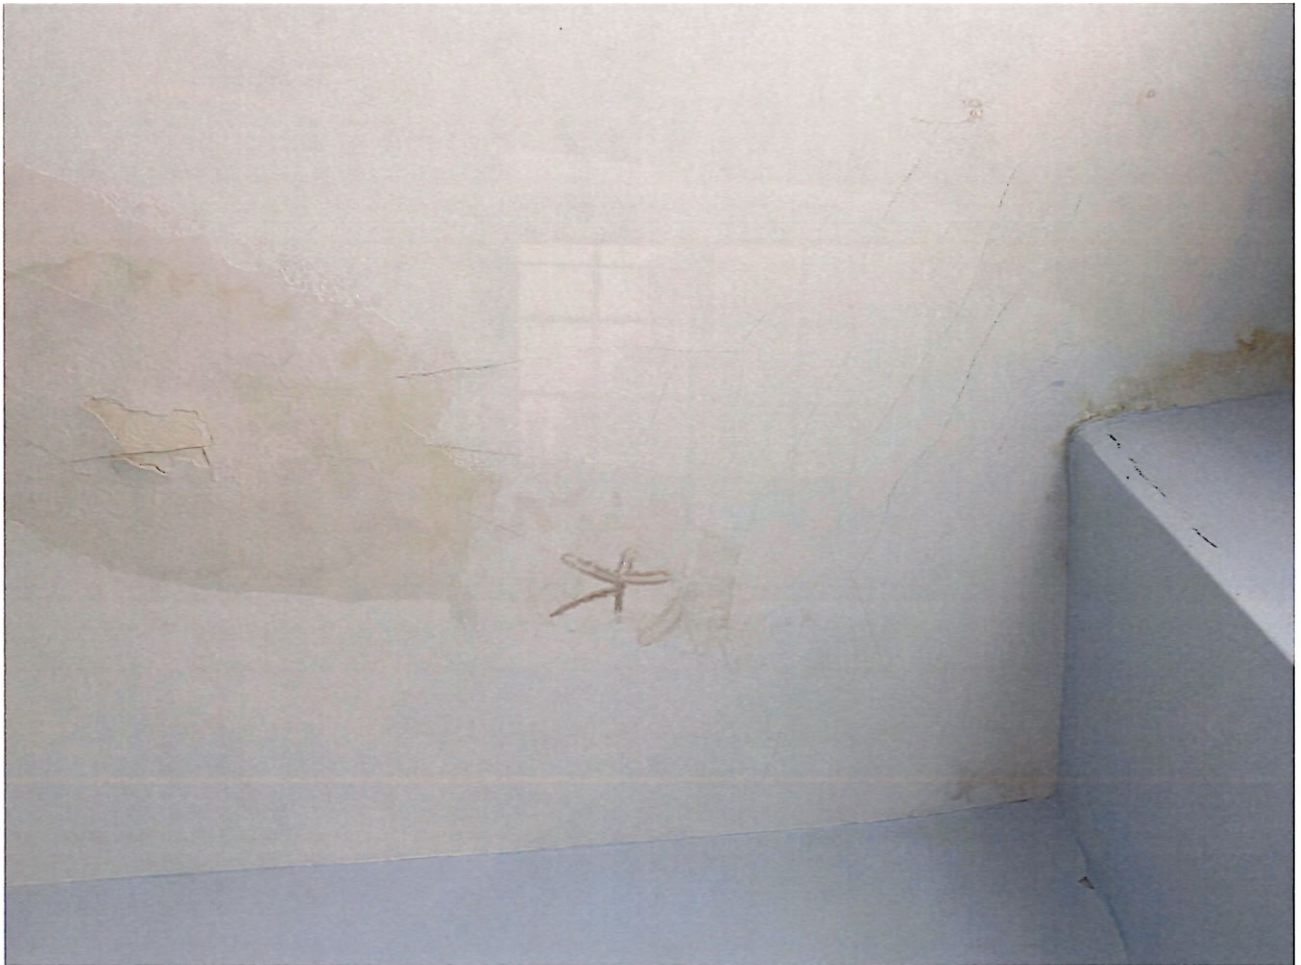
- On Tuesday, October 20th staff participated in a site visit with Ross Birch, owner's rep, and Ramzi Loqua, engineer. This visit included an external and internal visual evaluation. During the visit there was water damage to the second-floor ceiling of the front room (see photos); The third floor is a finished space, used as a bedroom. There is the front dormer, two windows in the gable end and also a rear dormer. The front and rear dormers are offset. Unfortunately, because the space is finished and currently occupied it was not possible to see any of the structure (see photos). Mr. Loqua was to return, take measurements and submit a report based on his visual examination. The report is anticipated and Mr. Loqua will be available to provide testimony at the hearing. As such, documentation for the project is limited with critical information regarding the roof and dormer's framing and structure undeterminable at this time, and may be determined incomplete by the Commission; and

Ceiling water damage, 2nd Floor
