**PROJECT REVIEW**

1. **CASE 23.052, 28 AGNES STREET, Colonial Knife Company, before 1908 (PLD-INDUSTRIAL & COMMERCIAL BUILDINGS)**  
See attached ICBS form.

**STRUCTURAL ASSESSMENT REPORT  
OF EXISTING BUILDINGS**

YTL Project #2023-061  
April 2023

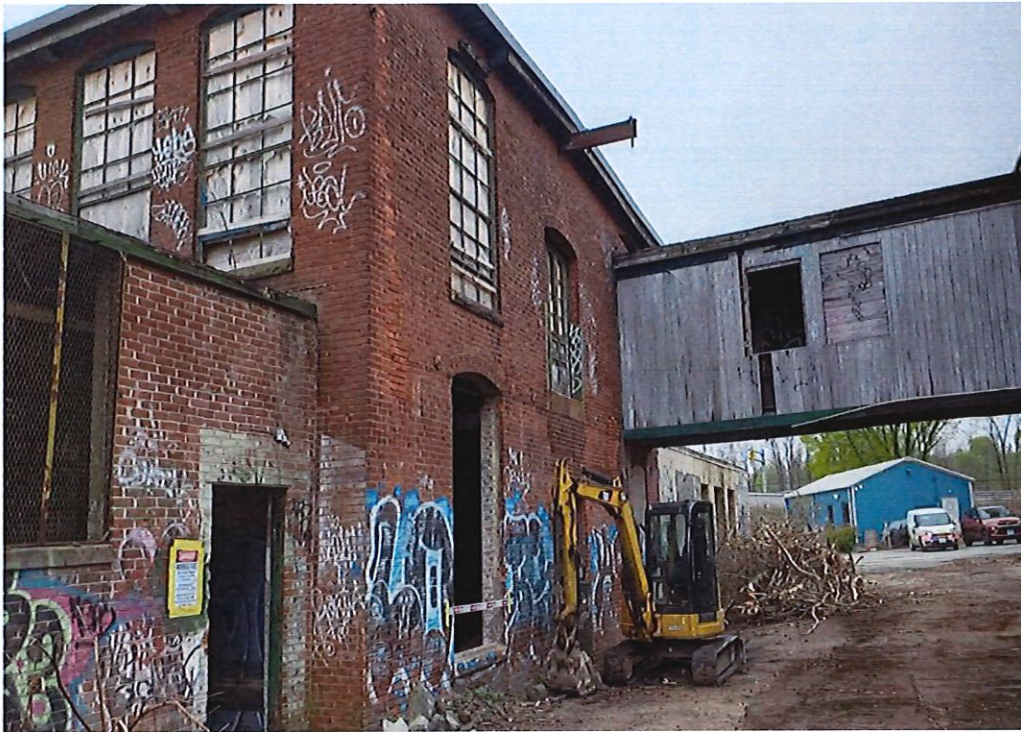
PHOTO 9: View of Western Face of Building 3

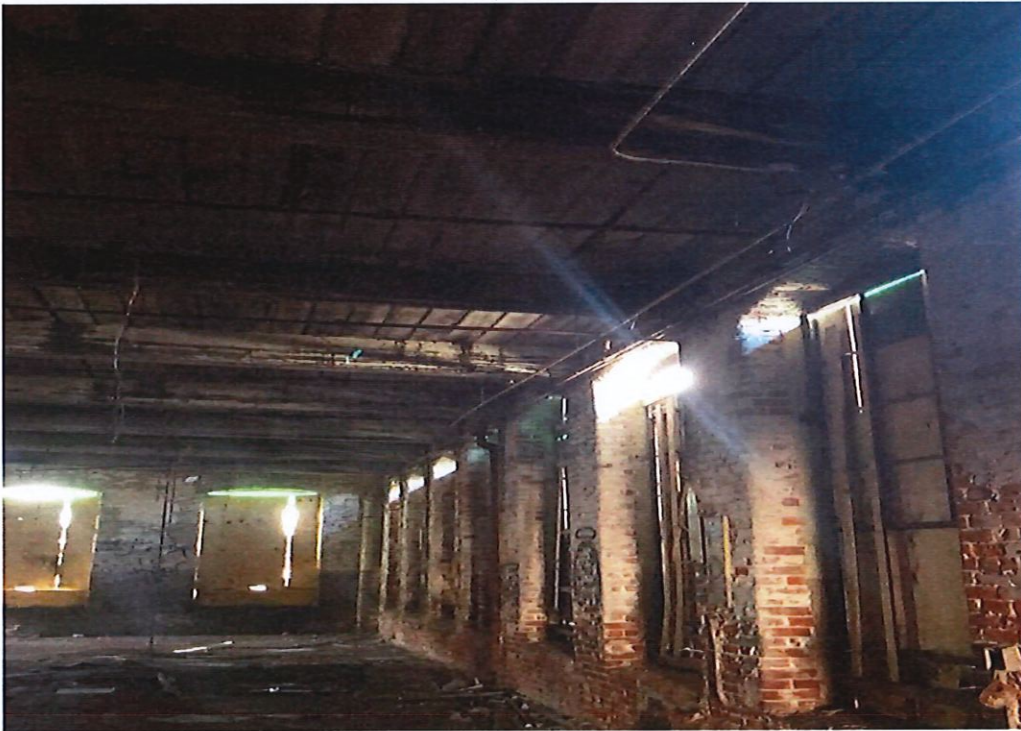
PHOTO 10: Typical Interior View of First Floor in Building 3

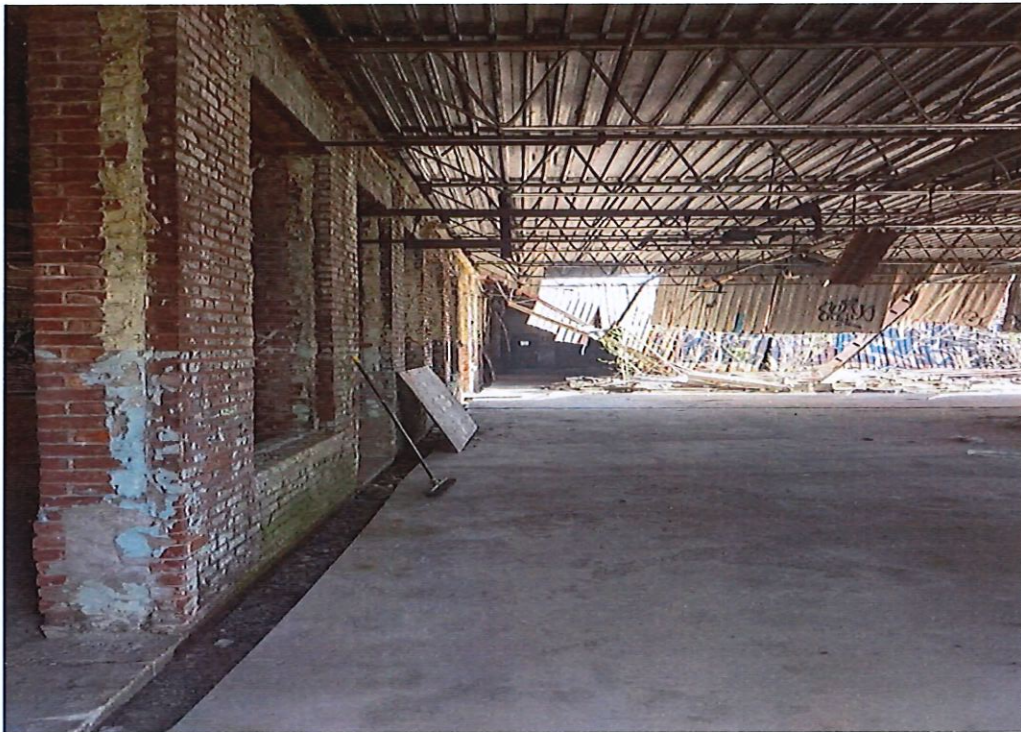
PHOTO 7: Interior View of Wall Between Buildings 2 and 3

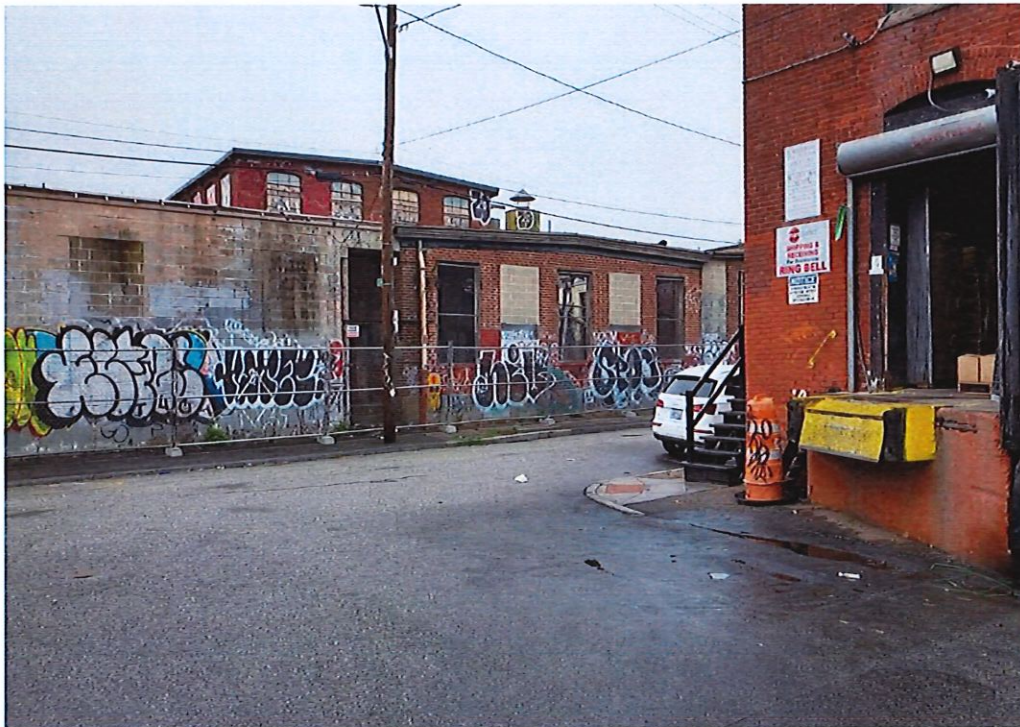
PHOTO 8: View of Building 3 From Agnes Street

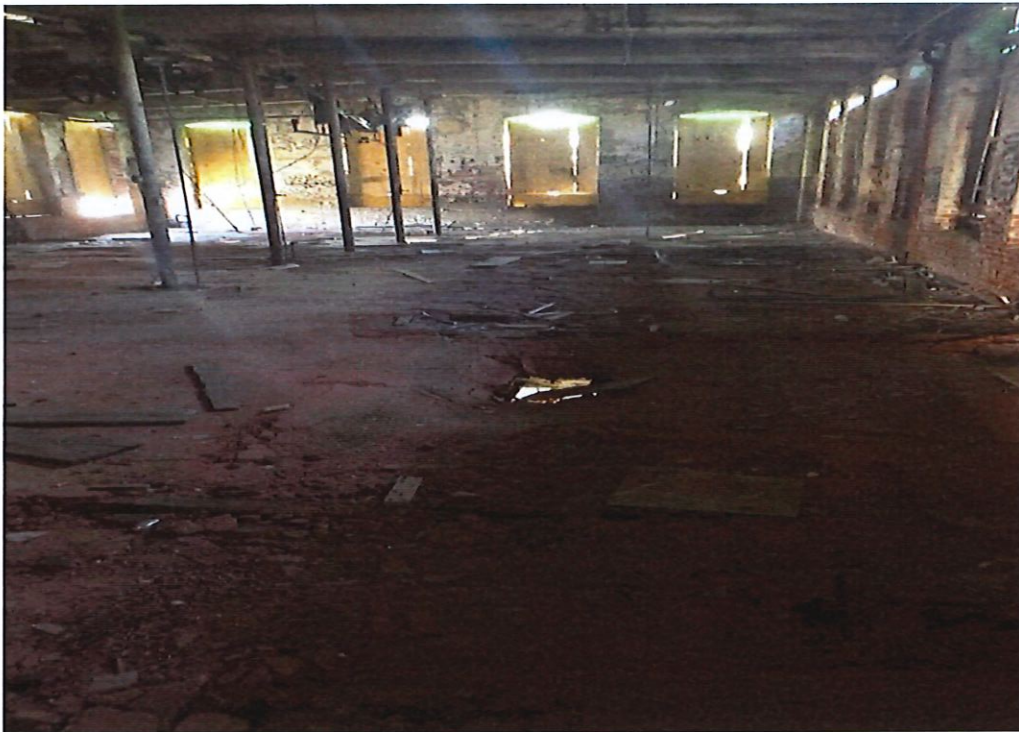
PHOTO 11: Typical Interior View of Second Floor in Building 3

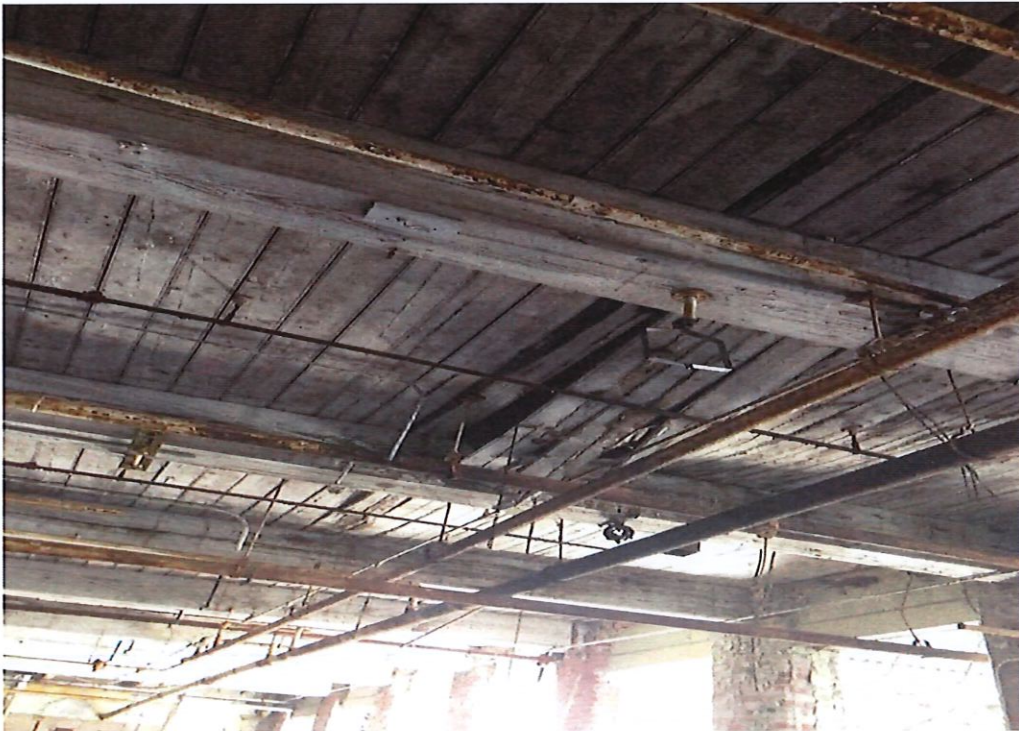
PHOTO 12: Typical Interior View of Second Floor Roof in Building 3

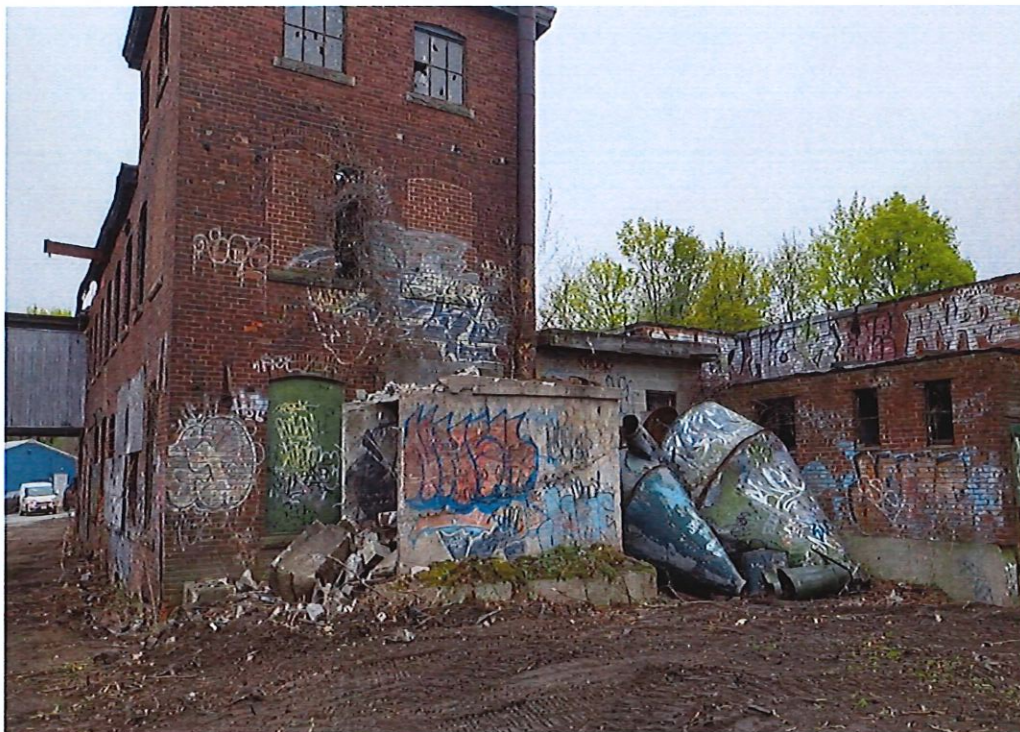
PHOTO 27: View of Northern Face of Building 8

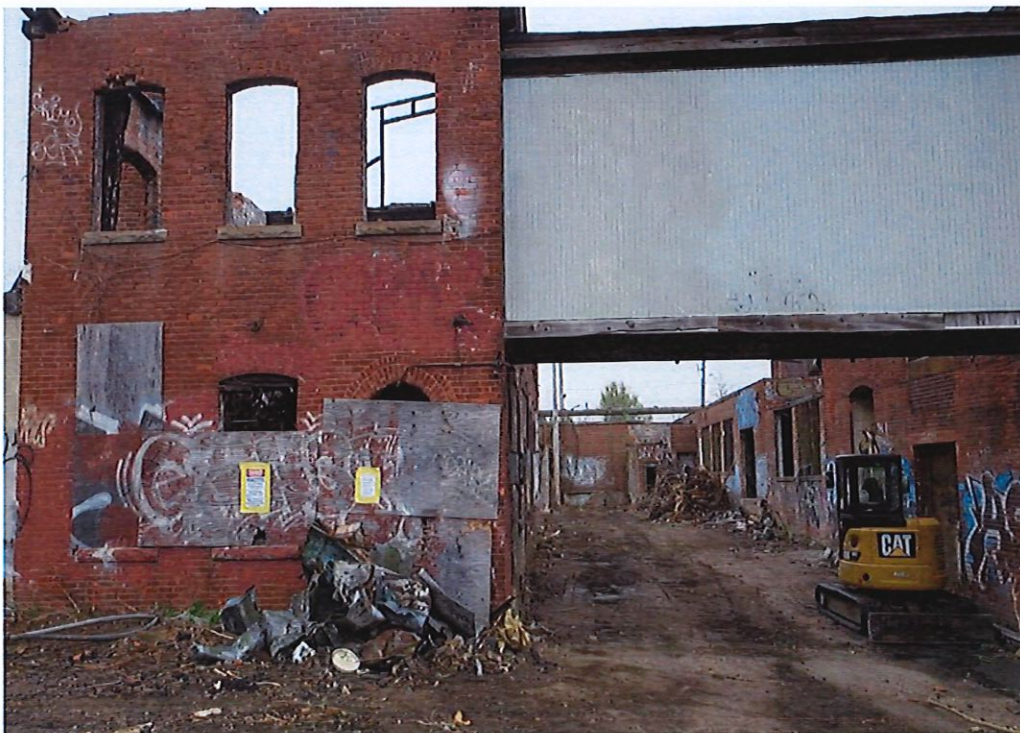
PHOTO 28: View of Southern Face of Building 8

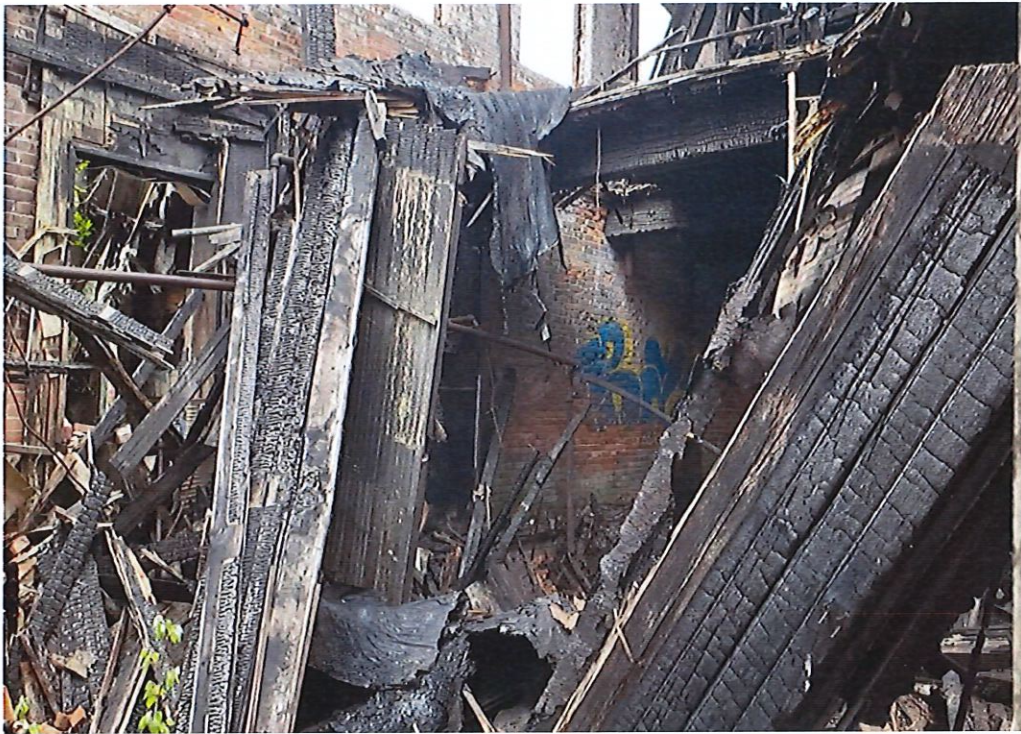
PHOTO 29: Typical Interior View of Building 8

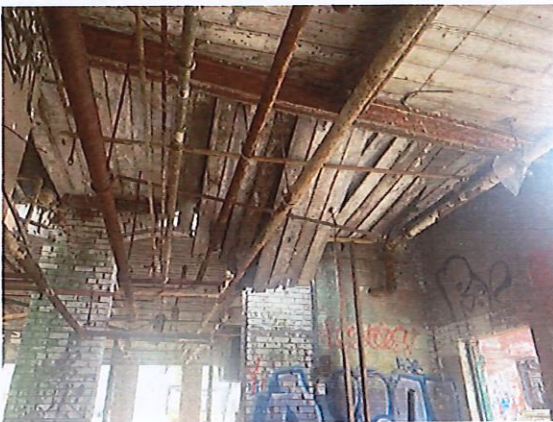
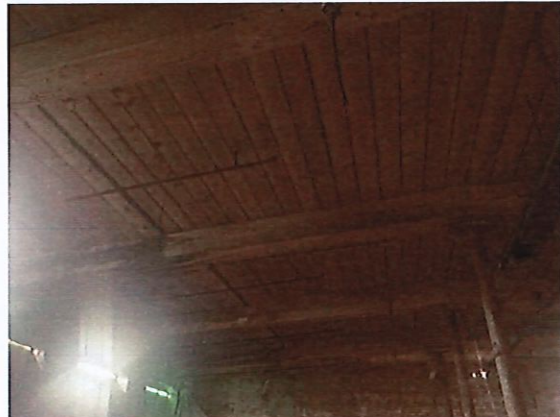
**4.1 Deteriorated and Collapsing Wood Roof Structures (Buildings #3 and #8)**

The condition of the existing roof structures varies from building to building. The roof of Building #8 is completely missing. The low roof structure adjacent to Building #3 is collapsing (see photo below left) creating lateral forces on the walls of Building #3. Even though Building #3 had the roofing material replaced in 2021, they did not replace any of the deteriorated roof decking or reinforce any of the deteriorated roof beams. It appears that they just roofed over the existing roofing material. See photo below right where there are deteriorated roof deck boards and roof beams that were not repaired as part of the new roofing material installation.

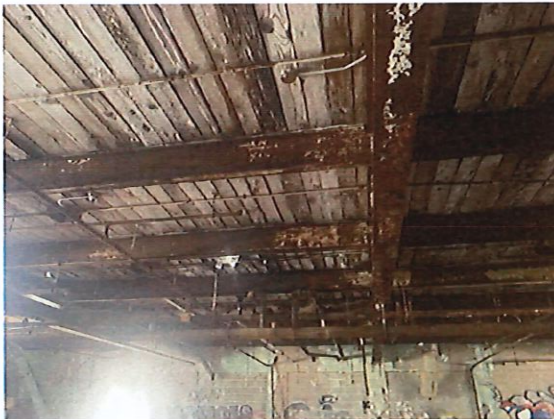
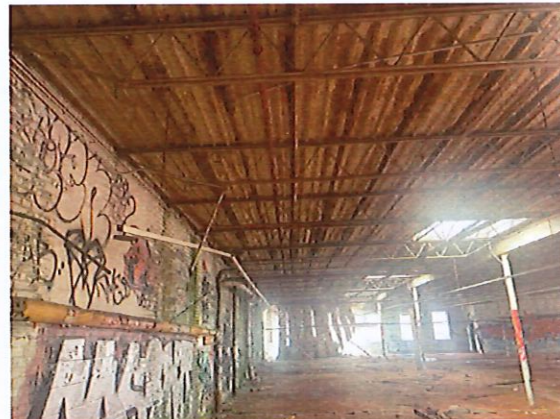
**4.2 Deterioration of Structural Steel at Roof**

All of the other one story buildings that have steel roof beams have deterioration of the wood roof decking (or metal roof decking) due to prolonged water entry, and the steel beams and open web steel roof joists have deterioration and delamination of the flanges, with significant loss of material. See photo below left of typical wood roof decking and steel roof beam deterioration. See photo below right of typical deterioration of metal roof decking and open web steel roof joists.

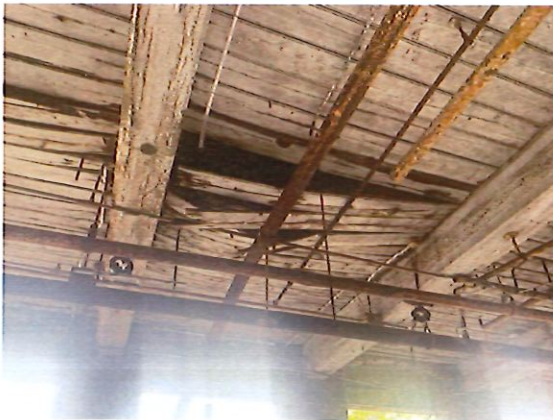
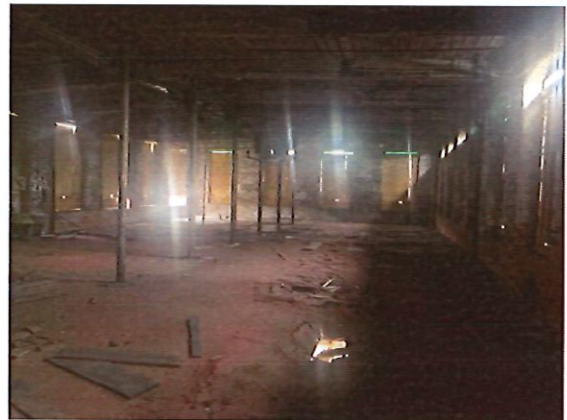
#### 4.3 Deterioration of Second Floor Structure (Building #3)

The second floor structure was exposed to water infiltration for many years prior to the installation of the new roofing in 2021. This has led to areas of localized collapse of the second floor decking, and compromised wood floor beams. Due to the severe deterioration, along with the hazardous topping material that was poured over the floor decking, the entire second floor deck would need to be removed and replaced. Most of the second floor beams would need to be reinforced due to localized deterioration. See photo below left of deteriorated second floor decking and beams as seen from below. See photo below right of deteriorated second floor from above, note red hazardous underlayment poured over entire area of floor.

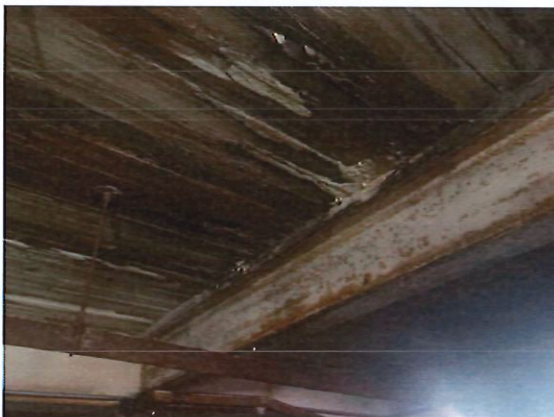
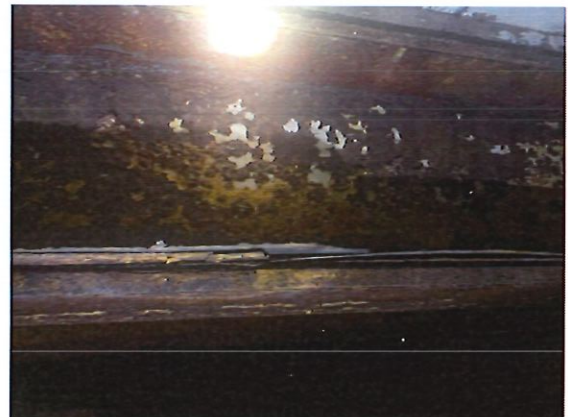
#### 4.3 Deterioration of Structural Steel at First Floor

All of the one story buildings that have basements with steel floor beams supporting the first floor have deterioration of the wood floor decking due to prolonged water entry, and the steel beams have severe deterioration and delamination of the flanges, with significant loss of material. See photo below left for mold on underside of deteriorated wood deck boards, taken from basement level. See photo below right for severely deteriorated delamination of bottom flange of first floor steel beam, taken from basement level.
