**RFP Title: REDEVELOPMENT OF CITY BUILDING LOCATED AT 99 KENYON STREET,  
PROVIDENCE, RI 02903**

**Addendum #: 4**

# AHERA - ASBESTOS RE-INSPECTION OF ACBM & PACM

OVERALL ROOF PLAN  
**A-101**

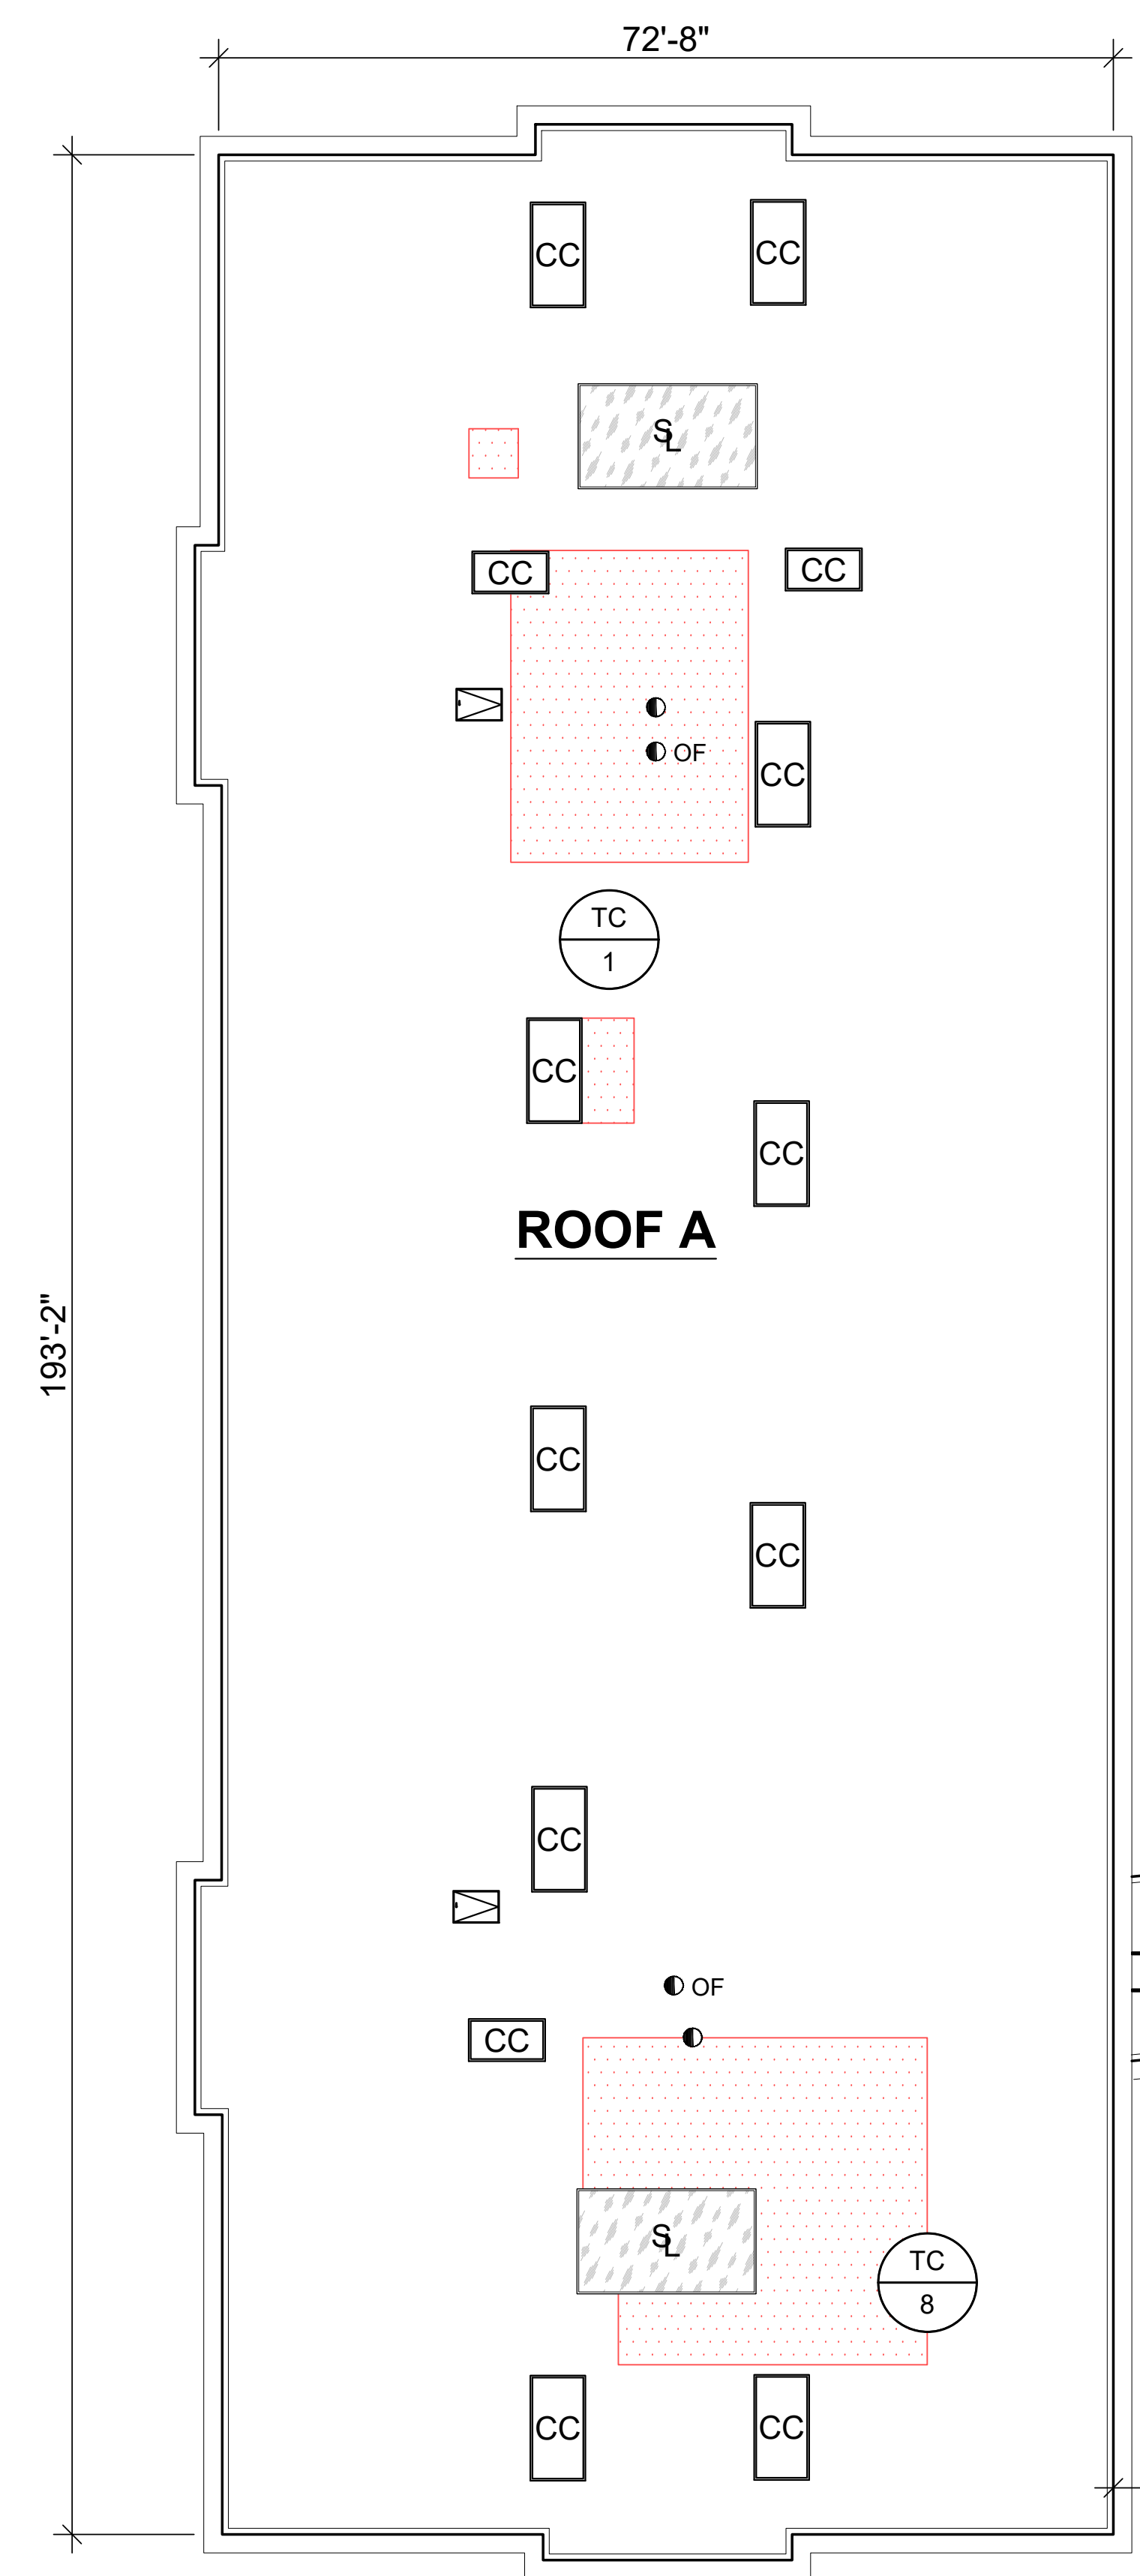
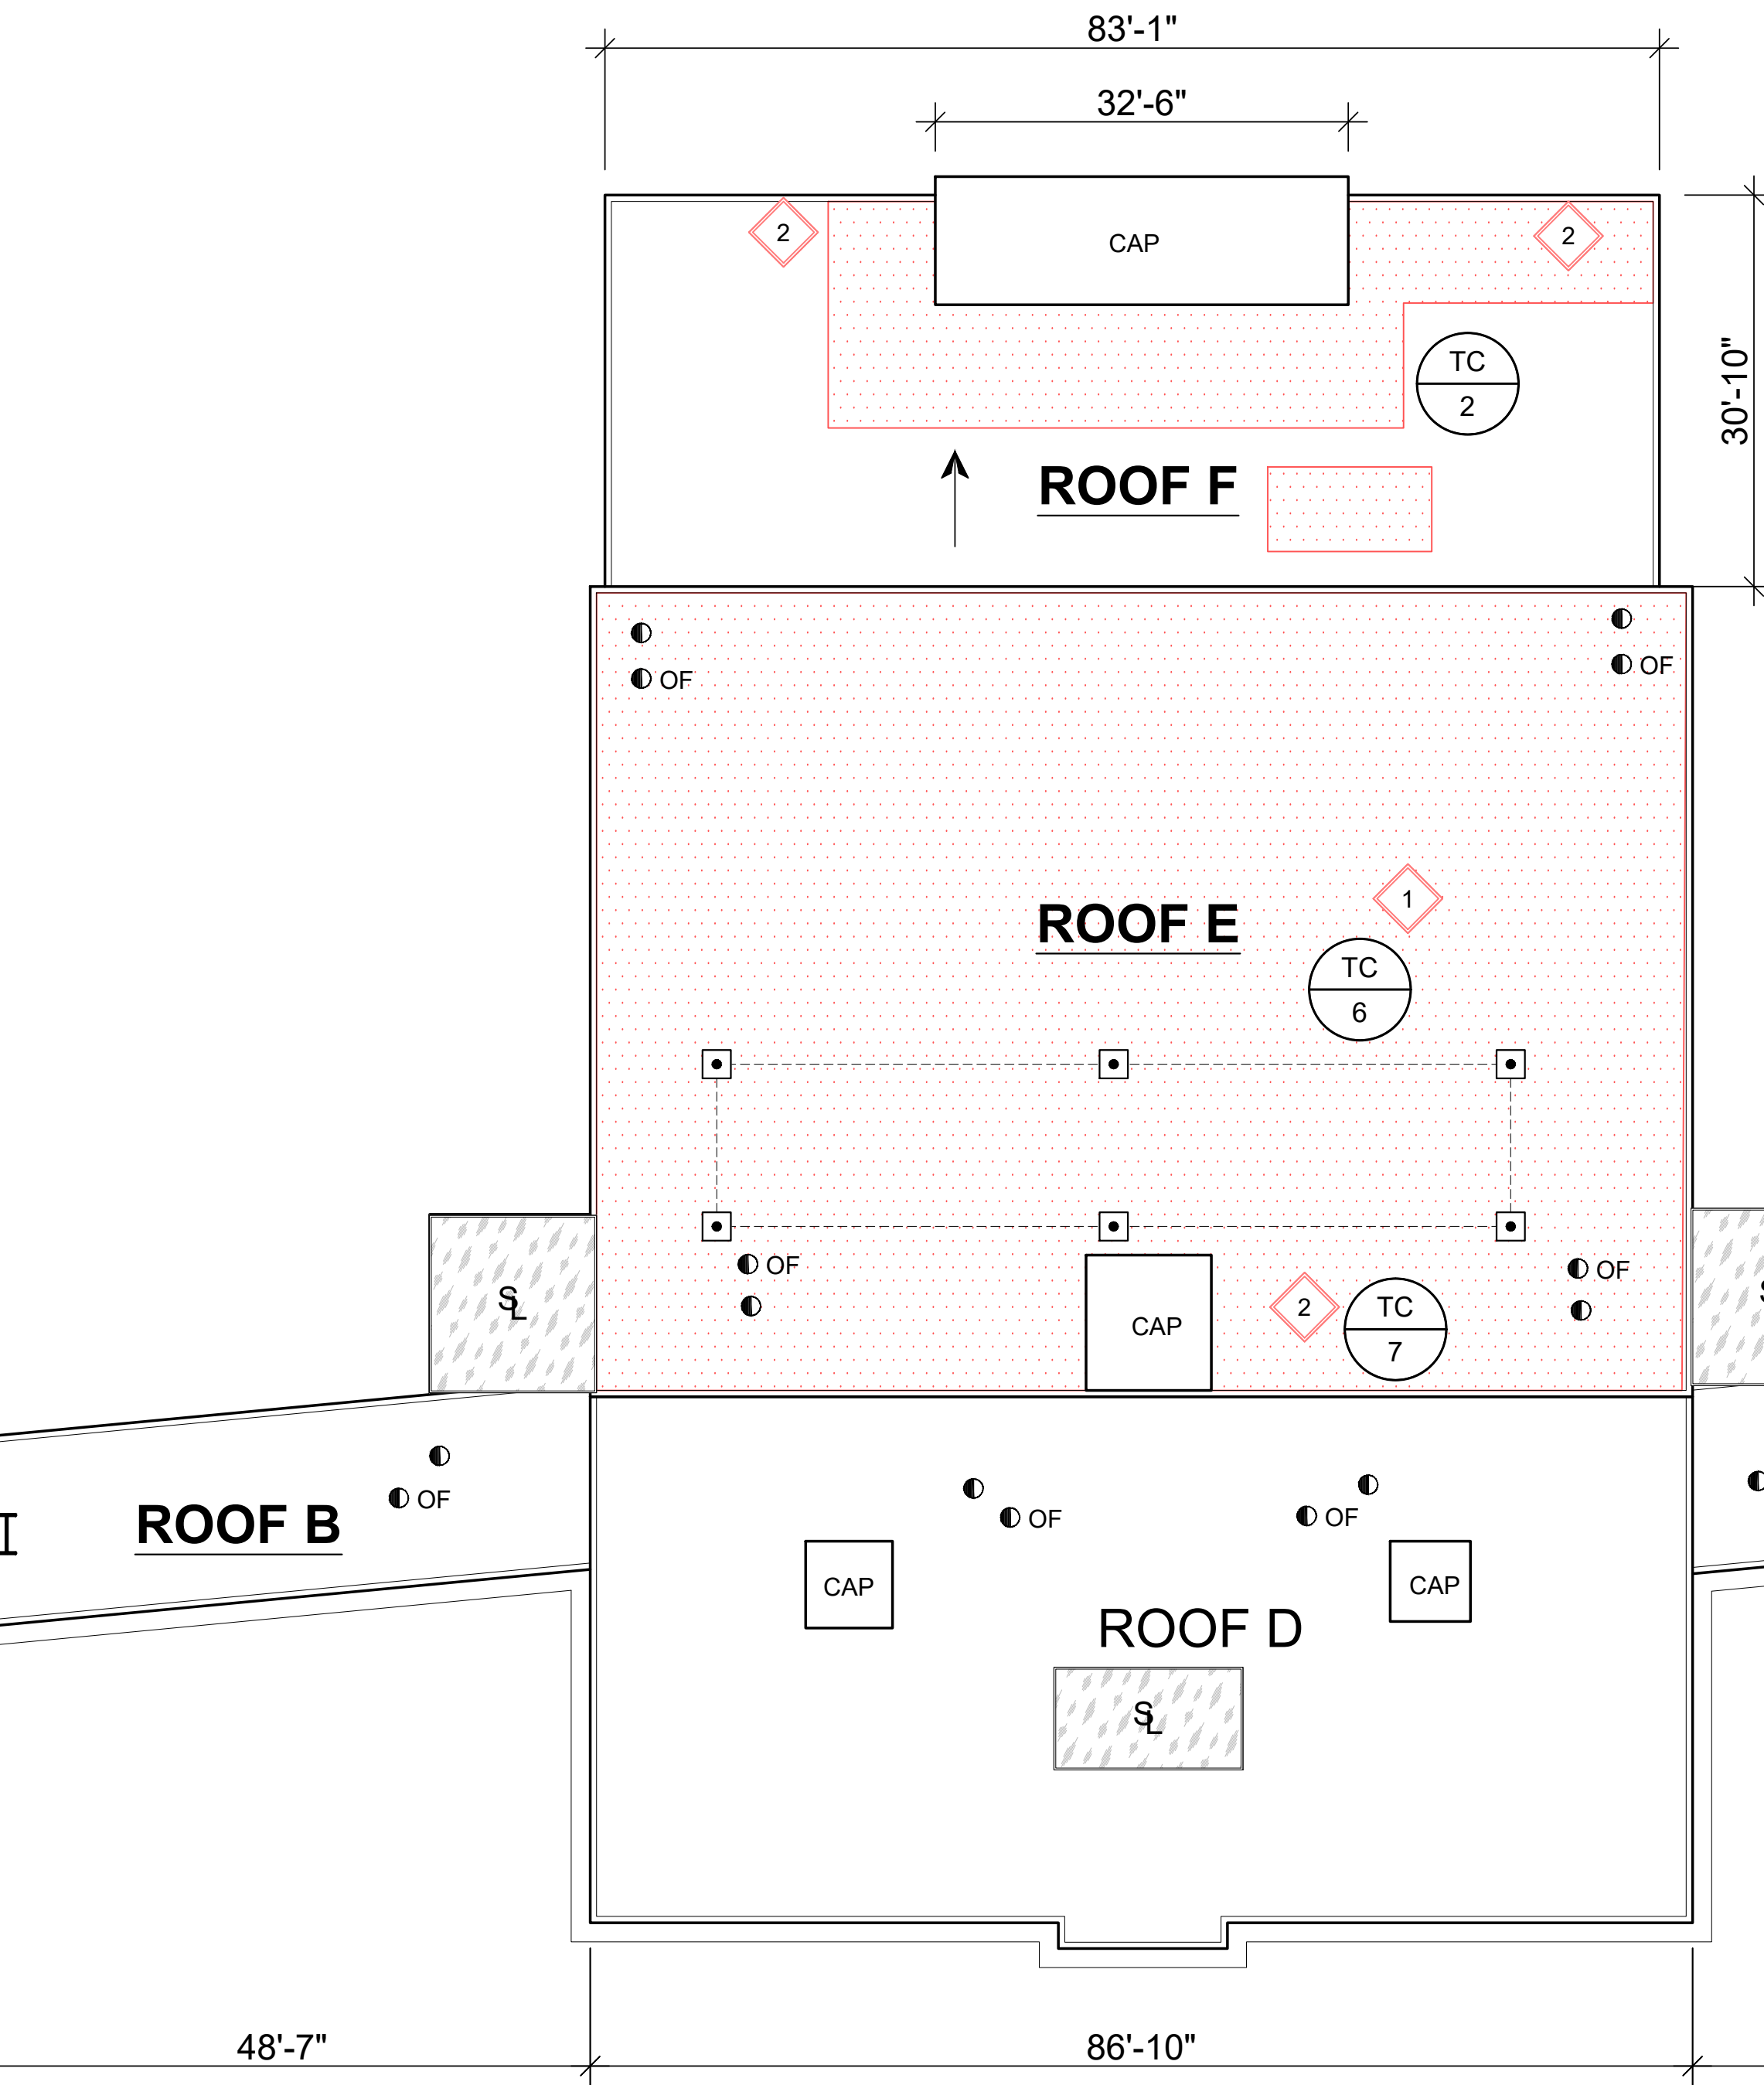
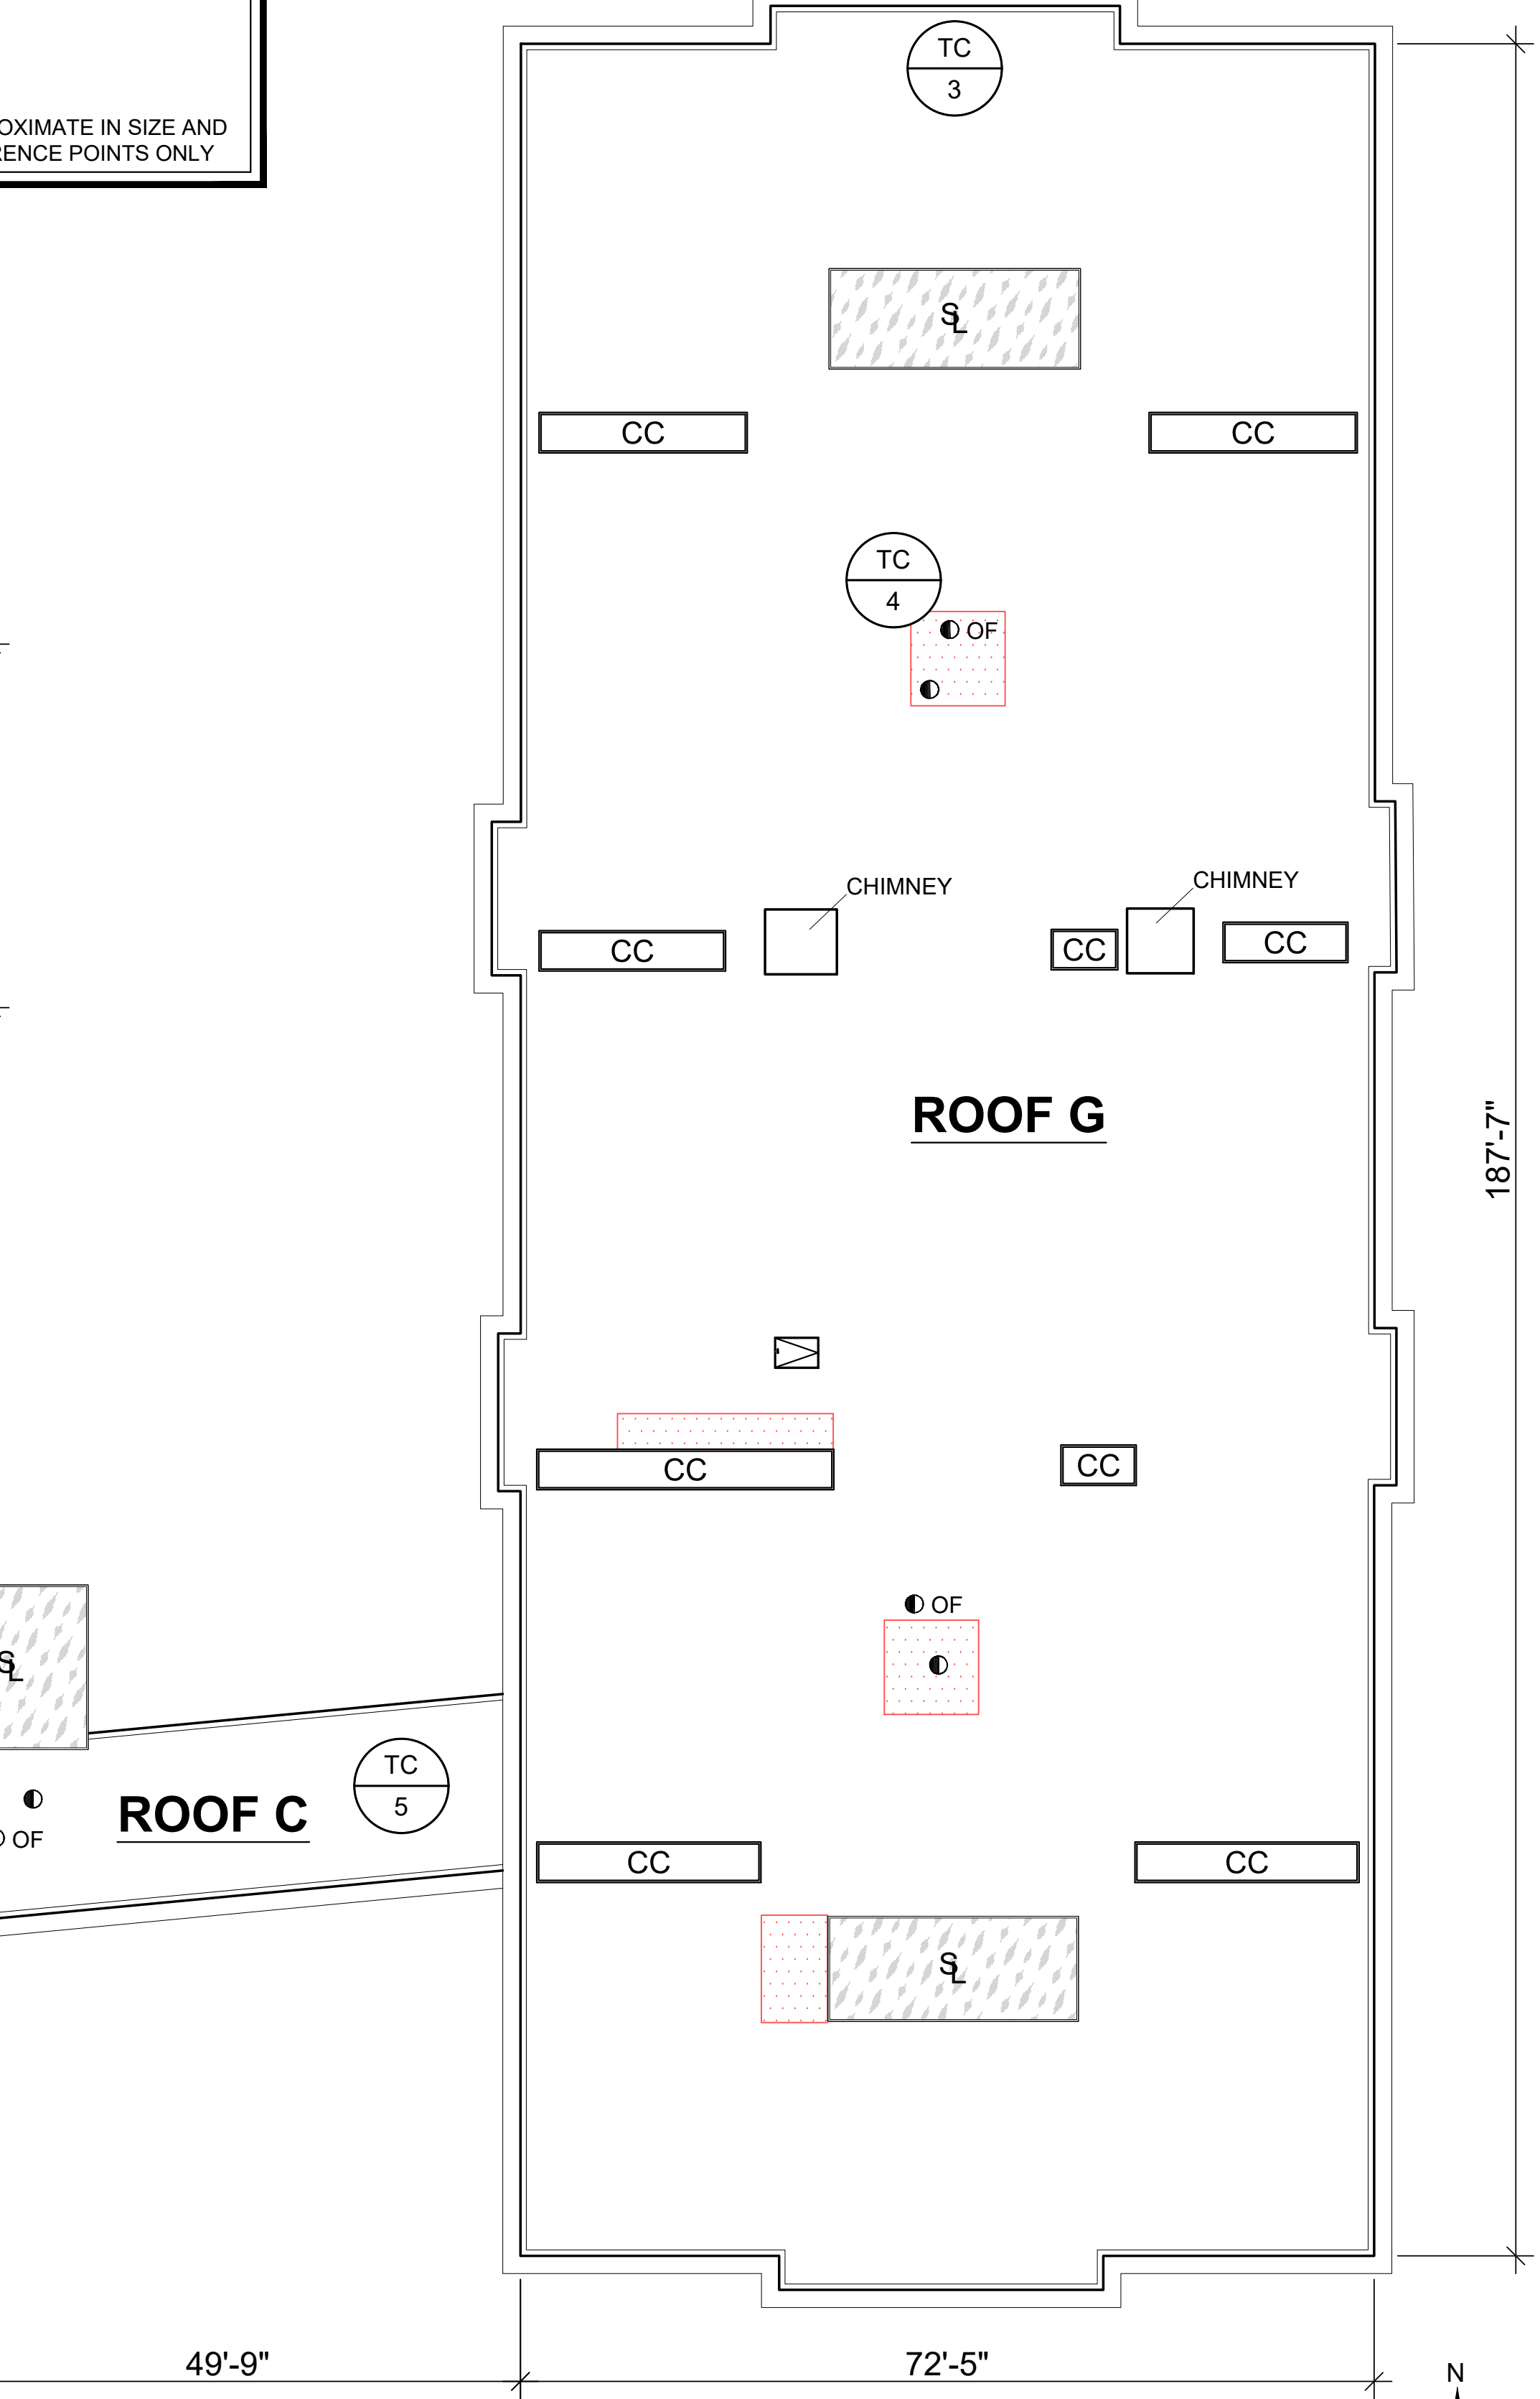
1 OVERALL ROOF PLAN  
A-1 SCALE: NTS

DEFICIENCY LIST	
1	DETERIORATED MEMBRANE
2	DEBRIS

MOISTURE SURVEY RESULTS				
ROOF SECTION	APPROX. SIZE (SF)	NUMBER OF WET AREAS	APPROX. WET AREAS (SF)	PERCENTAGE WET
ROOF 'A'	13,894	4	1,253	9%
ROOF 'B'	665	--	-	-
ROOF 'C'	689	--	-	-
ROOF 'D'	3,474	--	-	-
ROOF 'E'	5,452	1	5,452	100%
ROOF 'F'	2,272	2	786	35%
ROOF 'G'	13,600	4	234	2%
TOTAL	40,046	11	7,725	19%

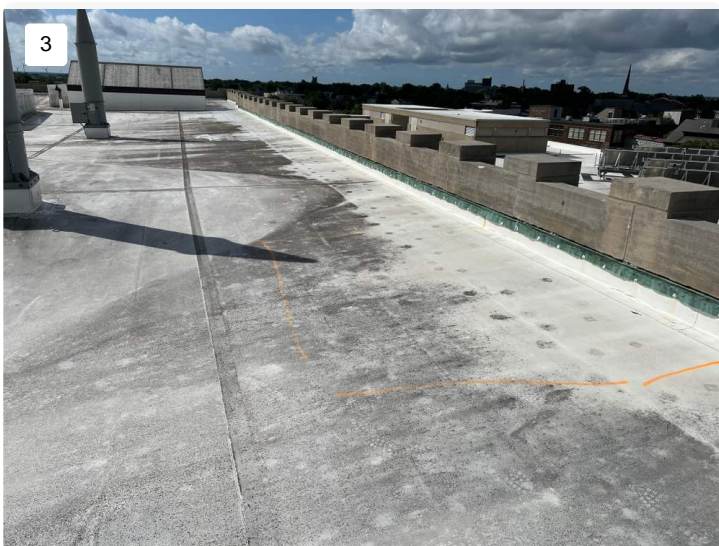
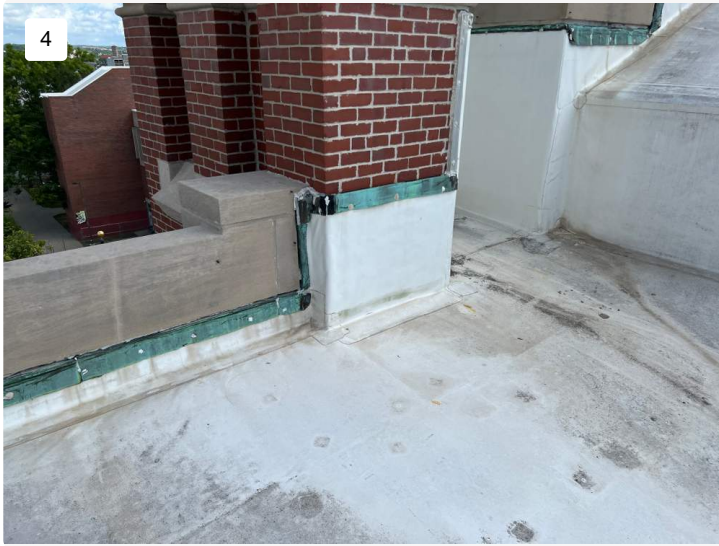
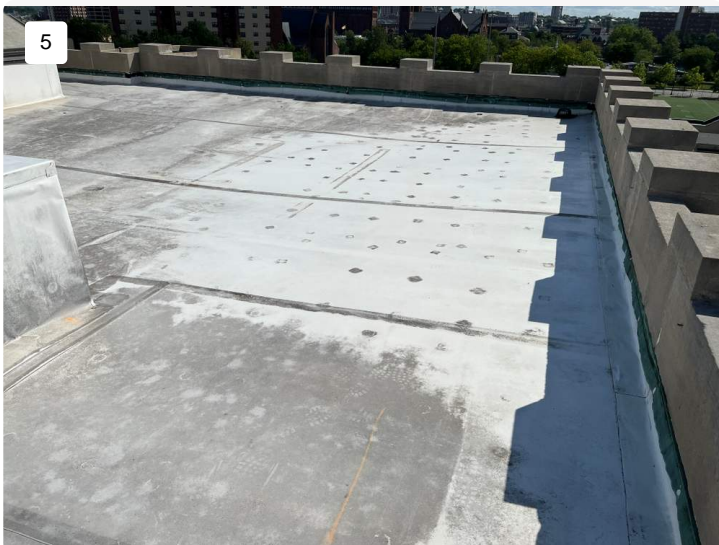
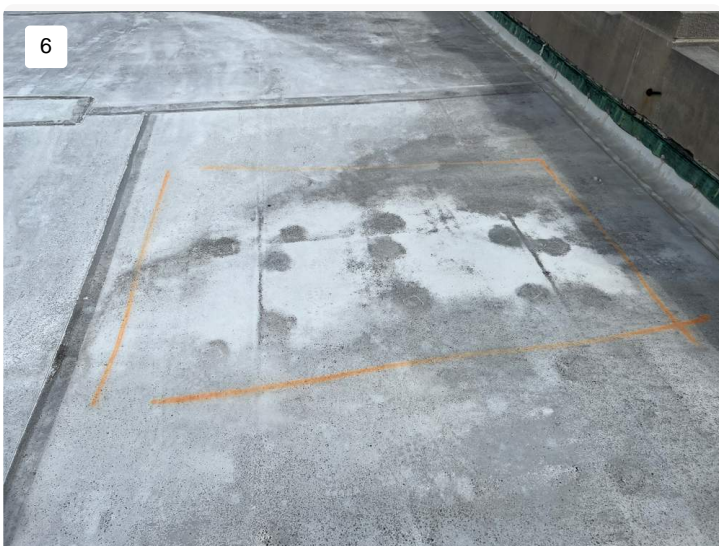
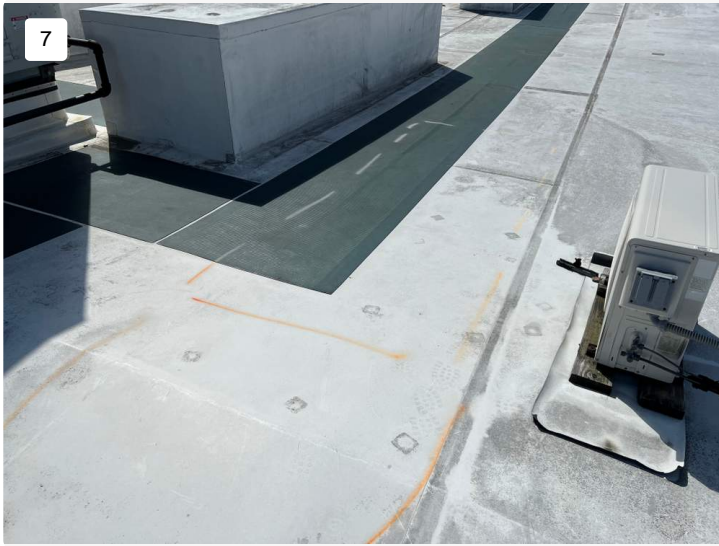
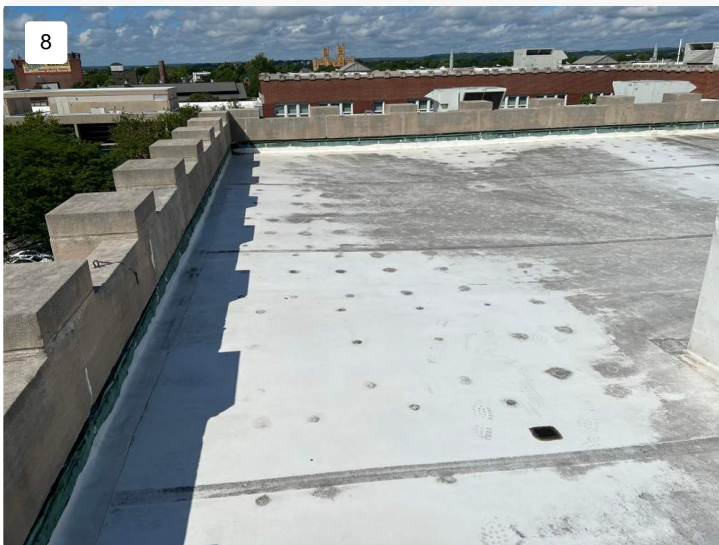
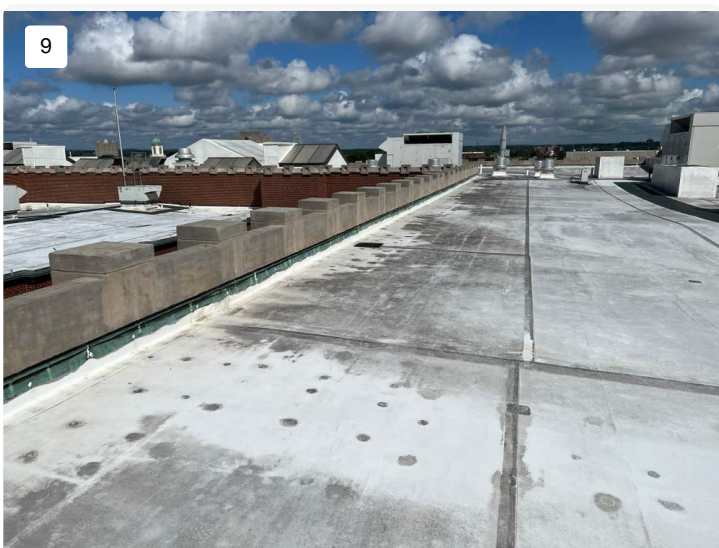
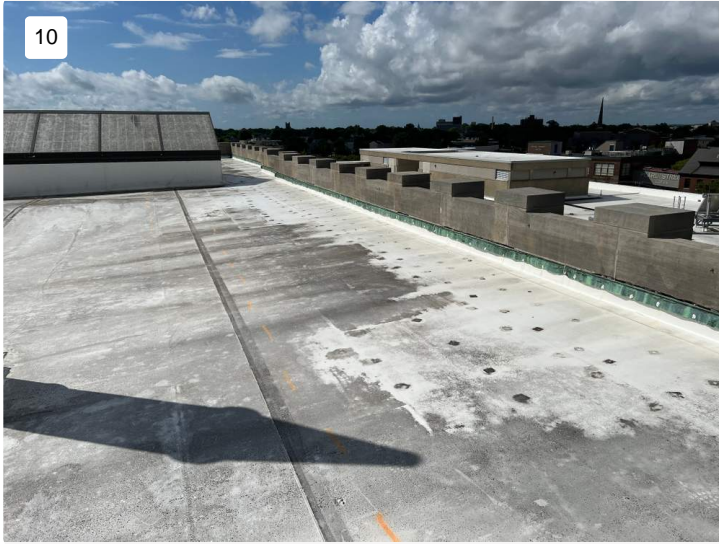
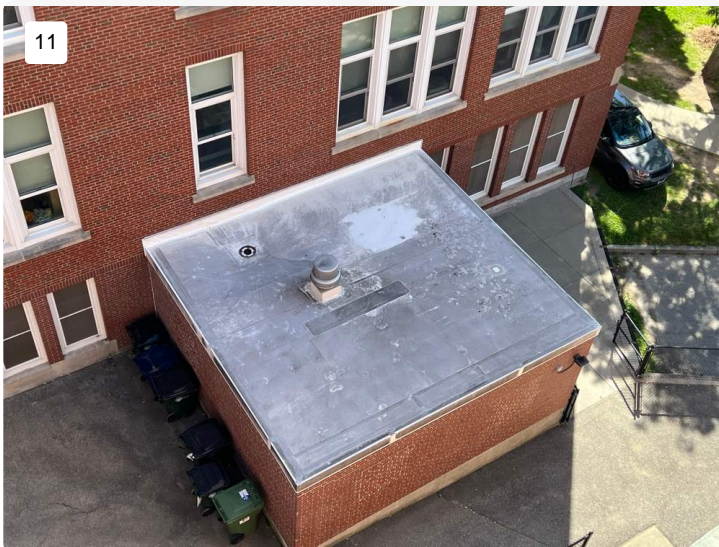
An infrared moisture survey was performed, and the result of the survey was positive - approximately **6,372 square feet (12%)** of the roof was wet, and the remaining roof area was dry. Please reference the roof plans for additional information.

Anomaly - wet insulation - marked with spray paint

The wet insulation should be removed / replaced with like kind as soon as budget allows. This repair work will be required before performing a roof restoration and will cost approx. \$25.00 square foot - **\$159,000. The masonry conditions that interface with the roof should be repaired before performing this scope.**

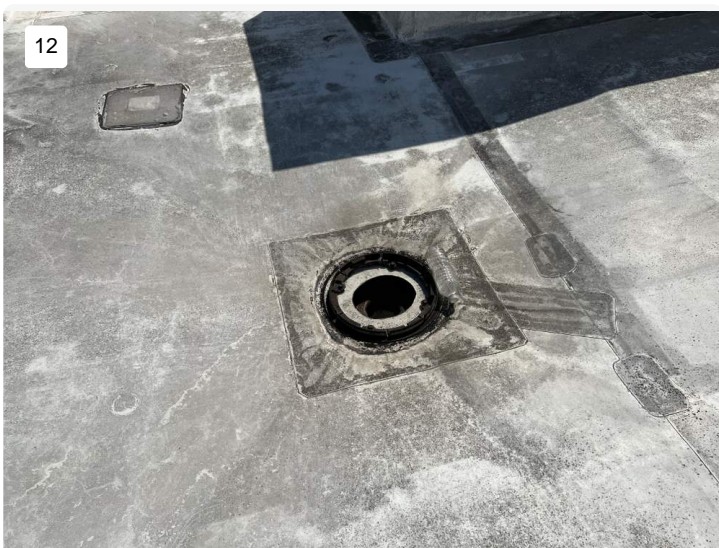
Missing drain strainer

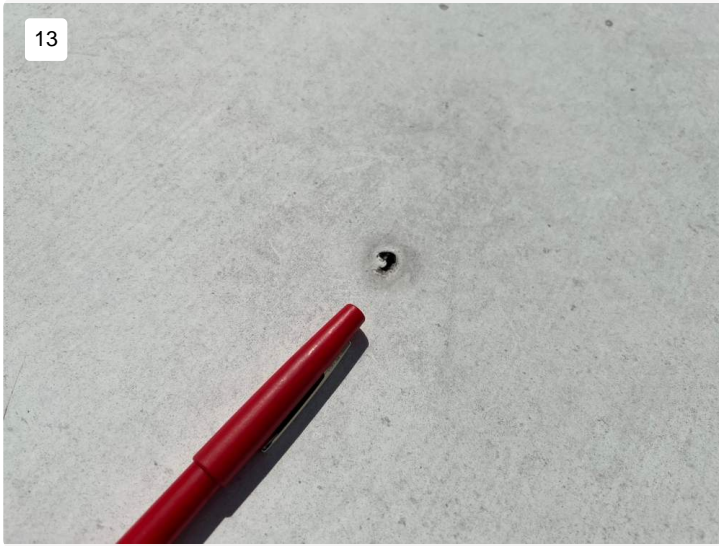
Puncture in single ply membrane

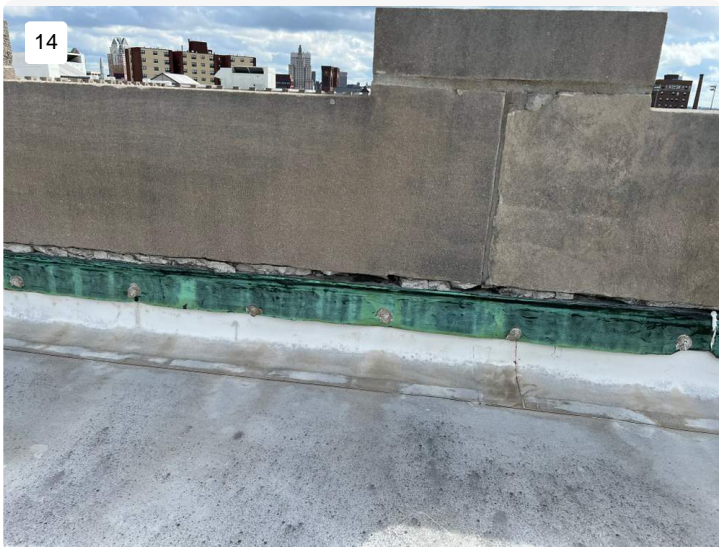
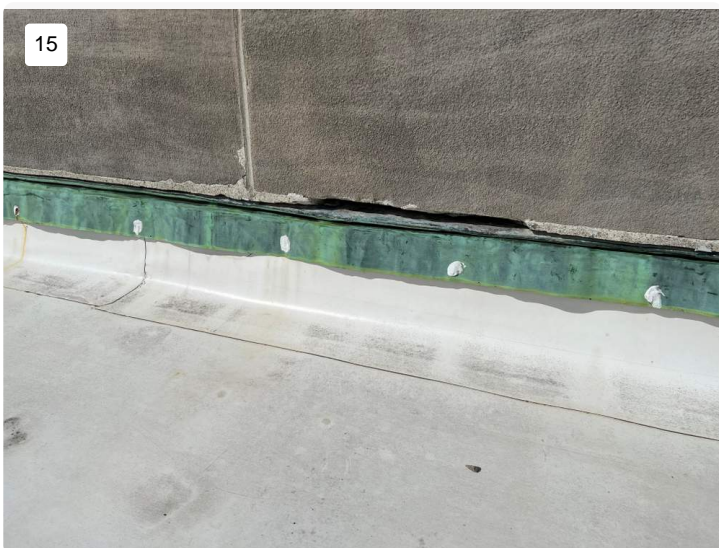
Deteriorated mortar joint at copper thru-wall flashing - typical

A complete building façade condition evaluation should be performed as soon as budget allows. Many of the roofing deficiencies/failures are from poor masonry conditions found at the roof interfaces i.e., low/damaged thru-wall flashings, deteriorated cap stones/joints, etc.

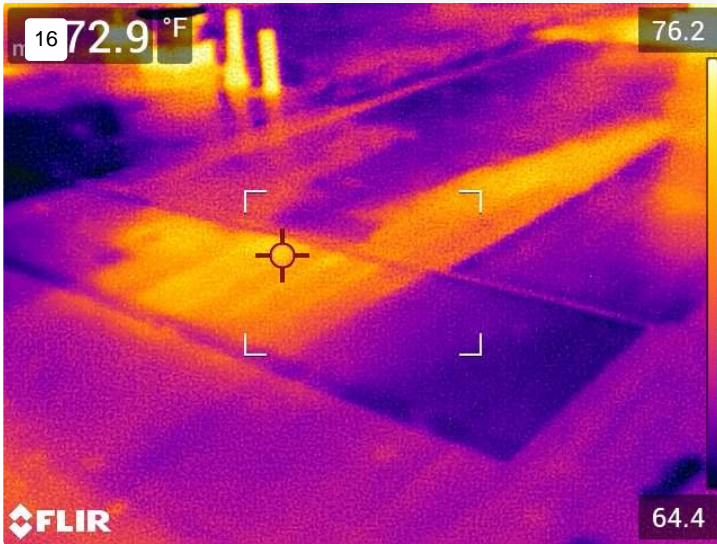
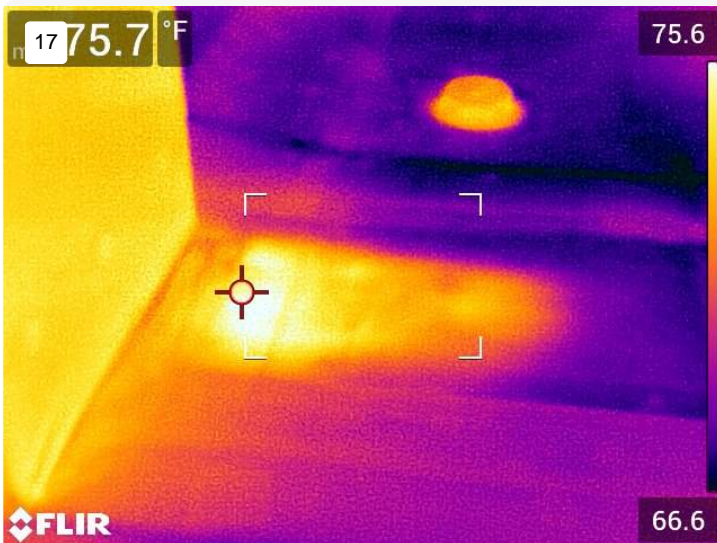
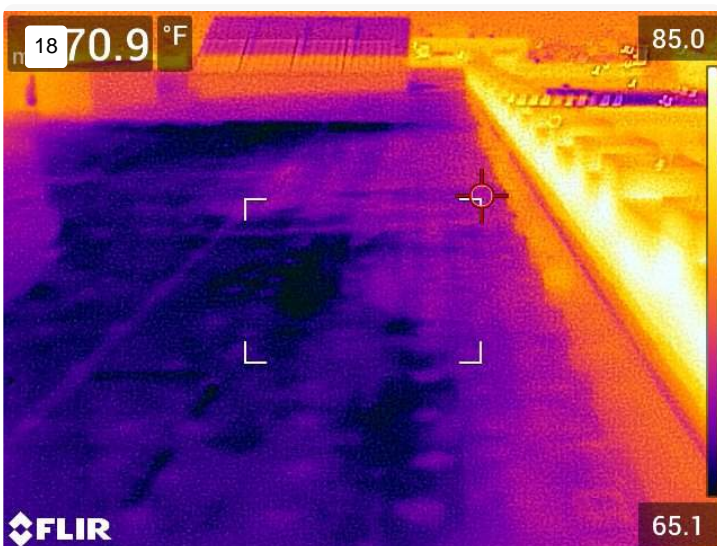
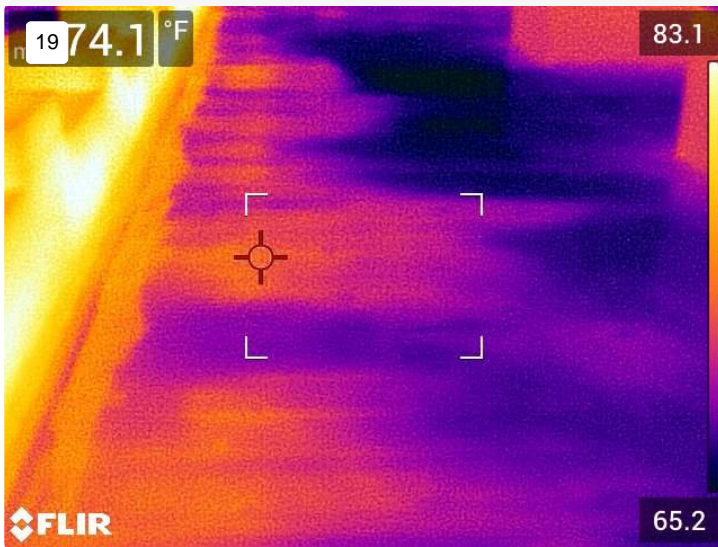
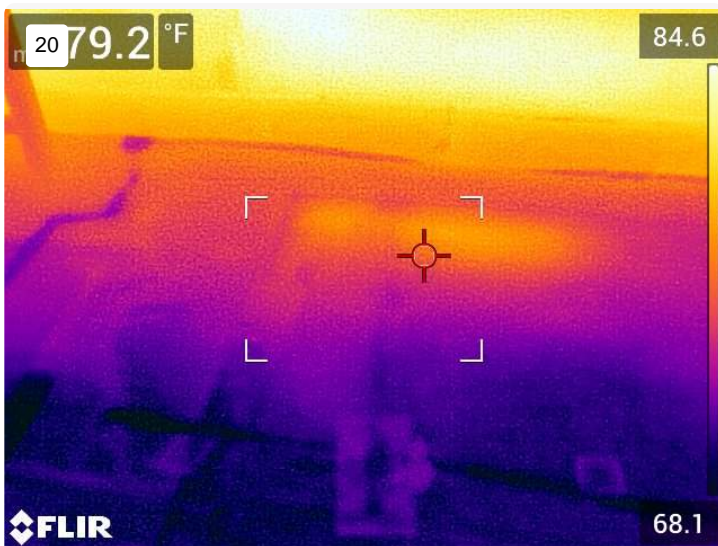
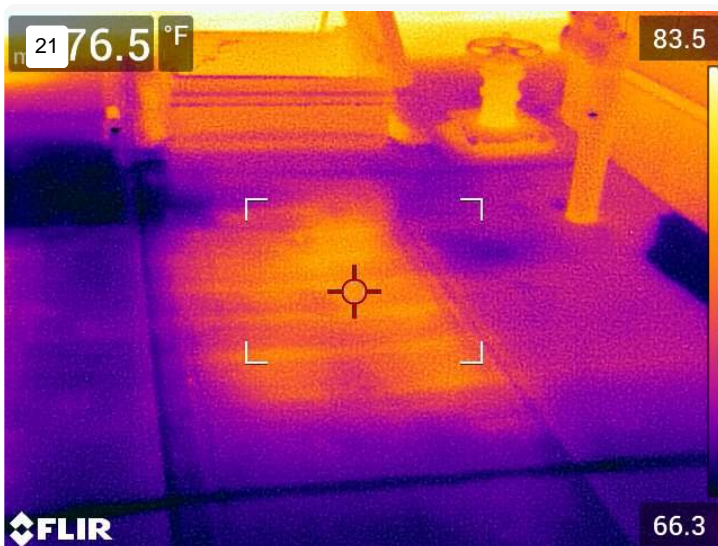
Thermogram identifying anomaly (wet insulation) in the roof assembly.
