**1. CASE 25.128, 361 WEST FOUNTAIN STREET, United Transportation Company, 1910 (PLD-ICBD)
CONTRIBUTING**

361 West Fountain Street, Providence

RE: STRUCTURAL ASSESMENT
361 WEST FOUNTAIN STREET
PROVIDENCE, RI 02903
CE&C PROJECT NO. 25037.00

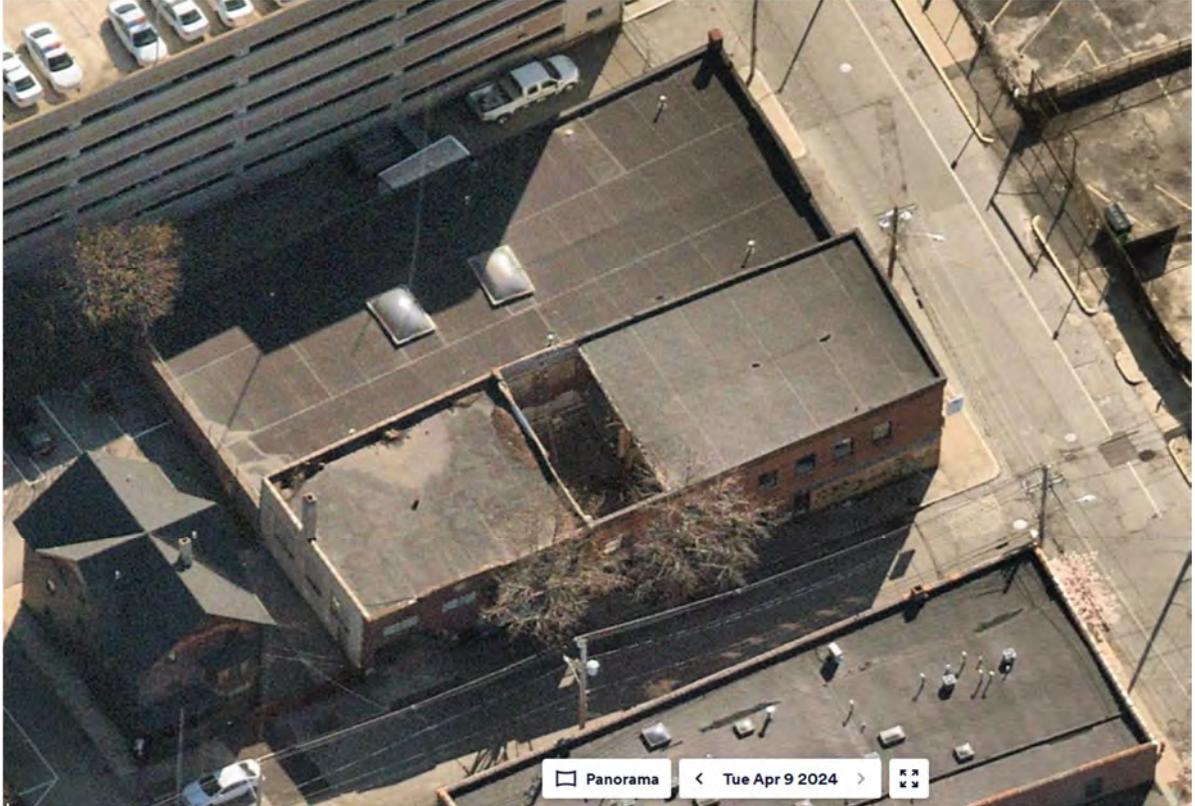
Photo 3 - 361 West Fountain Street aerial view from the west in March 2024 after collapse and removal of debris. This represents the present condition.

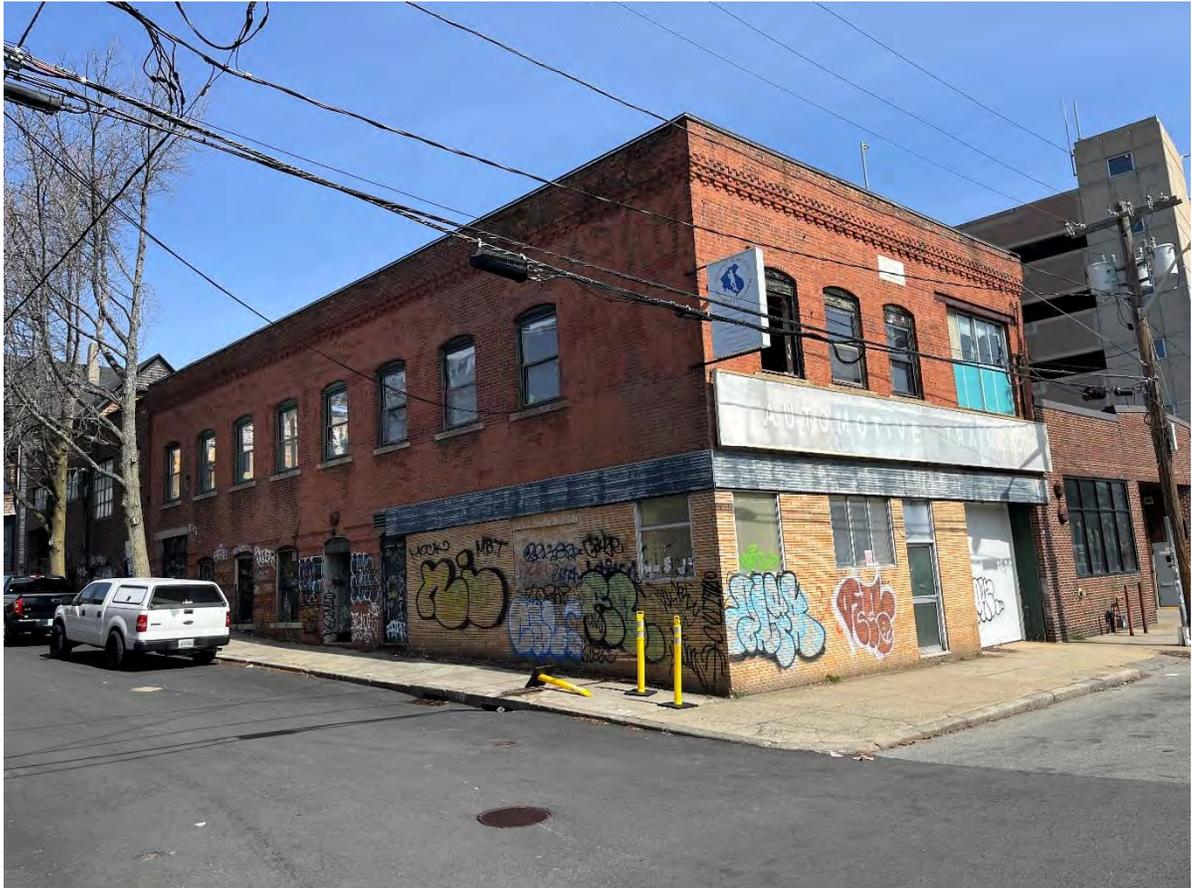
Photo 4 - 361 West Fountain Street view looking northeast. West Fountain Street is on the right and Cargill Street is on the left. This is the "front" portion of the building.

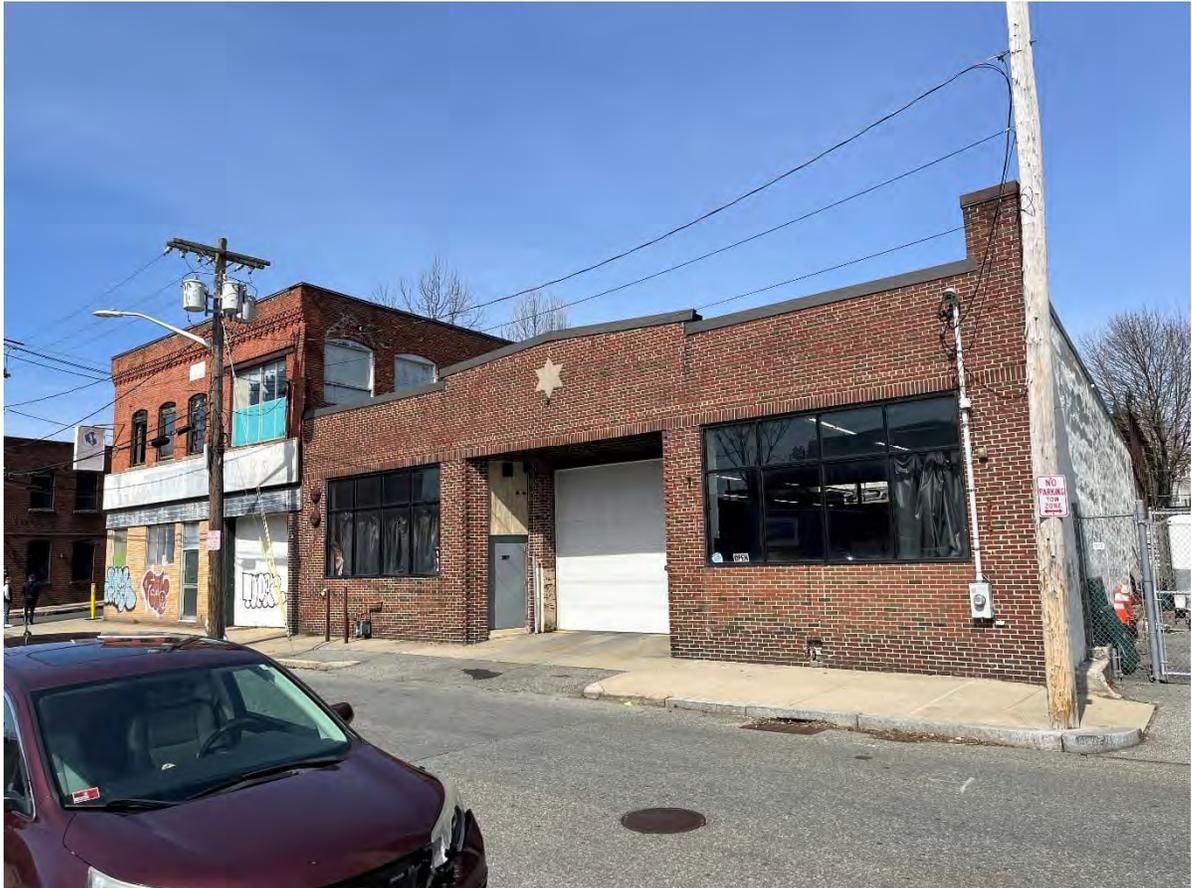
Photo 5 - 361 West Fountain Street (2-story building on the left) view looking northwest. The one story building in the foreground is the adjacent 357 West Fountain Street.

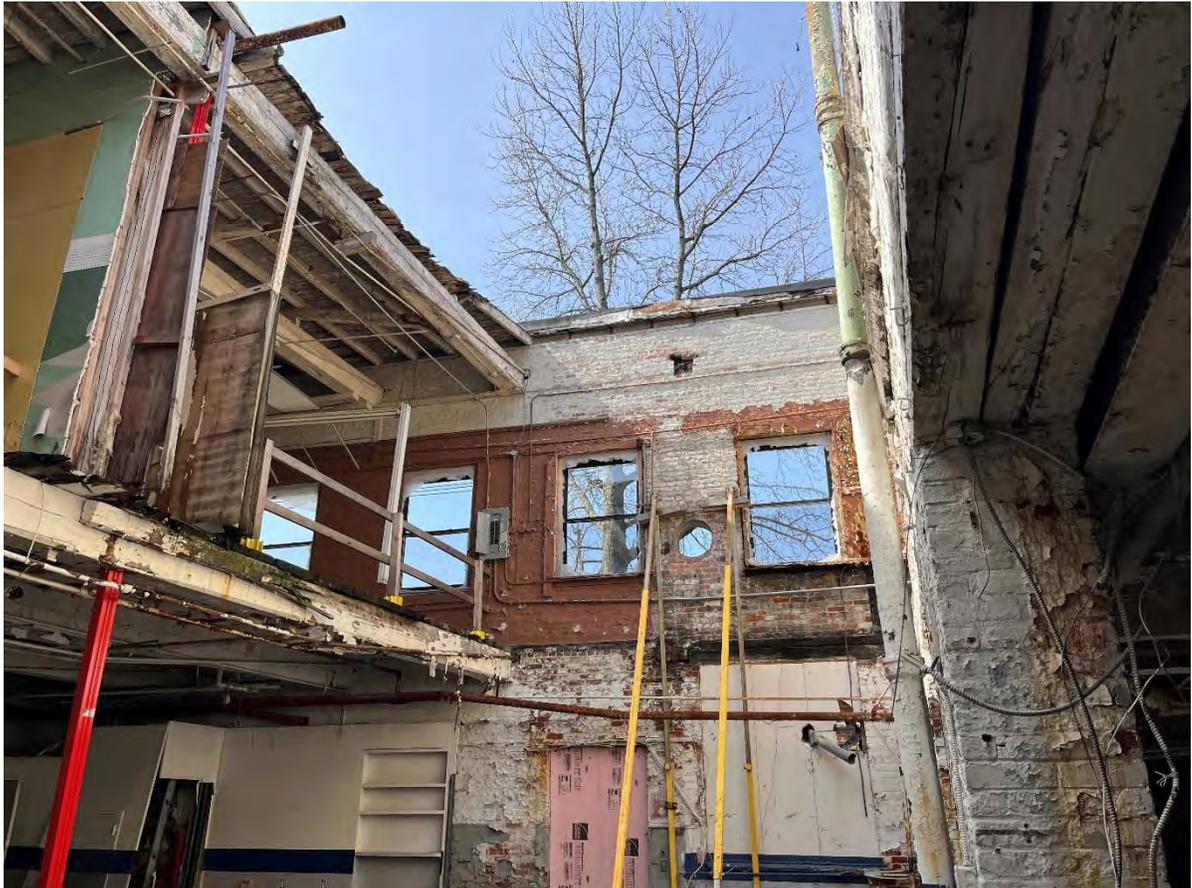
The previous owners installed temporary vertical shoring beneath the floor and roof beams immediately adjacent to the collapsed portions, and lateral bracing at the east and west walls at the locations of outward bulging (photos 9-13). By doing so the Building Department withdrew the condemnation order. However these shoring devices, the lateral ones in particular, appear to have been hastily installed, utilizing 2x wood blocks and plywood shims haphazardly stacked and fastened into the brick walls with masonry screws. The subsequent years of weathering has caused decay in the wood blocks & shims. Given the poor condition and inadequate method of attachment to the walls the devices appear to provide very little lateral resistance and should not be relied upon.

Photo 10 – Interior view “front” portion looking southwest in area of collapse (formerly bays 8 & 9). Note the twin lateral bracing towers and two shoring columns (painted red) supporting the damaged roof and floor beams.

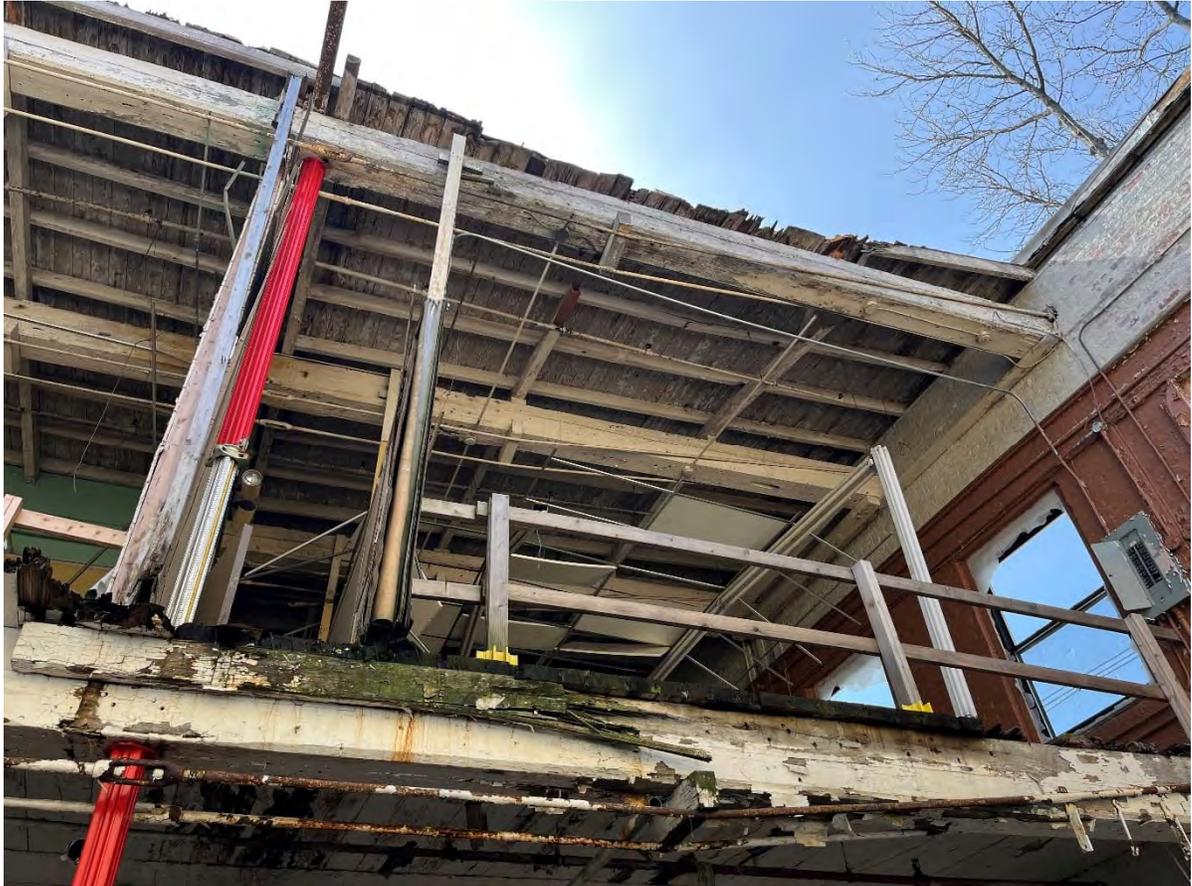
Photo 11 – Interior view “front” portion looking southwest. The steel tension rods with turnbuckles which add capacity to wood roof and floor beams #7 are visible. Note the two shoring columns (painted red) supporting the damaged roof and floor beams, the two broken roof purlins, and broken roof rafters in the remaining portion.

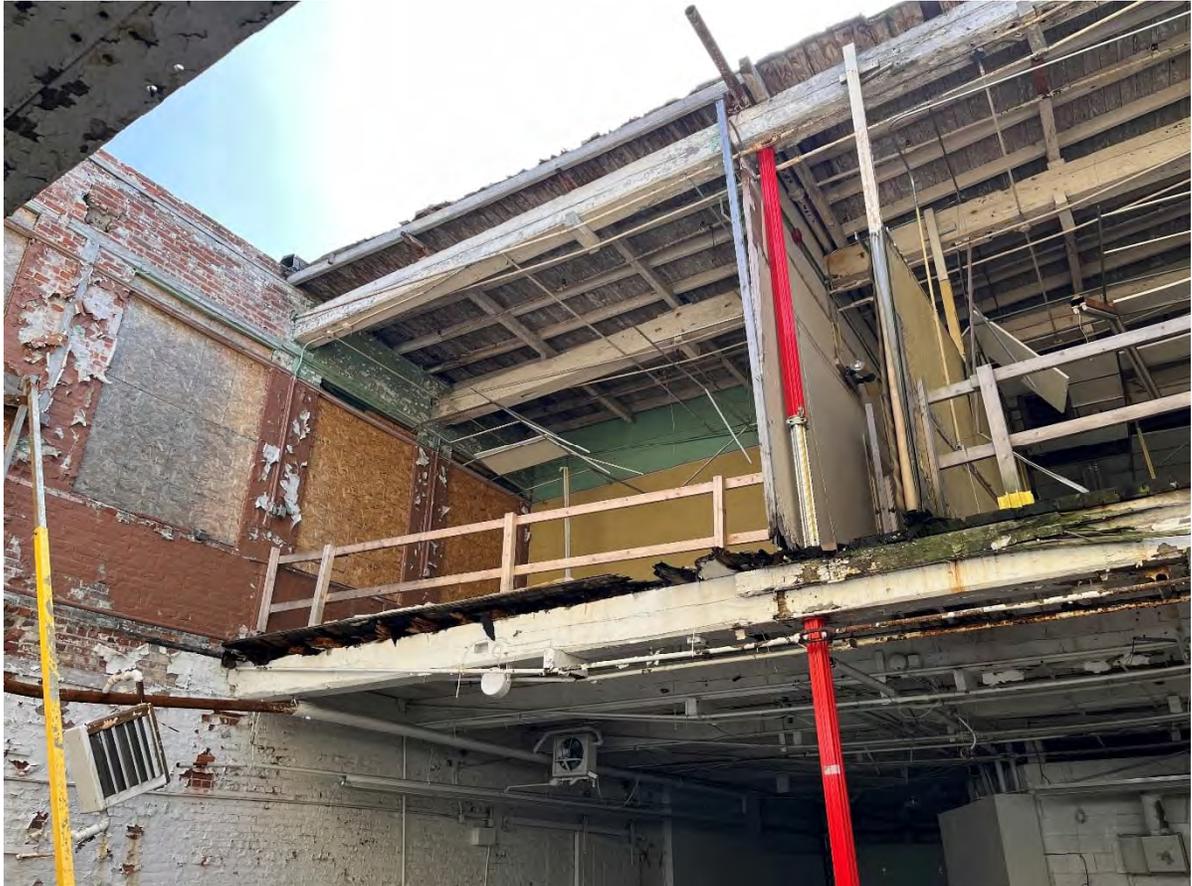
Photo 12 – Interior view “front” portion looking southeast. The steel tension rods with turnbuckles which add capacity to wood roof and floor beams #7 are visible. Note the two shoring columns (painted red) supporting the damaged roof and floor beams. The dividing walls on the second story are non-load bearing partitions.

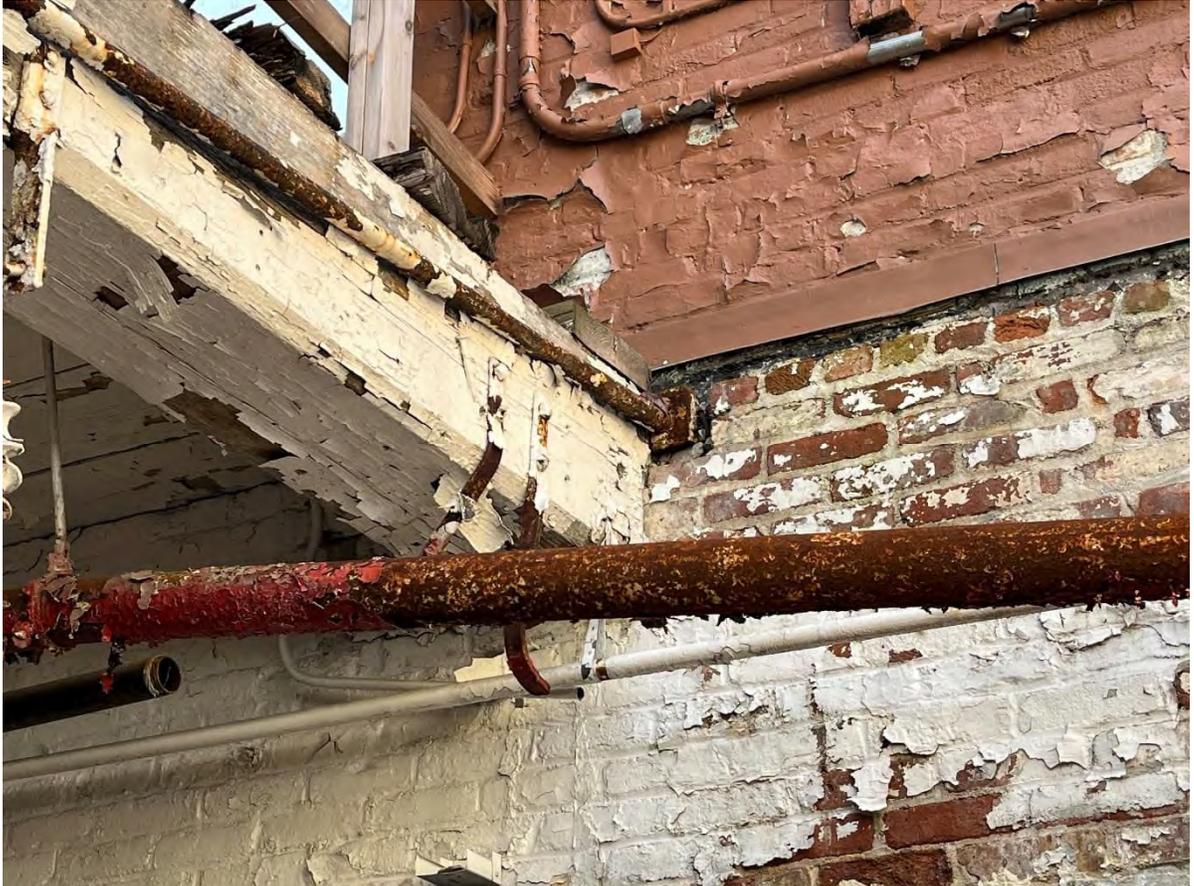
The cause of the collapse is clear; impounded water on the roof exceeded the design capacity of the structure. Per observations made during our visit the likely failure mechanism is as follows: forces from the impounded water exceeded the elastic limit of the steel backing plates, deforming them past their yield capacity and resulting in their sudden failure. Without the assistance of the steel components, the upward thrust effects were eliminated and the wood roof beam, which is much too small for the 40' span length, correspondingly failed. The 12' plummet of the collapsed roof structure onto the second floor caused the sudden failure of the underlying floor beam through the exact same means. The shock induced by this successive collapse caused a sudden momentary over stresses in at least four of the adjacent floor beams (the remainder were not visible due to ceiling finishes), similarly deforming their steel backing plates beyond the elastic limit, but apparently not quite to the yield point, resulting in the visible damage (pulling-away) of the surrounding interior brick courses (photos 14-16).

Photo 14 – Interior view “front” portion looking southwest at the west end of floor beam #7. The steel tension rod backing plate, which was once embedded within the brick wall, is visible.

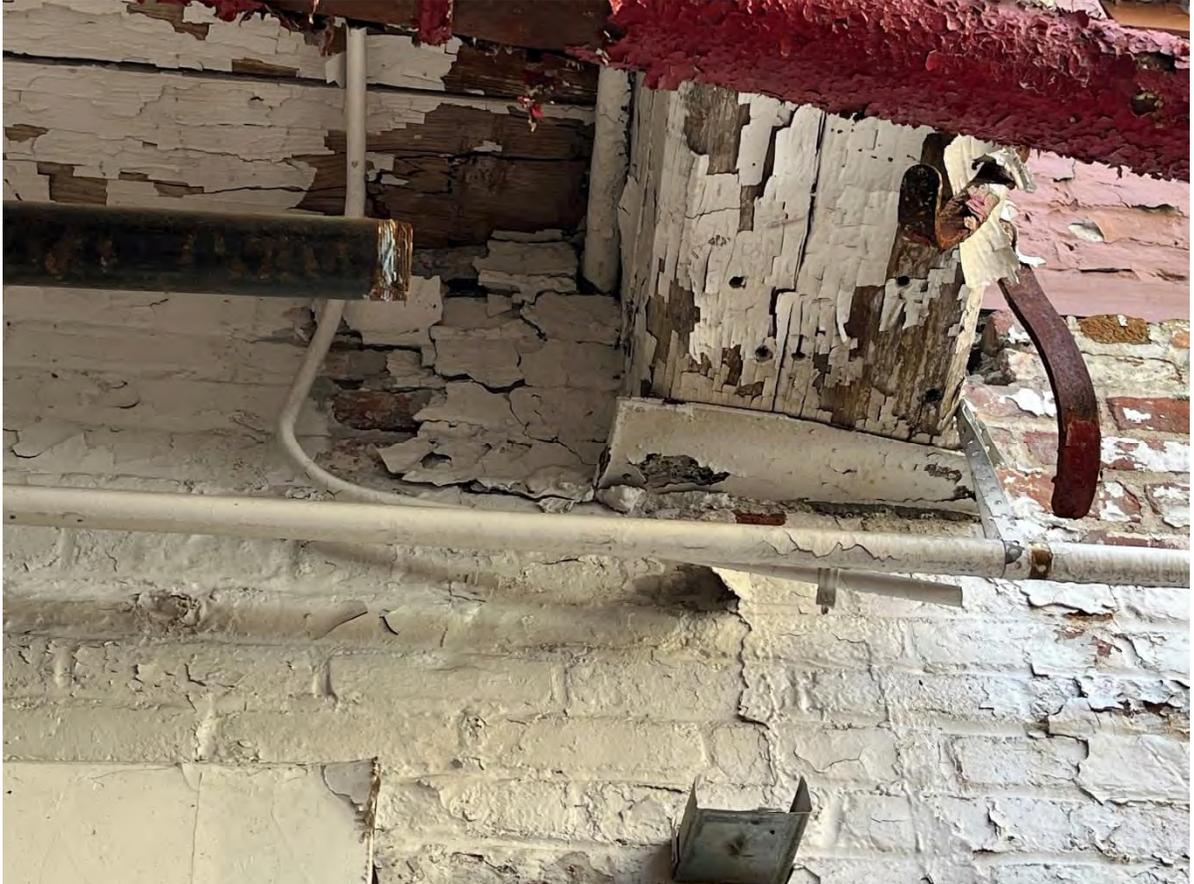
Photo 15 – Interior view “front” portion looking west at the west end of floor beam #7. Note the damage to the brick coursing due to deformation of the embedded steel tension rod backing plate.

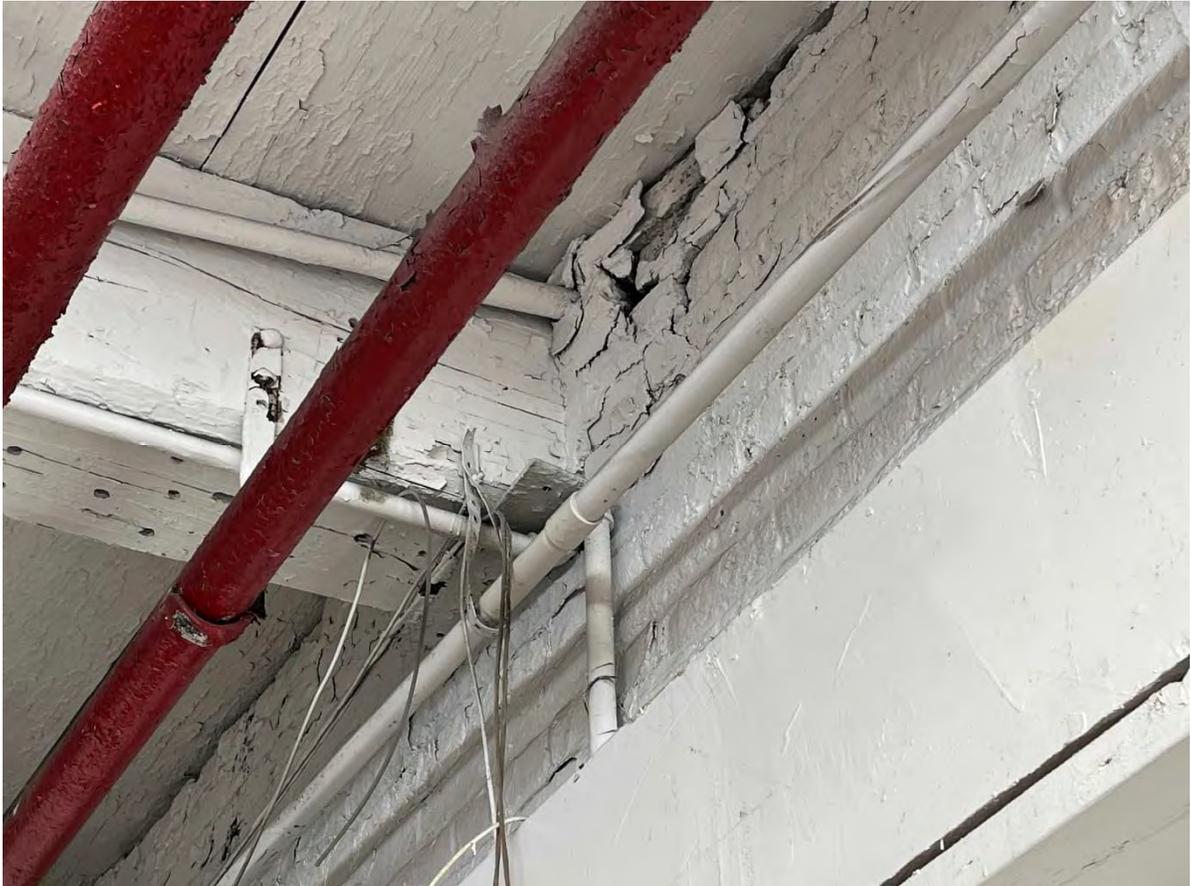
Photo 16 – Interior view “front” portion looking southwest at the west end of floor beam #6. Note the damage to the brick coursing due to deformation of the embedded steel tension rod backing plate.

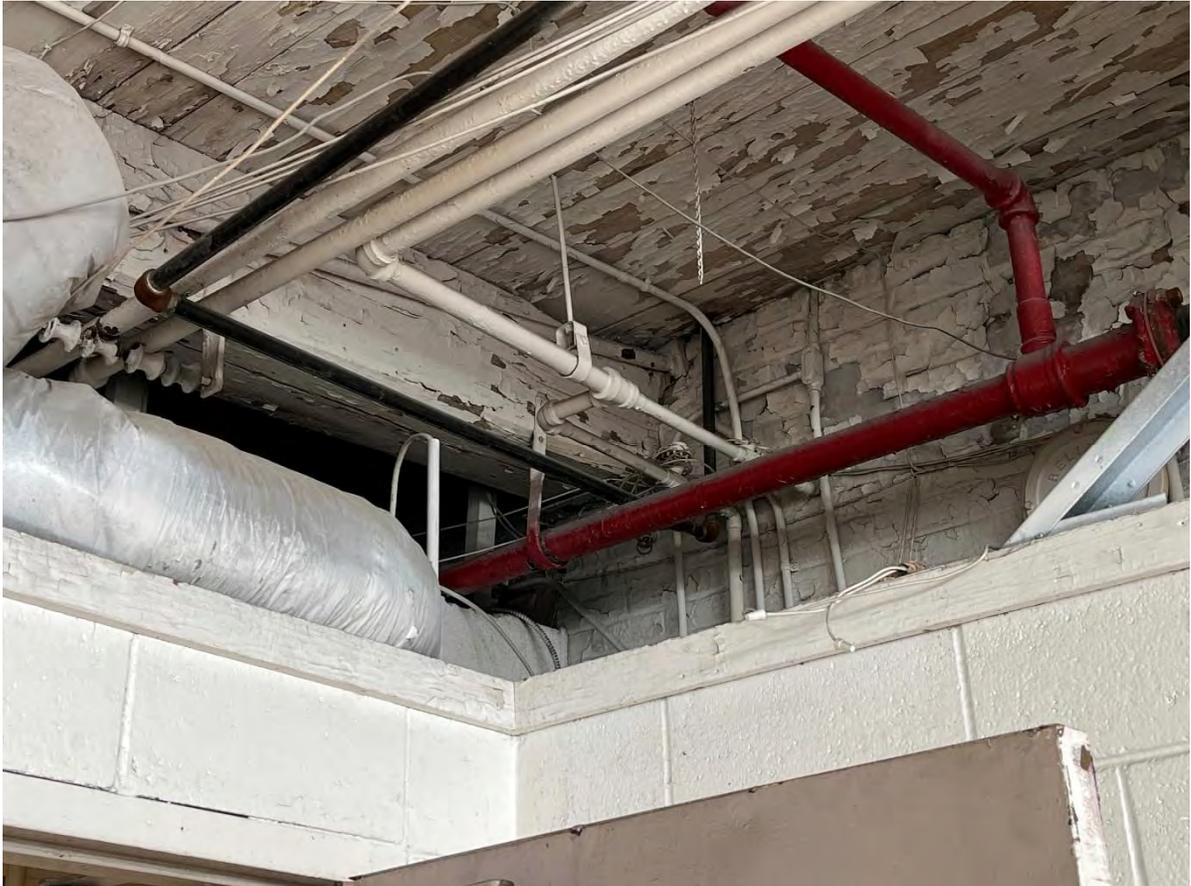
The exposed components of the roof and floor systems exhibit areas severe of decay which suggests this damage was many years in the making and has not necessarily occurred during the past 2+ years of full exposure to weather. The floor planks in the bay immediately adjacent to the collapse are water saturated and visibly decayed (photo 18). The two adjacent floor beams exhibit similar deficiencies, with longitudinal splits and water leakage actively removing the paint. The condition of the beam ends which are let into the masonry walls could not be assessed, but given the general dampness of the walls it is assumed that some degree of wood decay is present. This is particularly disturbing as the steel backing plates rely on the compressive resistance of the wood in these areas to properly transfer the tensile forces from the steel rods. Crushing of the wood fibers in the beam ends, further exacerbated by decay, could result in a sudden loss of capacity. This condition appears to be occurring at floor beam #5 (photo 17).

Photo 17 – Interior view “front” portion looking southwest at the west end of floor beam #5. At this location the steel tension rod backing plate appears to be withdrawing upward and over the back of the wood beam due to crushing of the wood fibers, possibly exacerbated by wood decay.

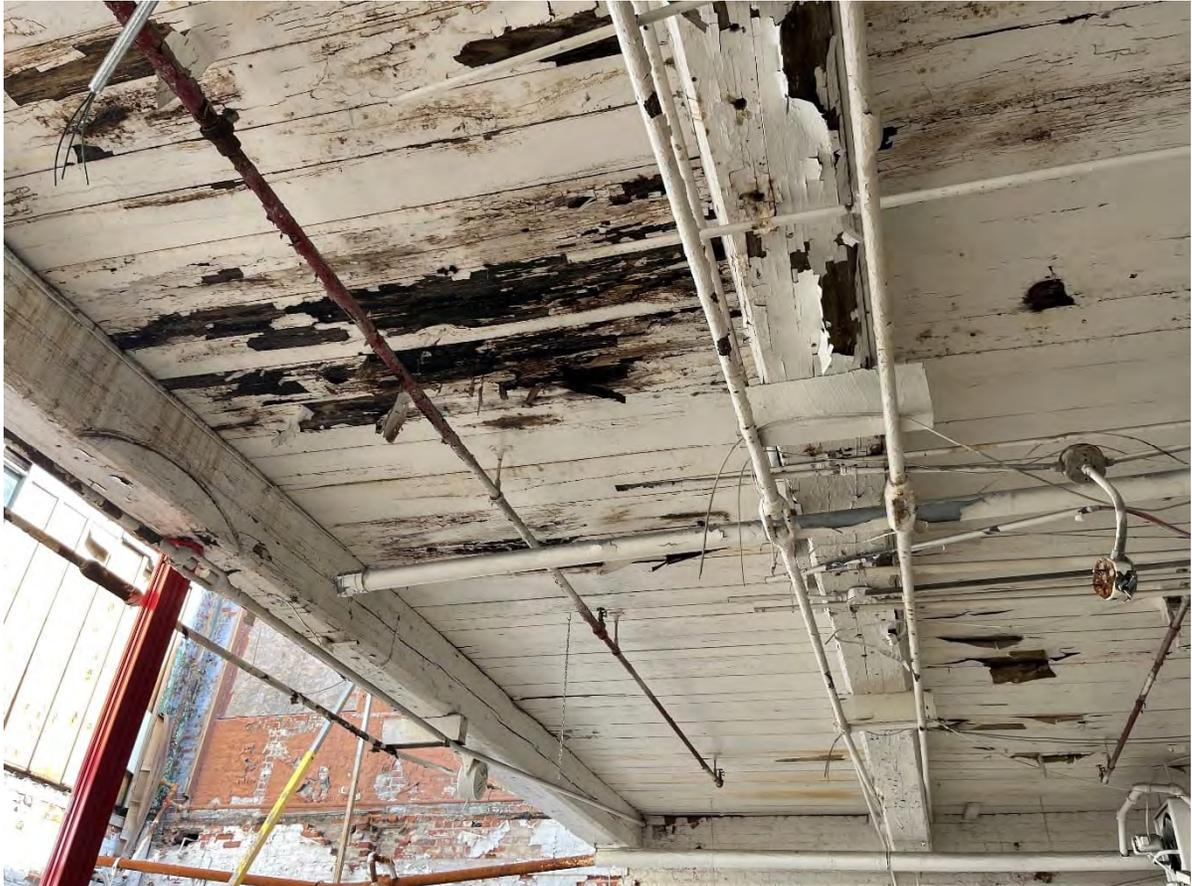
Photo 18 – Interior view “front” portion looking northeast at floor beams #7 and #6. Note severe decay of the wood plank flooring and water damage and longitudinal splitting of wood beams.

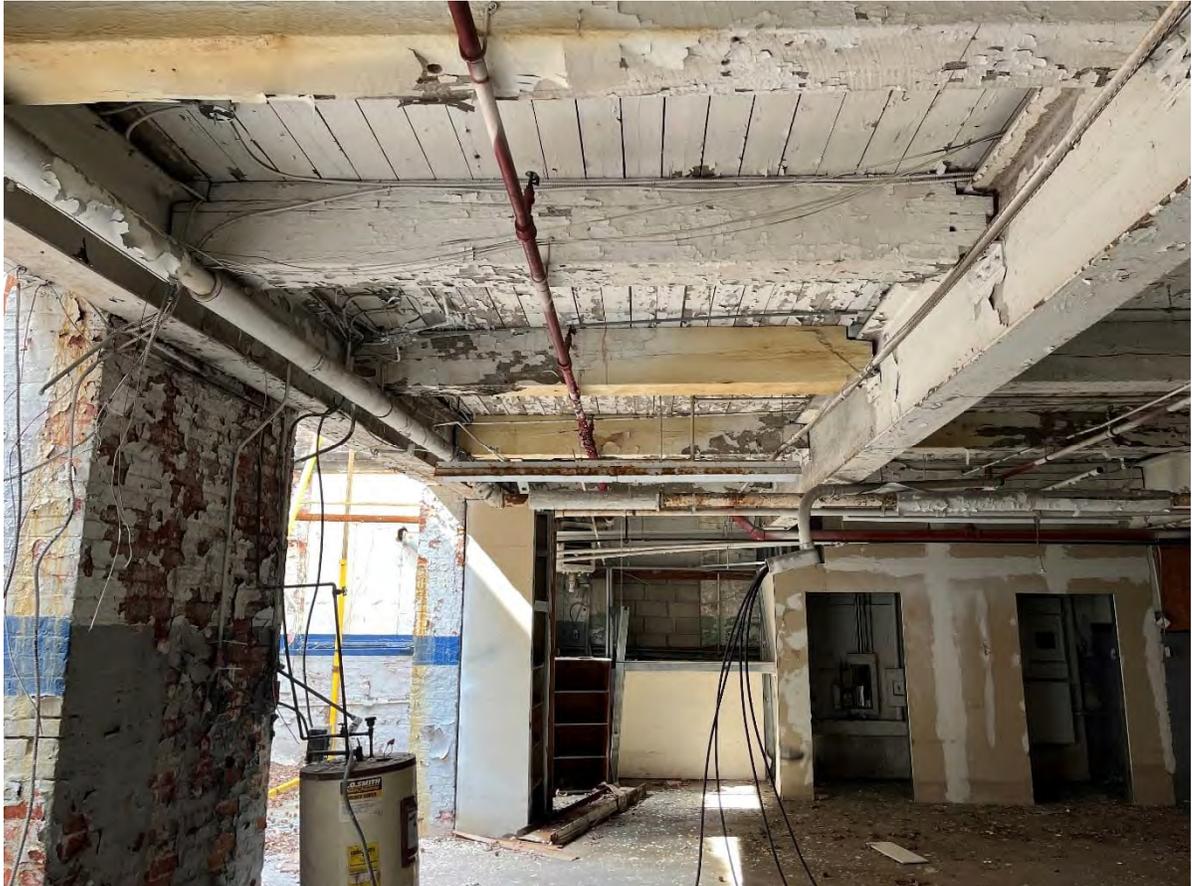
Generally speaking the rear portion of the building appeared to be in overall satisfactory condition, with some evidence of water infiltration and resulting damage, likely attributed to the lack of an adjoining roof, though the aerial images do indicate ponding from clogged roof drains is also present here. The wood beams displayed water staining and horizontal cracks and splits, some of which emanate from notches in the beam ends that were necessitated to achieve the proper installation height (photos 21 & 22). The steel girders

Photo 21 – Interior view “rear” portion looking west adjacent to the dividing wall between the “rear” and “front” portions. Note water staining (yellowing) and damage to the wood floor beams. Also note the notching of the top and bottom surfaces of the wood floor beam ends and the resulting longitudinal splitting which emanates from these notches.

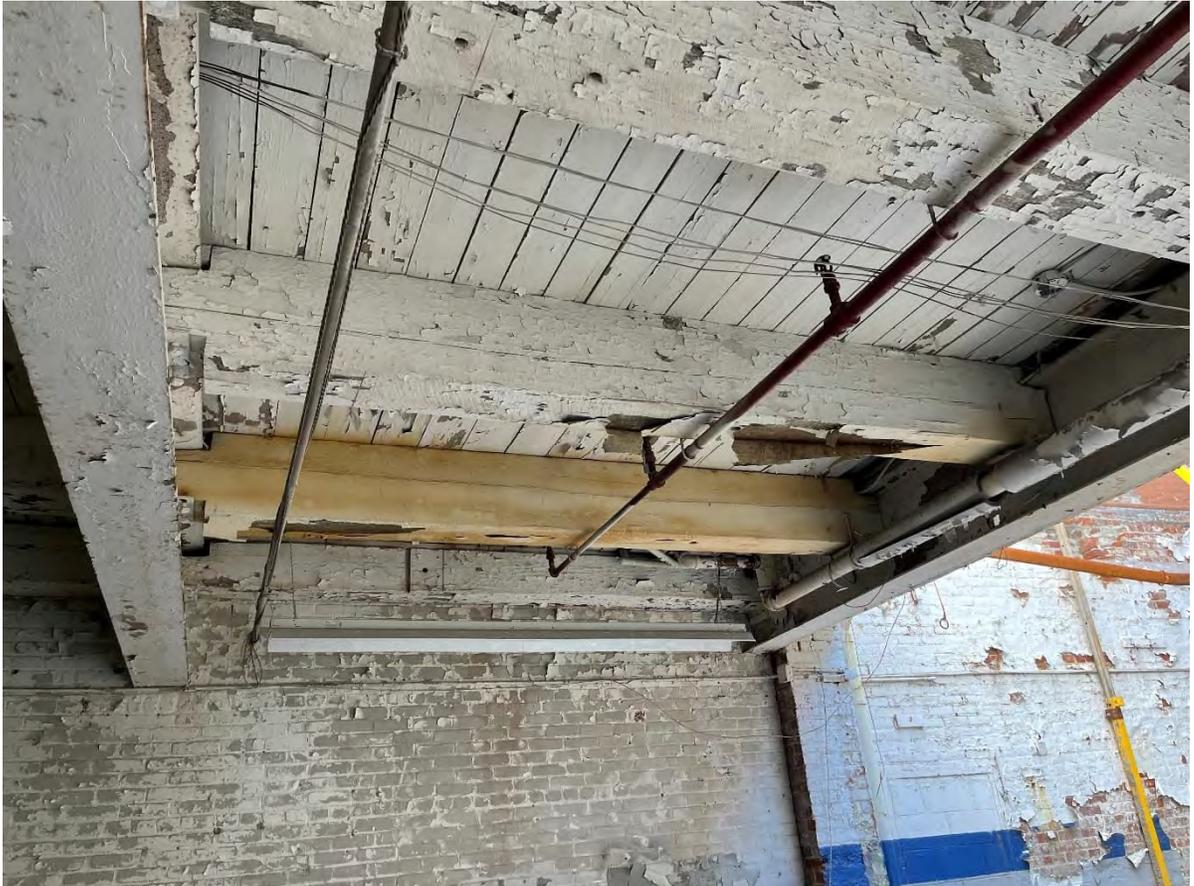
Photo 22 – Interior view “rear” portion looking east adjacent to the dividing wall between the “rear” and “front” portions. Note water staining (yellowing) and damage to the wood floor beams. Also note the notching of the top and bottom surfaces of the wood floor beam ends and longitudinal splitting.

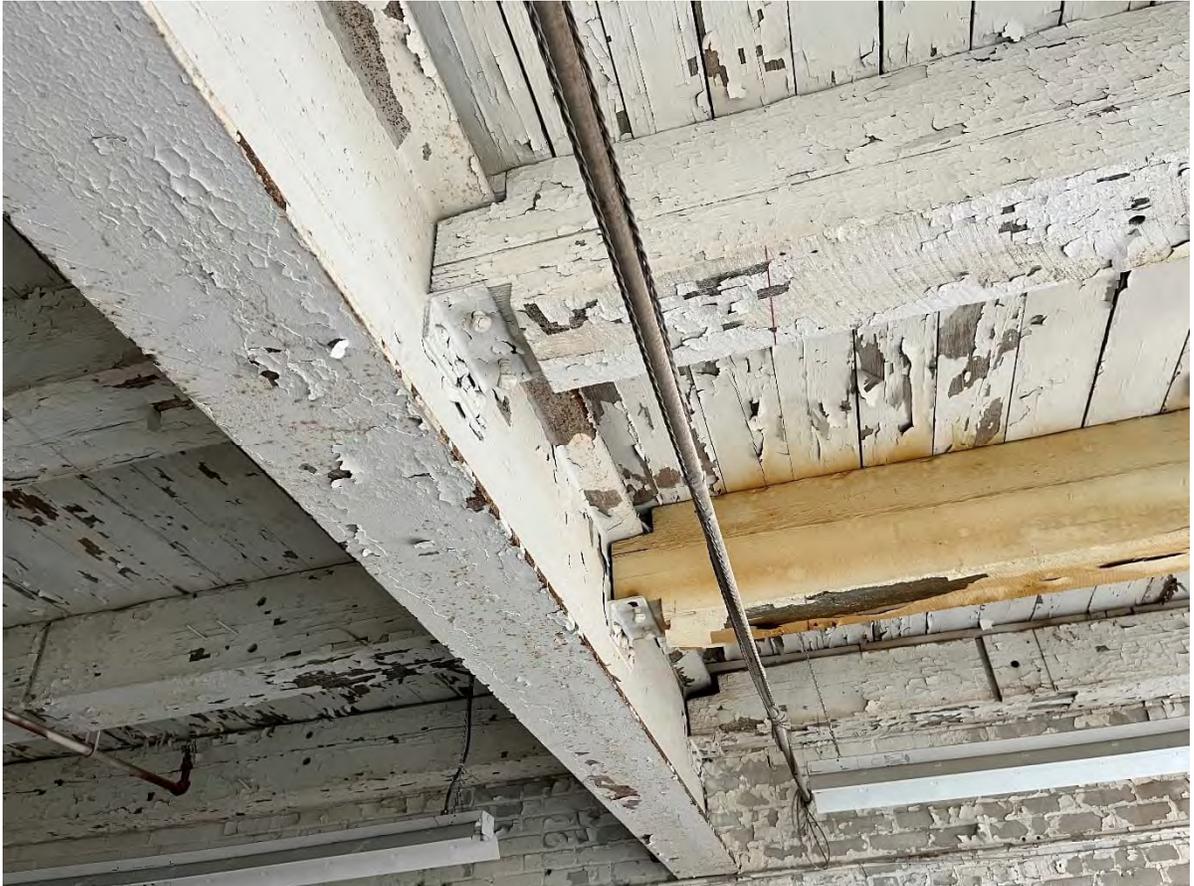
themselves appeared to be in reasonably good condition, with the only noteworthy related deficiencies being step cracking of the brick walls beneath the girder bearing points, possibly indicating an overstress of the supporting walls (photo 24). Although they visually appeared to be in good order, the rivets which join the clip angles to the steel girders can be a problematic structural detail as they are subject to fatigue-related failure when exposed to prolonged cyclical loading (this portion of the building was once a parking garage, photo 23).

Photo 23 – Interior view “rear” portion looking northeast. Detail of the riveted clip angles which support the wood floor beams. Riveted connections are a fatigue-prone detail.

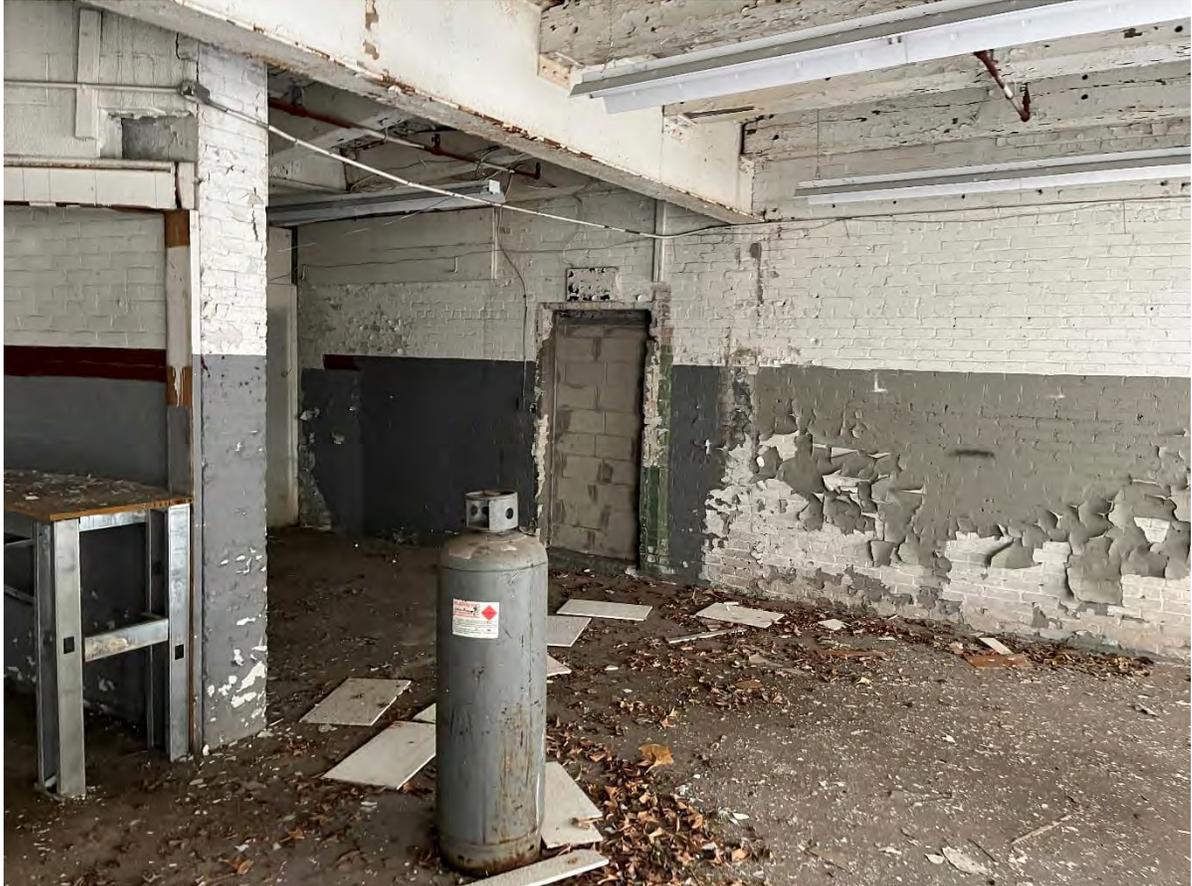
Photo 24 – Interior view “rear” portion looking northeast. Note step cracking in brick masonry wall mortar joints beneath the east end of the 24” deep steel girder.
