**2. CASE 26.105, 113 BROADWAY, Commercial Building, pre1875, 1921, 1956 (BROADWAY)**  
NON-CONTRIBUTING

RE: STRUCTURAL ASSESSMENT  
113 BROADWAY  
PROVIDENCE, RI 02903  
CE&C PROJECT NO. 25087.00

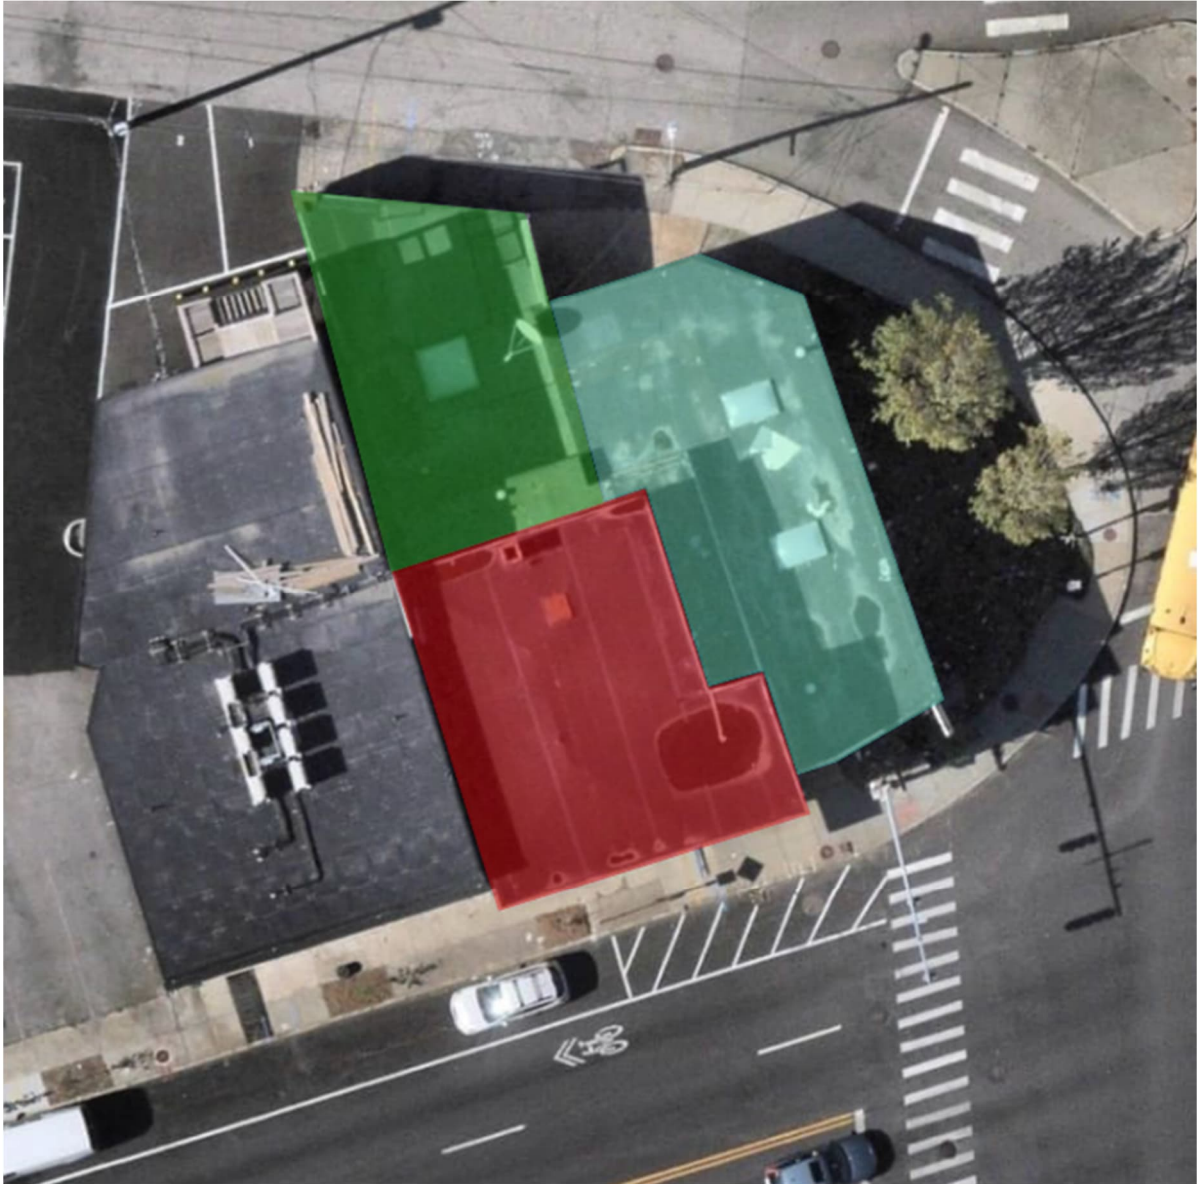
Photo 1: 113 Broadway Building Overview. Red = Southern Portion, Green = Northern Portion, Cyan = Eastern Portion. Note large puddle on roof of Southern Portion. This is the location of the “southeastern protrusion” noted in the report.

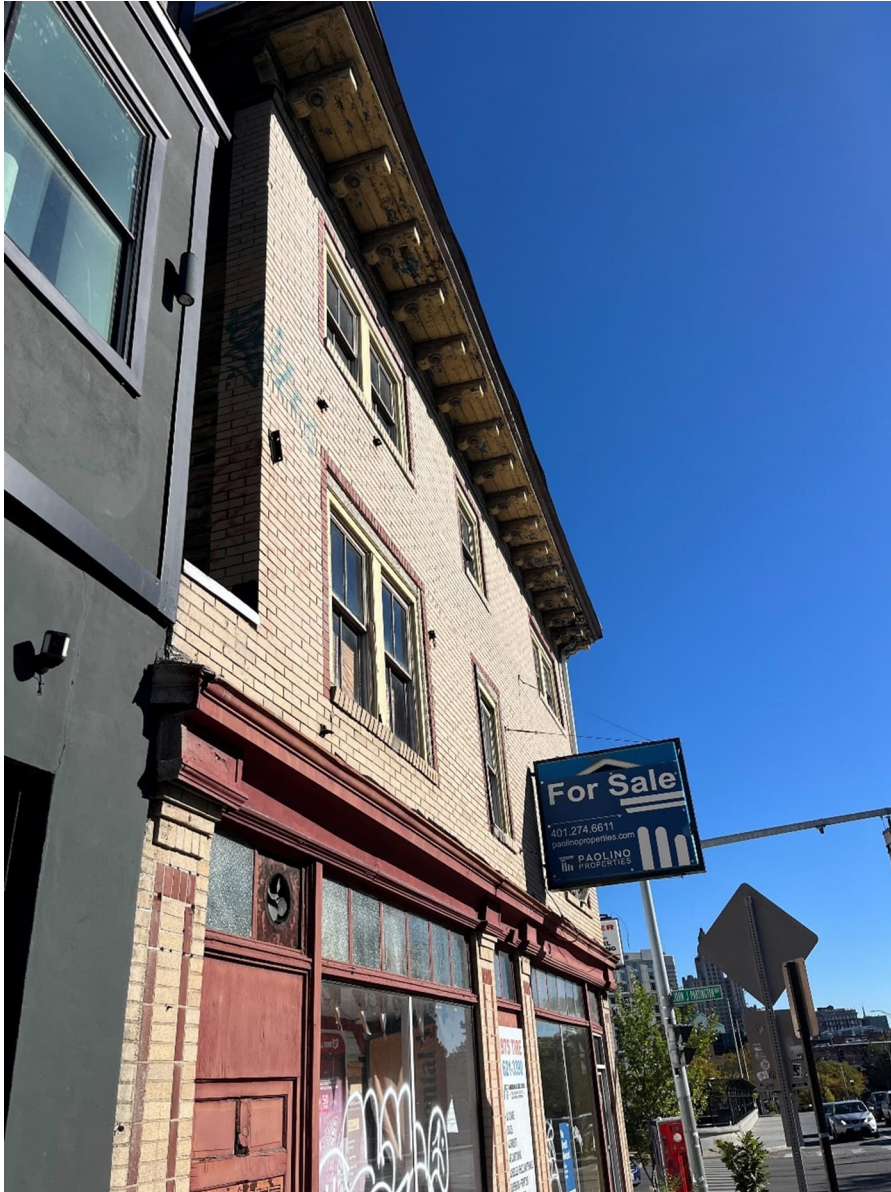
(Photo 13), (the beam at the eastern storefront window displayed similar a deflection), (Photo 6). The combination of beam deflection and floor joist deterioration caused by water infiltration has resulted in the noted deficiencies. The separation of the south load bearing wall from the floor structure is clearly discernible from the exterior as an out of plumb wall (Photo 6). The brick veneer is similarly pulling away from the underlying wood substrate, as evidenced by an undulated surface and nearly 1" wide gap behind the veneer when viewed from the east, which indicates deterioration of the brick ties or rotting of the underlying wood framing which they are anchored to (Photo 7).

Photo 6 – 113 Broadway South Elevation looking Northeast. Note undulations of building façade caused by a combination of structurally inadequate framing and the separation of the brick veneer from the wood substrate.

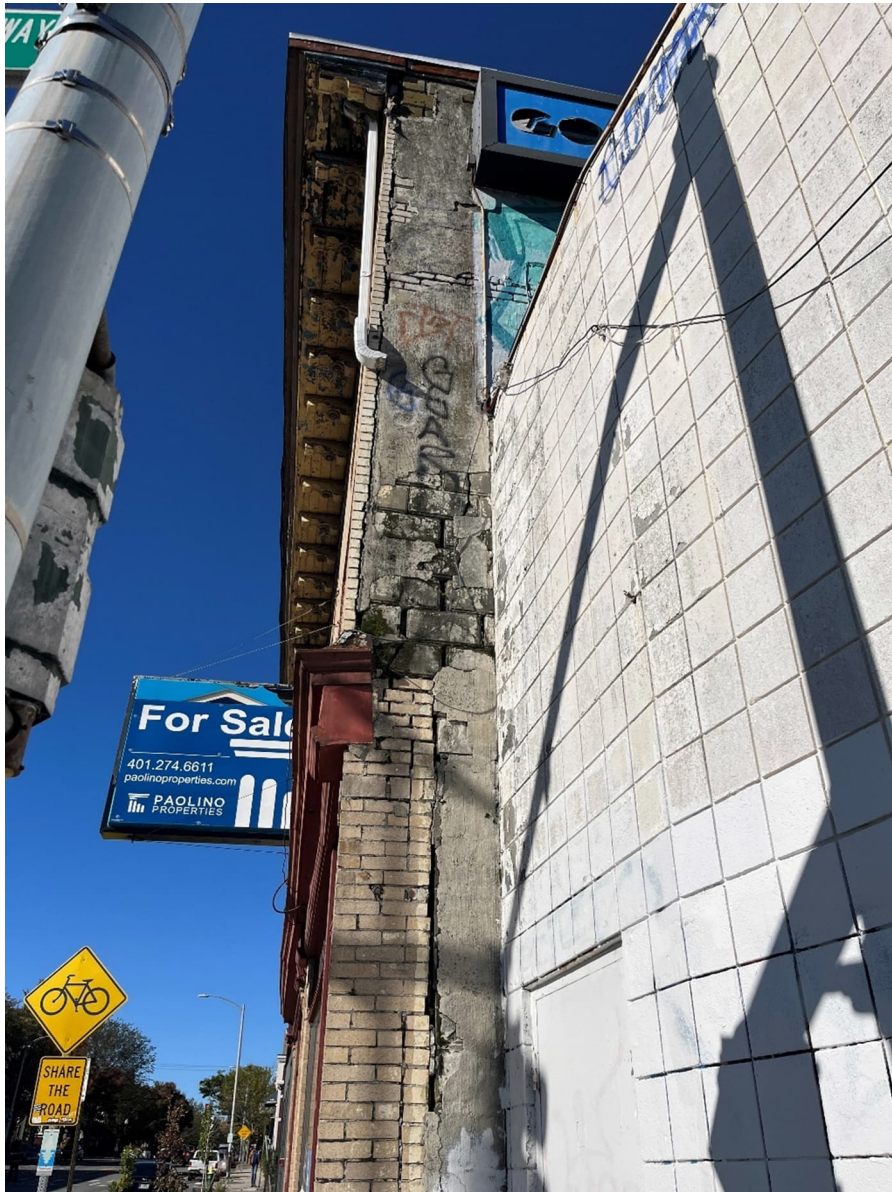
The severing of the connection between the south exterior load bearing wall and the second story floor plane, and the separation of the brick veneer from the underlying wood substrate are most concerning, especially given the buildings direct frontage on Broadway. Collapse of the beam/wall, or release of the brick veneer onto the public right of way below could cause significant damage or injury.

Photo 7 – 113 Broadway Southeast corner of building looking West. Note the separation of the brick veneer from the wood substrate is clearly visible in the form of a 1"± wide crack over the entire building height. Also note the lack of a decorative soffit overhang at the East wall of the "southeast protrusion".

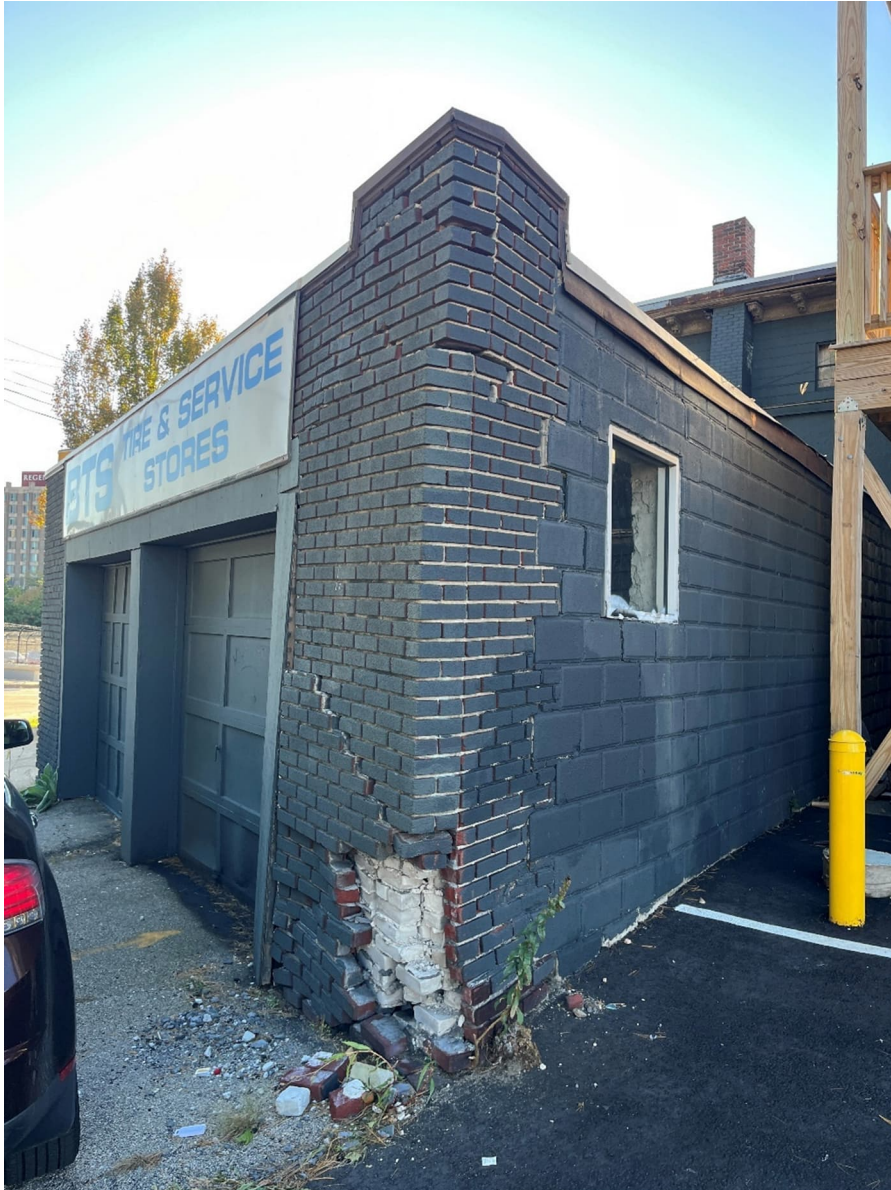
Photo 10 - 113 Broadway, Northern portion looking Southeast. Note extensive vehicular impact damage to the northwest corner of the building.

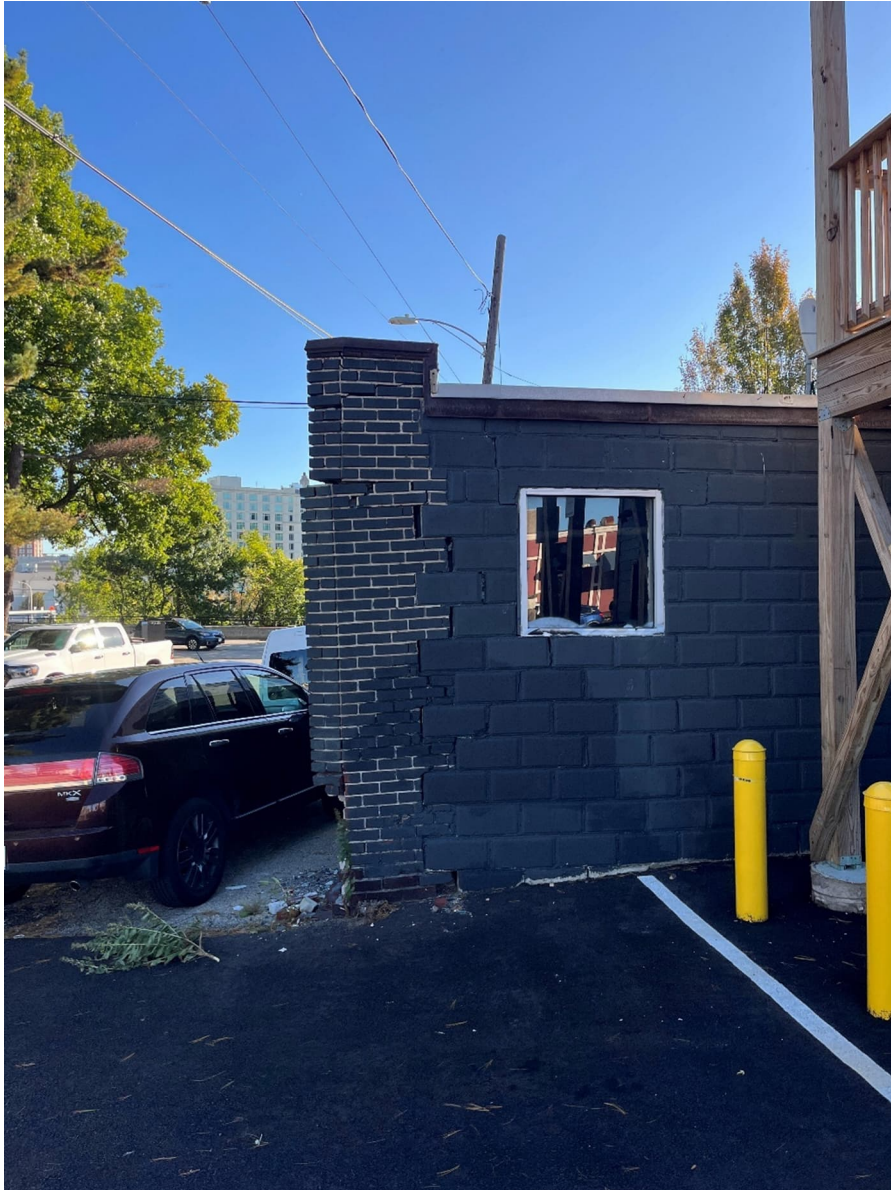
Photo 11 - 113 Broadway, Northern portion looking East. Note extensive vehicular impact damage to the northwest corner of the building. While visually impressive, the lesser damaged western CMU wall is load bearing, not the heavily damaged northern brick wall.

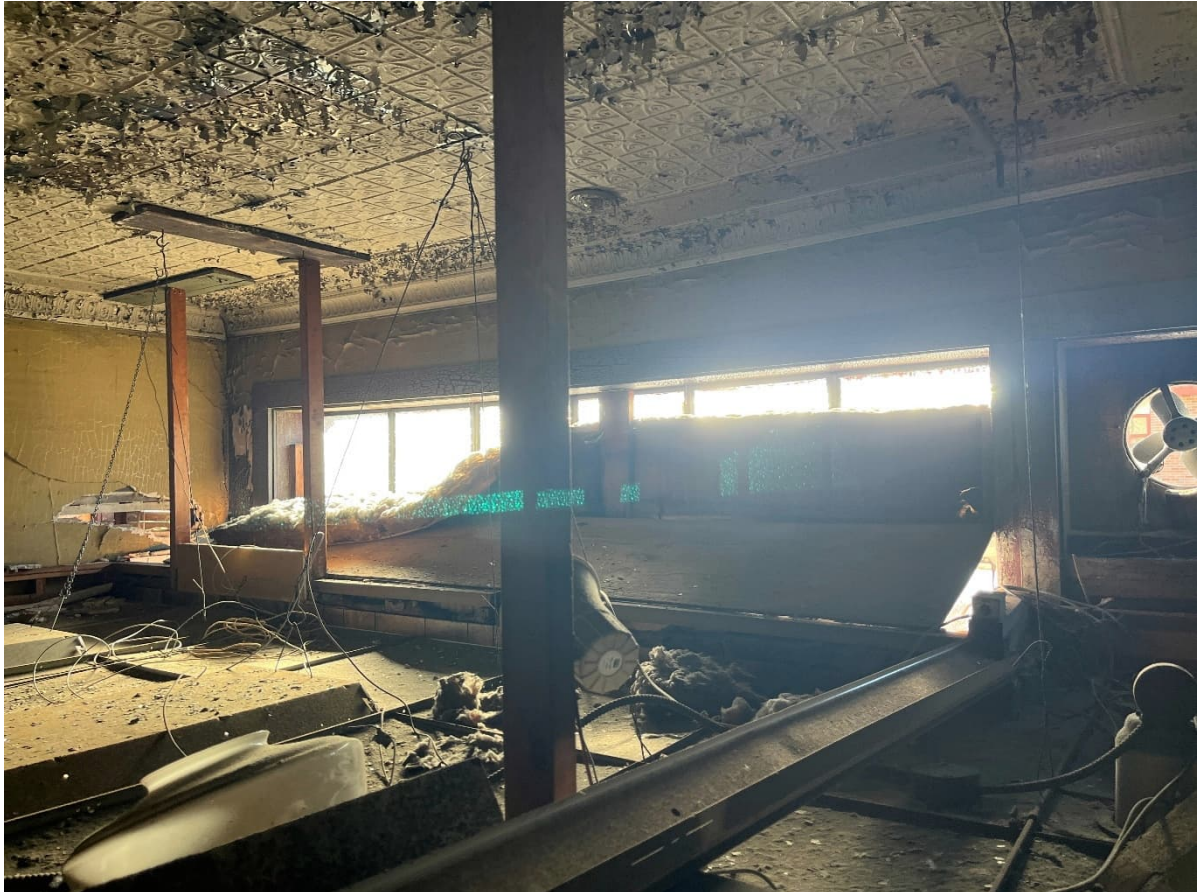
Photo 13 – Southern Portion, first story western half looking southeast. View from above the existing drop ceiling. Note the deflection in the header beam above the western storefront window. The observed second story floor/wall separation is directly above this location.

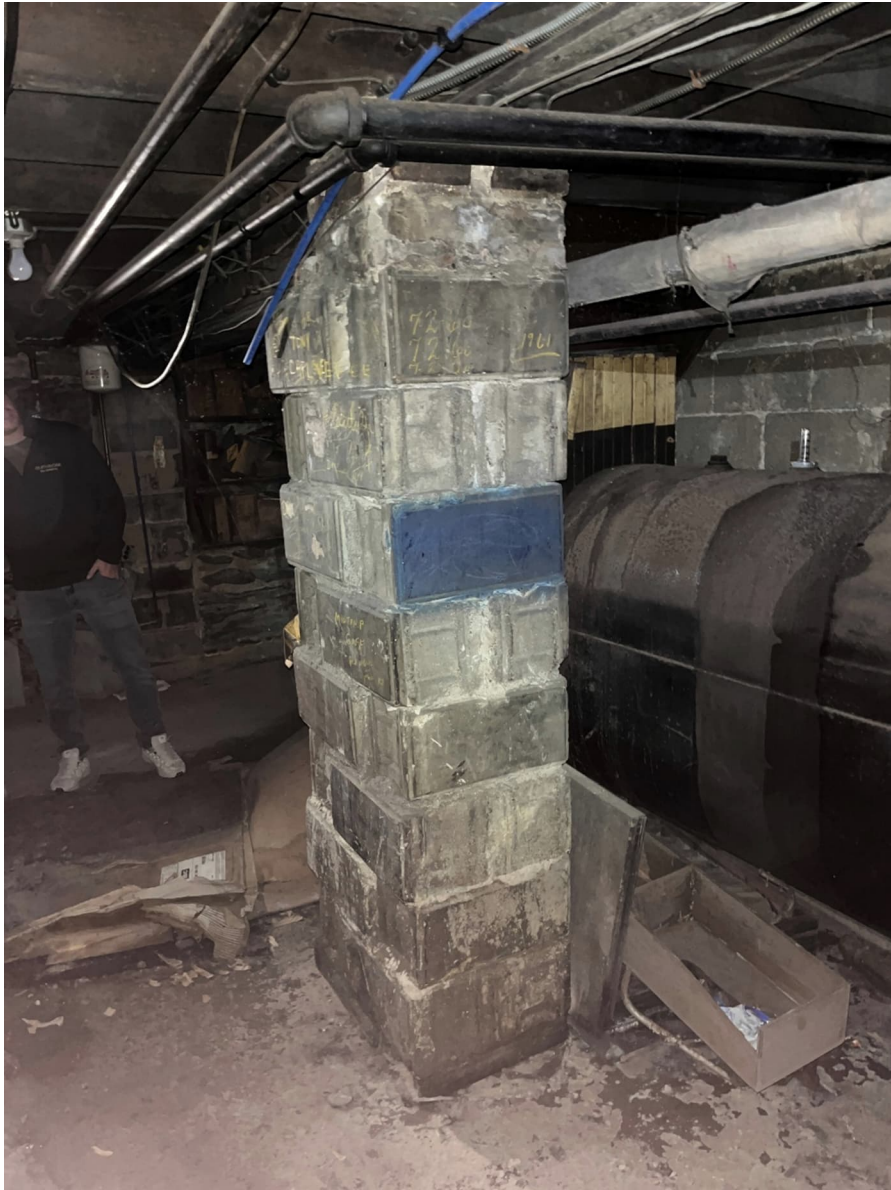
Photo 14 – Southern Portion, basement looking southeast. Typical CMU pier which supports a first story metal column. Note the CMU block is the same as those utilized for the eastern exterior wall and the Northern Portion exterior walls, which suggests they were constructed at the same time. The original rubble stone foundation wall is visible in the background as well as a CMU pier that has been integrated into the stone wall which supports one of the south façade storefront metal columns.

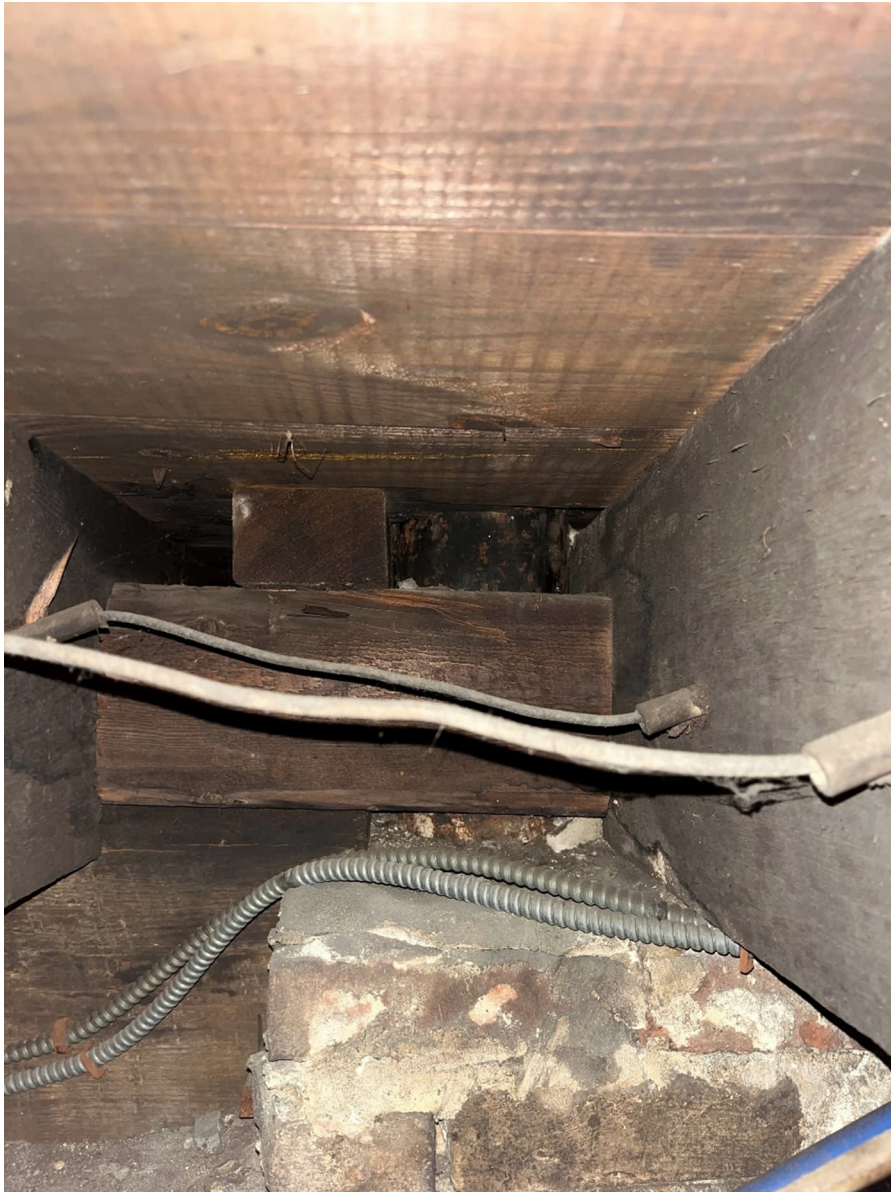
Photo 15 – Southern Portion, basement looking east. Photos shows the top of the CMU pier in the previous photo. The first story metal column is visible in the upper center-right of the photo (black/rust colored). The CMU pier also supports a large wooden beam (on the bottom left). The first story wood floor joists are visible on the left and right edges. The wood in the foreground adjacent to / in front of the metal column appears to be subfloor blocking.

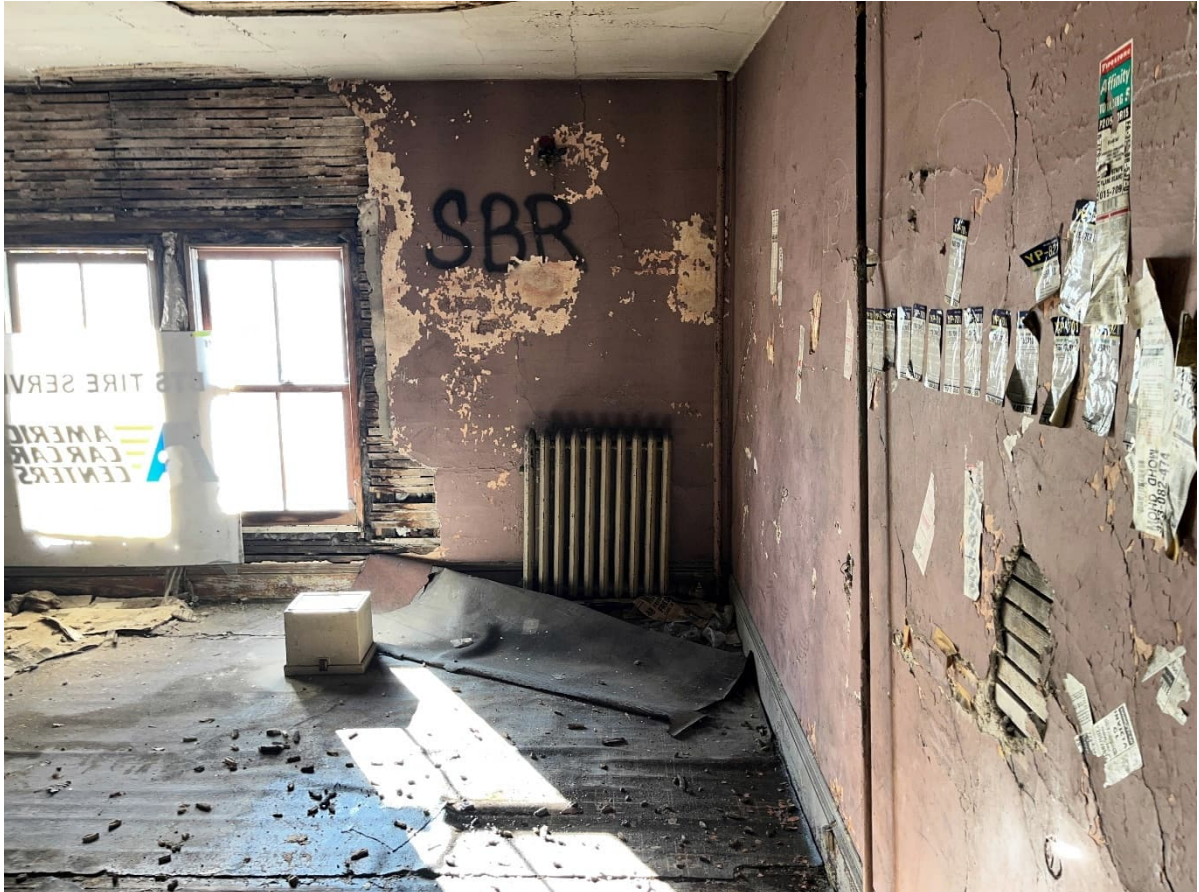
Photo 17 – Southern Portion, second story southeast chamber looking south. This is the “southeast protrusion”. Note the crooked radiator which indicates the out of level floor. Also note the wall, ceiling, and floor damages due to active water infiltration through the failed roof membrane.

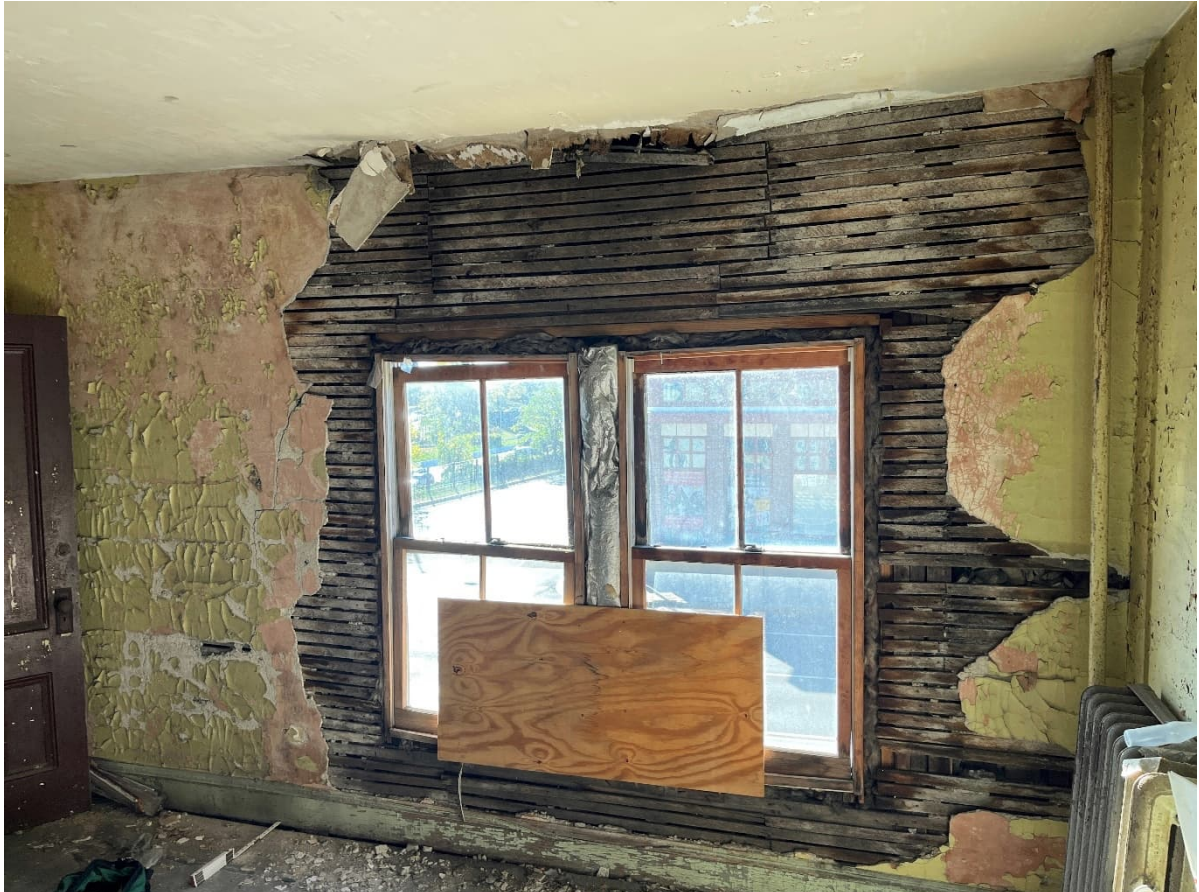
Water infiltration, caused by a flashing / membrane failure at the south parapet/roof plane interface, has eroded much of interior wall finishes in the southwestern chambers and adjacent stair hall (Photo 18). On the second story, a gap over 1¾" wide exists between the south wall and floor planes (Photos 18-20). The second story floor joist ends at this location are visible through the gap and displayed rotting. The structural beam located directly beneath this area (above the western storefront window) exhibited over 1" of deflection,

Photo 18 – Southern Portion, second story southwest chamber looking south. Note the wall, ceiling, and floor damages due to active water infiltration through the failed roof membrane. The wall is separated from the floor framing by ~1¾" (note measuring ruler on the floor).

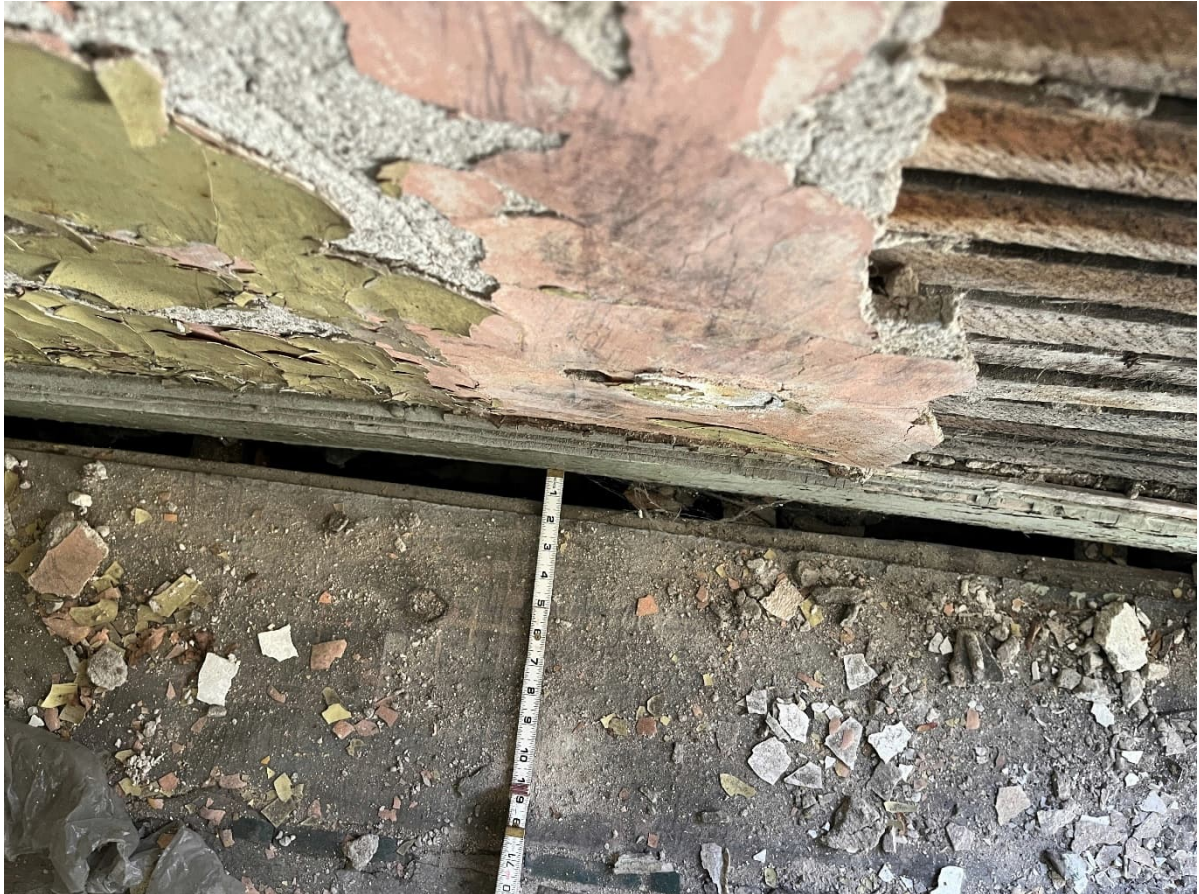
Photo 19 – Southern Portion, second story southwest chamber looking south/down. Detail of ~1¾" separation of floor and wall planes. Rotten floor joists were visible through this gap.

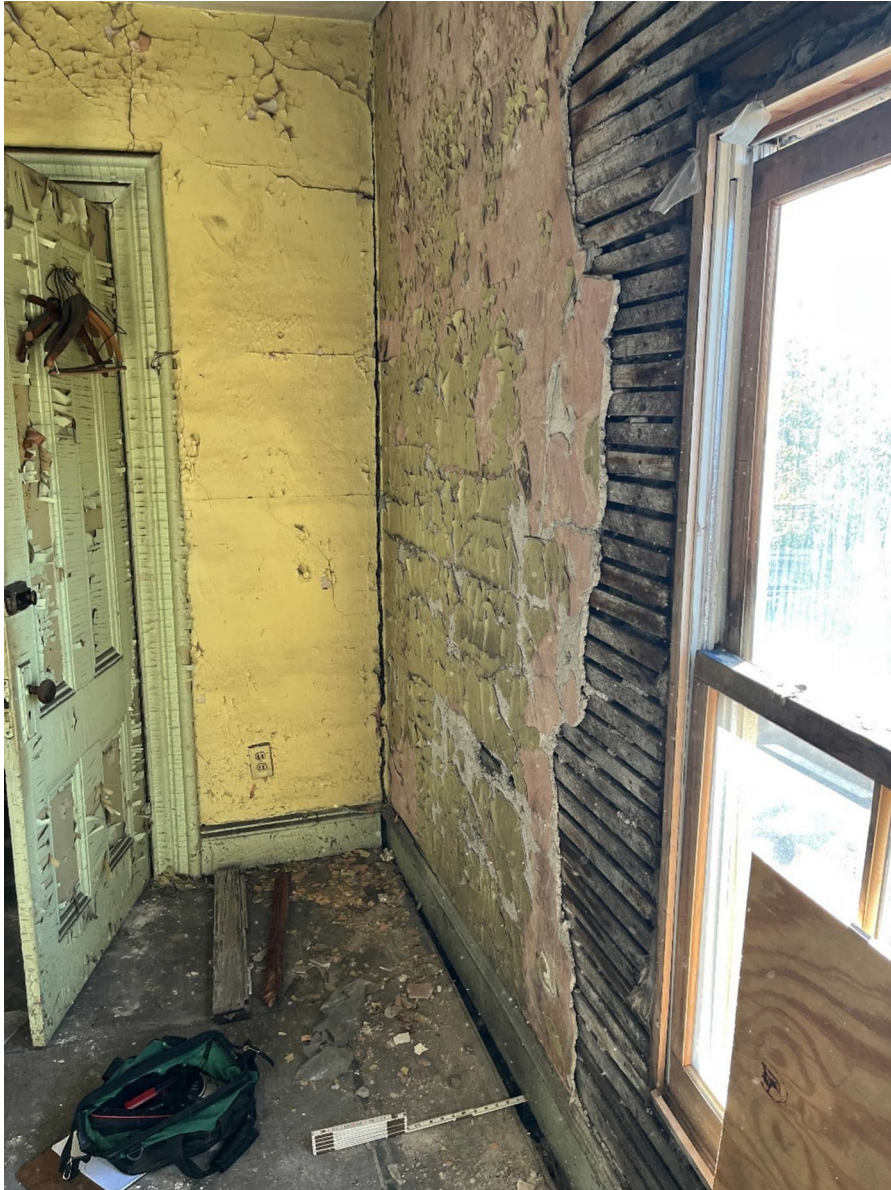
Photo 20 – Southern Portion, second story southwest chamber looking east. Note the ~1¾" separation of the floor and wall planes extends upward through the intersecting wall. The wall gap is wider at the base than at the top, indicating an outward movement caused by rotting floor framing and deflection of the underlying storefront window header beam.

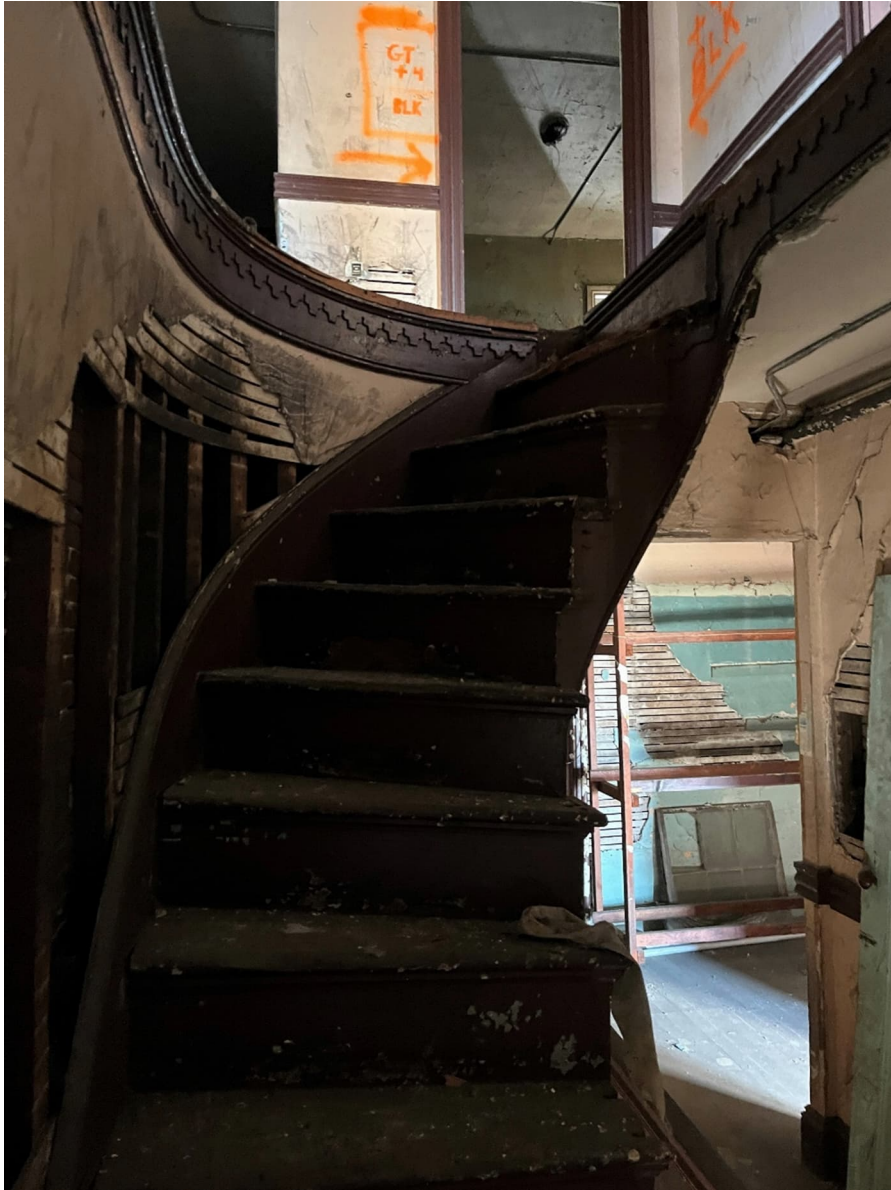
Although occupied as recently as 2022, the Southern portion of the building is in a severe state of disrepair. It has clearly not been maintained for many decades, with several broken or missing windows (many of which have been covered over with interior doors nailed to the walls), holes in the plaster walls and ceilings (from water infiltration and vandalism/neglect), and active roof leakage which has caused significant damage to the load carrying members. The once elegant second to third story curved staircase has been vandalized, and its questionable support structure, undoubtedly weakened by water intrusion, leaves users with a sense of unease (Photo 21).

Photo 21 – Southern Portion, second story looking north. The once elegant curved staircase leads to the third story. Note damages due to neglect, vandalism, and active water infiltration from the failed roof membrane. The staircase sags discernably to the inside of the curve.

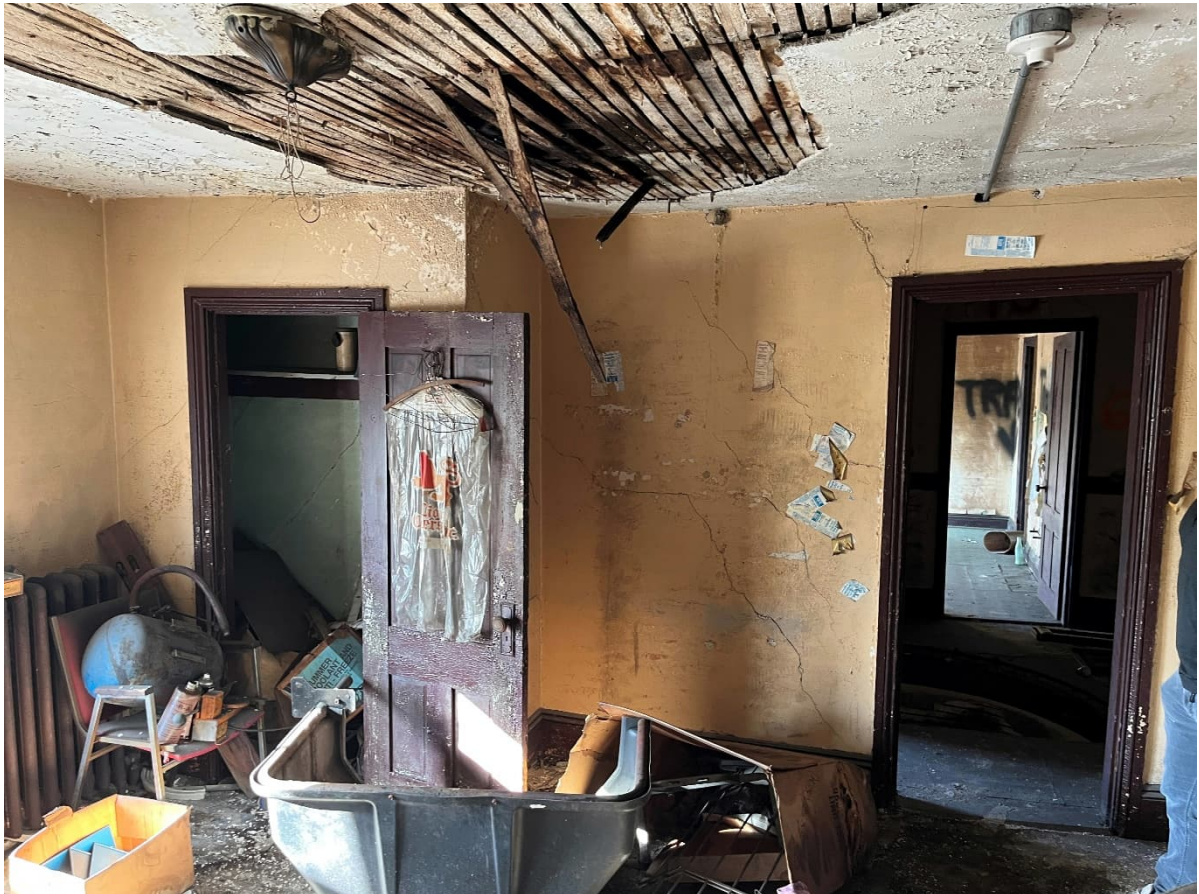
Photo 22 – Southern Portion, third story southeast chamber looking west. This is the “southeast protrusion”. Note the severely sloped floor as indicated by the crooked doorway trim and diagonal shear cracking on the walls. Also note the ceiling damages due to active water infiltration through the failed roof membrane.

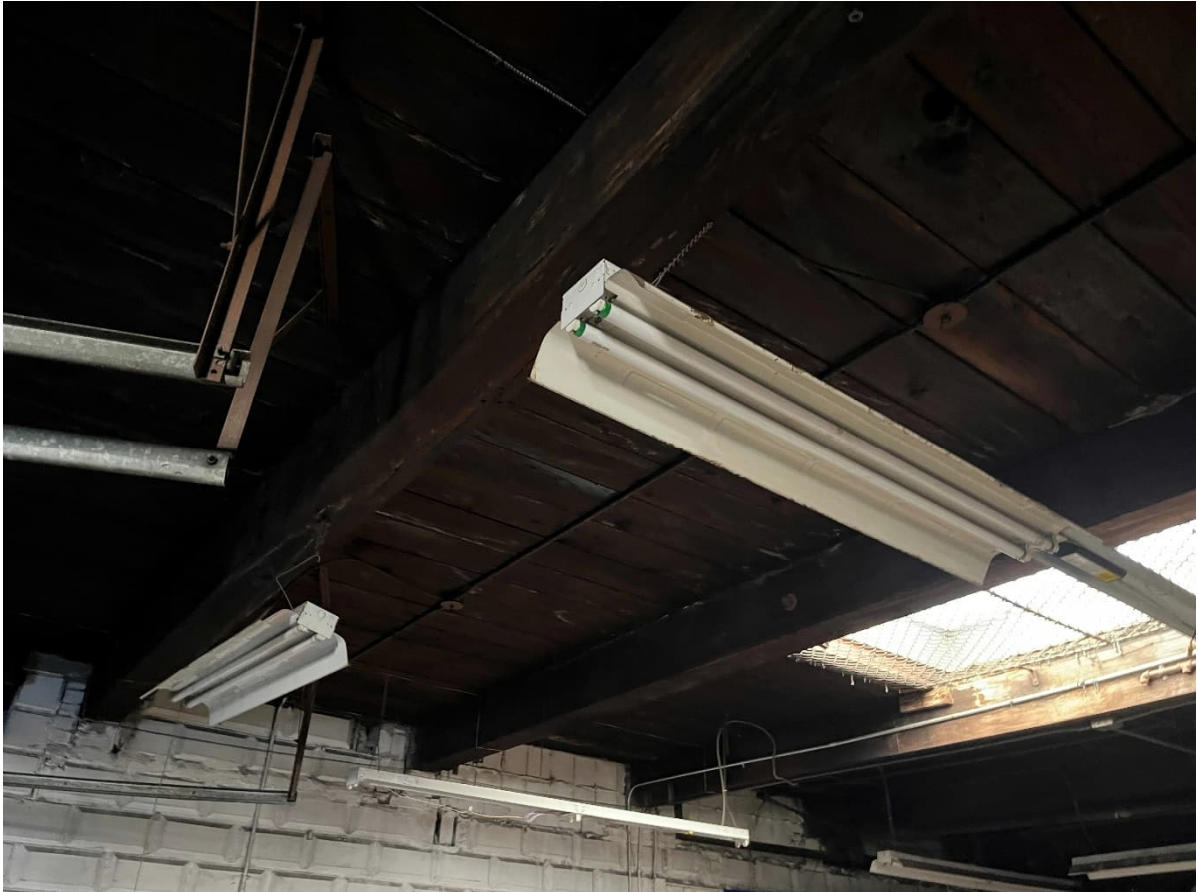
Photo 24 – Northern Portion, typical interior view looking east. Note the typical construction – CMU block walls with heavy wood timber rafters. Some water damage and active infiltration was noted but overall the roof structure appeared to be intact.

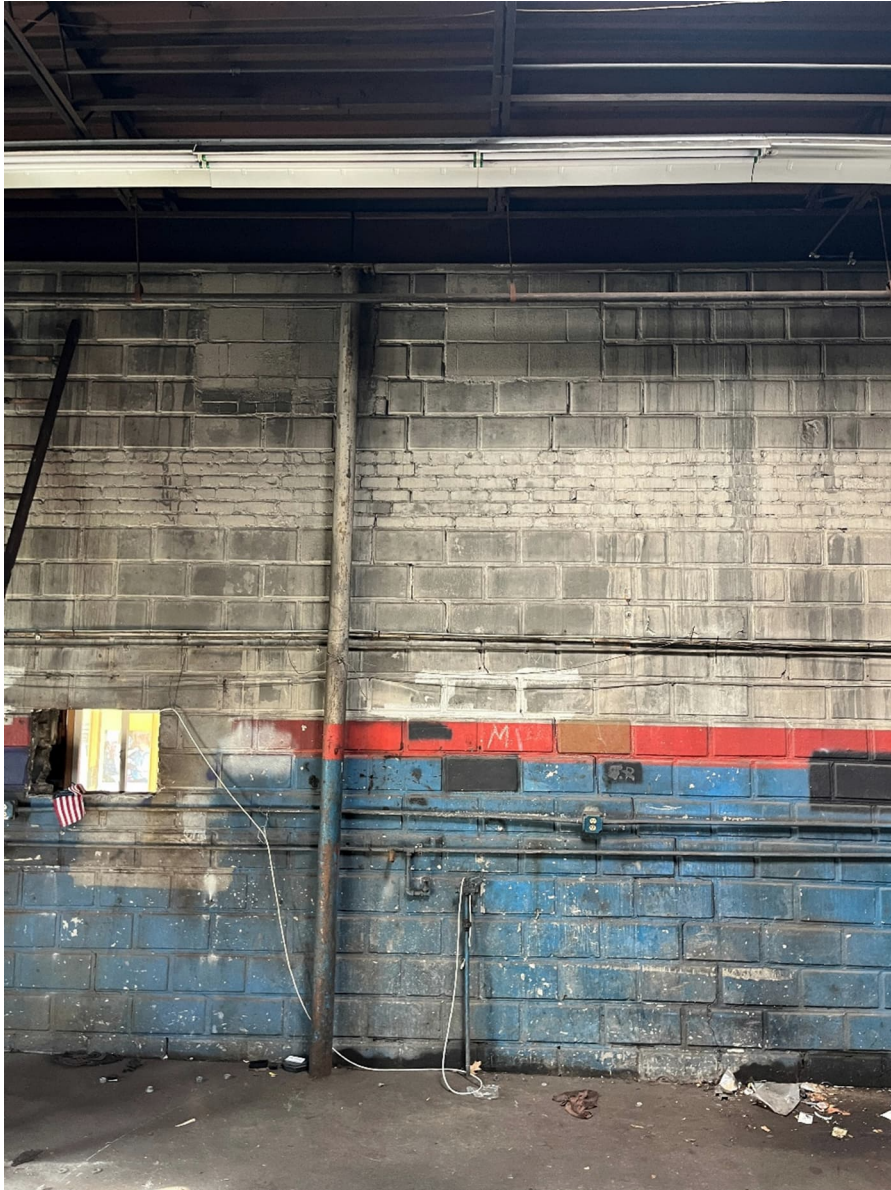
Photo 26 – Eastern Portion, typical interior view looking west. View of the steel header beam and steel columns which support the west ends of the open web steel joists. Note the step cracking in the “southeast protrusion” CMU wall, indicating foundation distress.

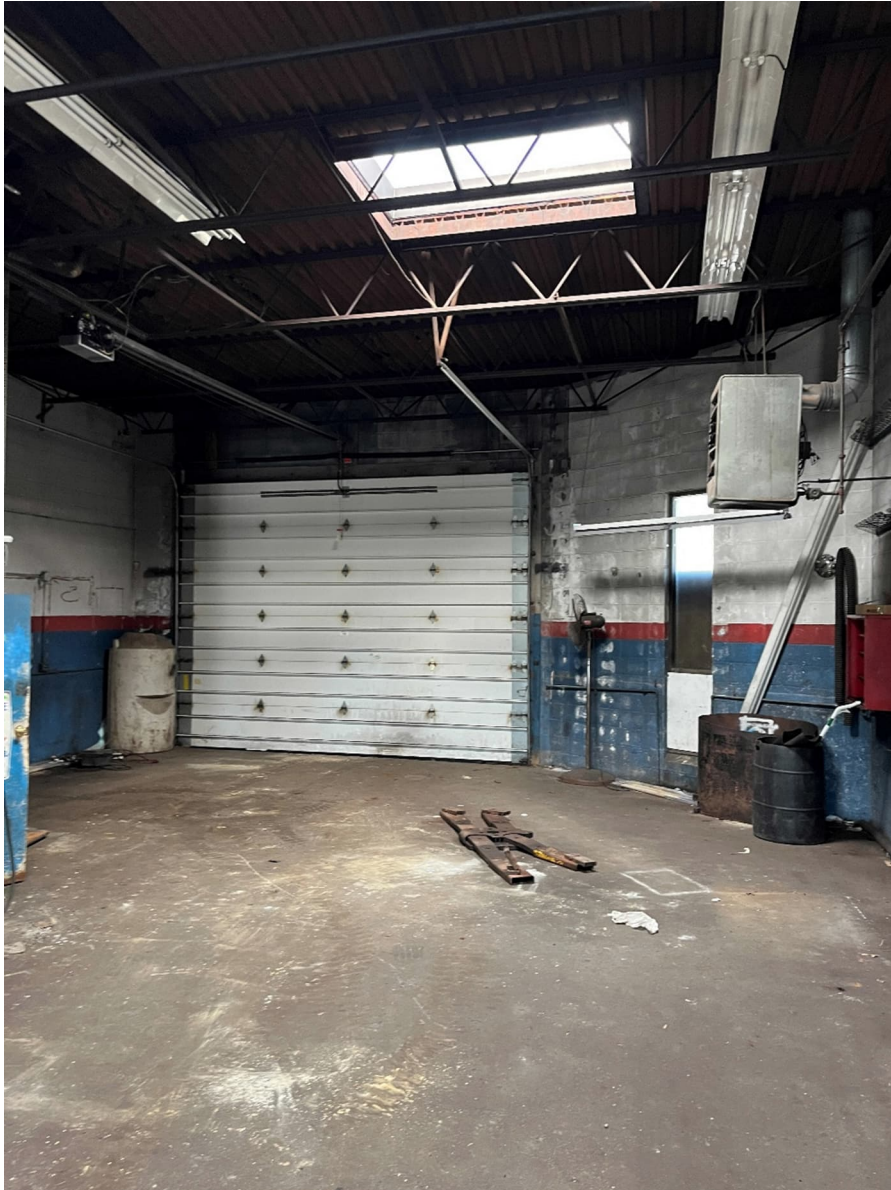
Photo 27 – Eastern Portion, typical interior view looking north toward the large garage door. Note the typical construction – CMU block walls with open web steel joists spaced at 4' on center which support corrugated metal roof panels and membrane roofing. The corrugated metal roof panels displayed severe water damage, but have apparently been repaired by installing another layer of roofing material above.

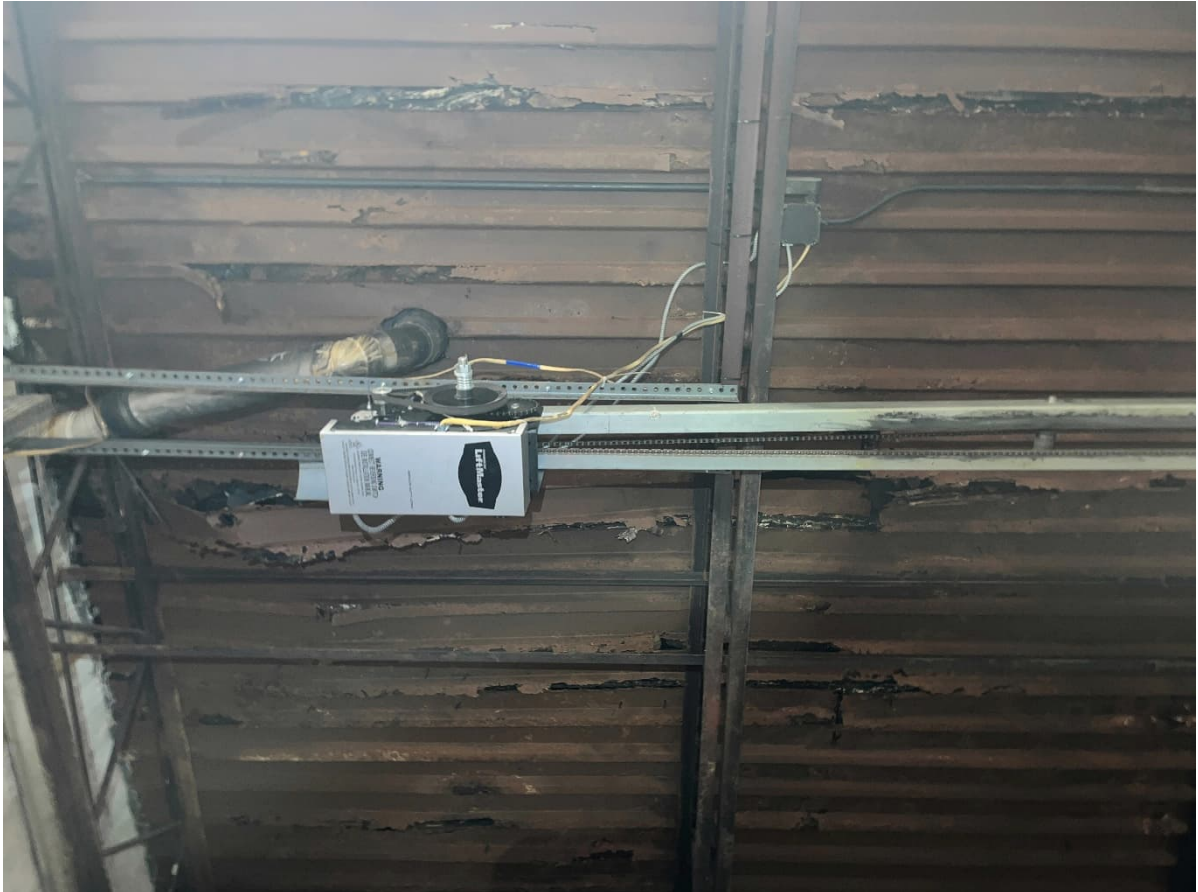
concern. The corrugated metal roof sheathing of the Eastern portion of the building is severely corroded with multiple through-holes (Photo 28). A secondary layer of sheathing of unknown composition has been added on top and, given the lack of observable leakage in this area, appears to be functioning satisfactorily.

Photo 28 – Eastern Portion, looking west/up. Detail of severely water damaged corrugated metal roof panels. Active water infiltration through the roof was not noted at the time of our inspection, presumably due to the installation of another layer of roofing material above.
