H:\HDC.Master\HDC Yearly Documentation\HDC.2021\Meeting Docs.2021\Staff Reports\sr04-26-21.doc

Applicant/Architect: Kevin Diamond, 269 Wickenden Street, Providence, RI 02903

Proposal: The scope of work proposed consists of Major Alterations and includes:

8 Barnes St. Providence, RI, 02906

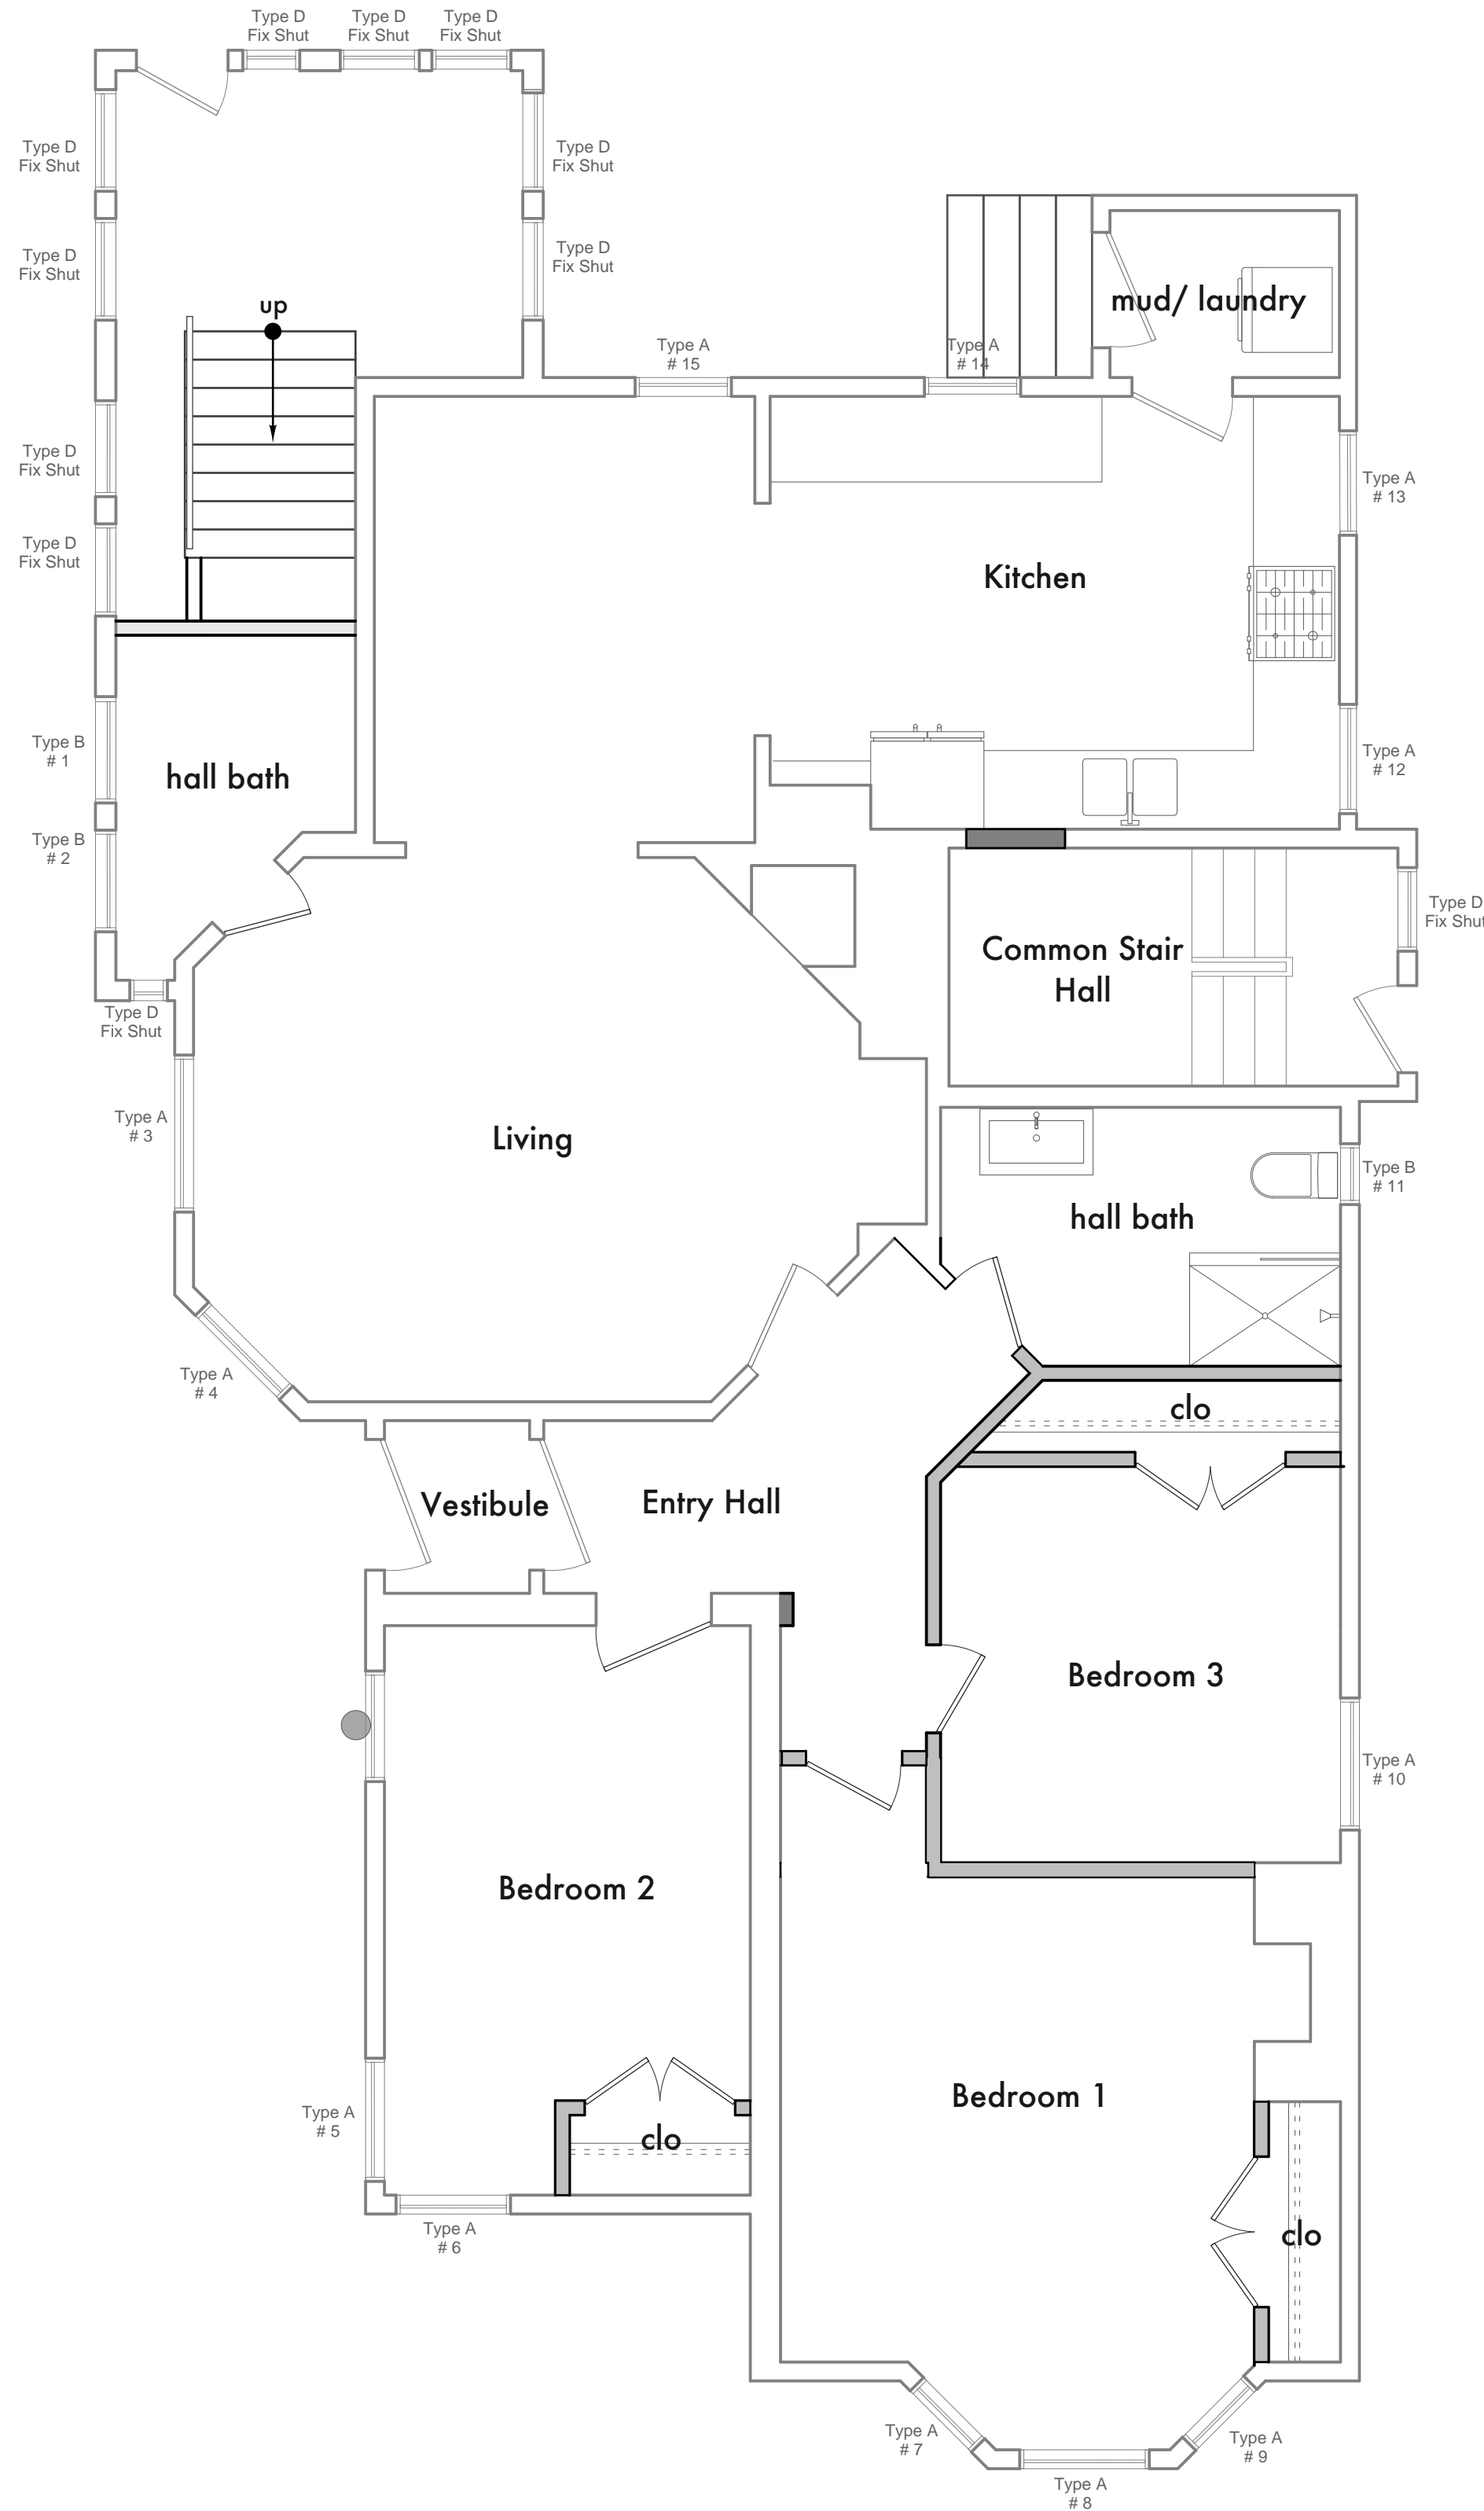
1
A2 Floor Plan - Level 1
1/4" = 1'-0"

Replace Majority of windows as shown. Windows that contain special lite patterns to remain in place as marked throughout the plans

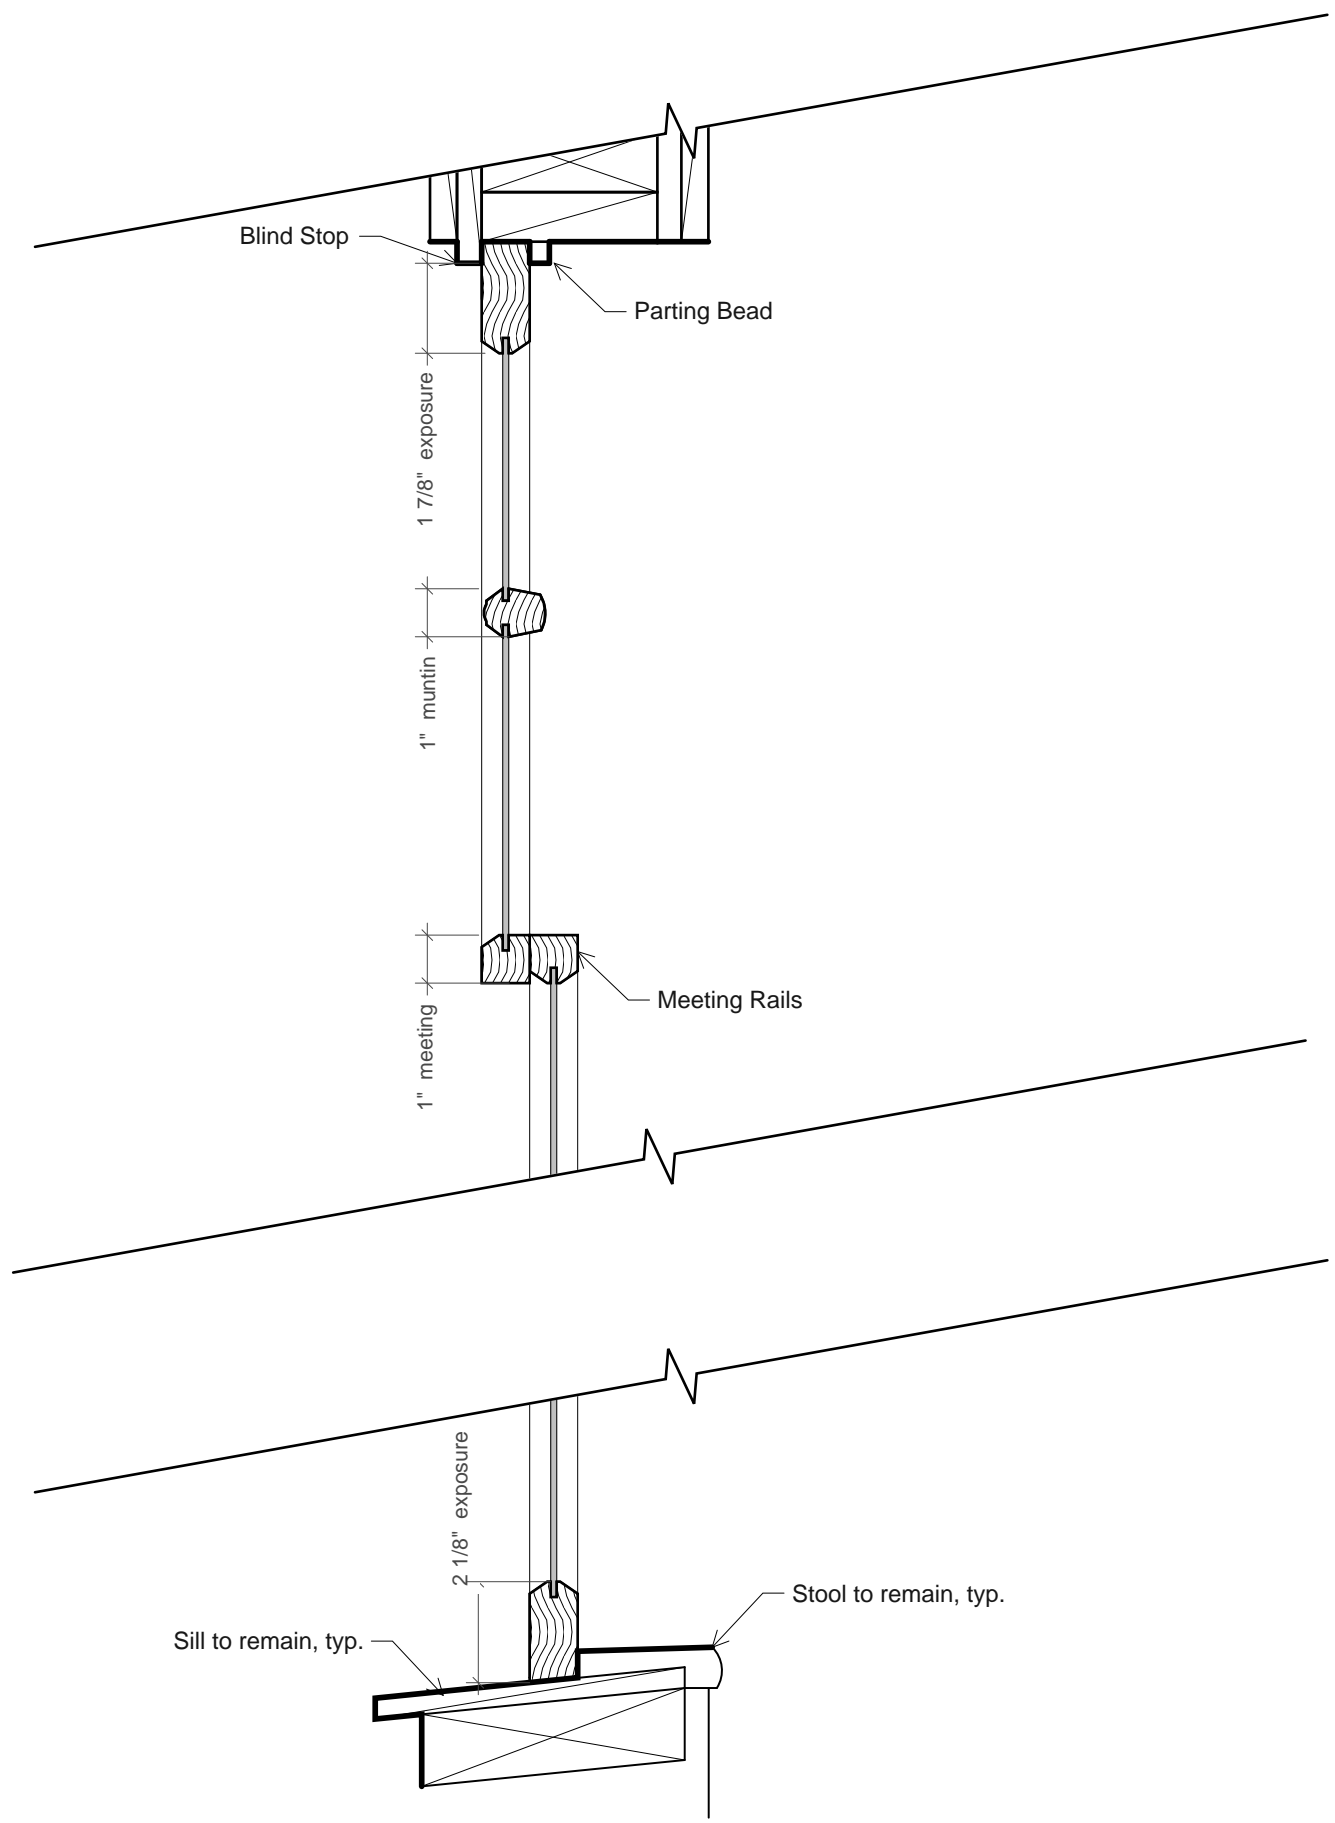
2
A3

Typical Existing Window Section

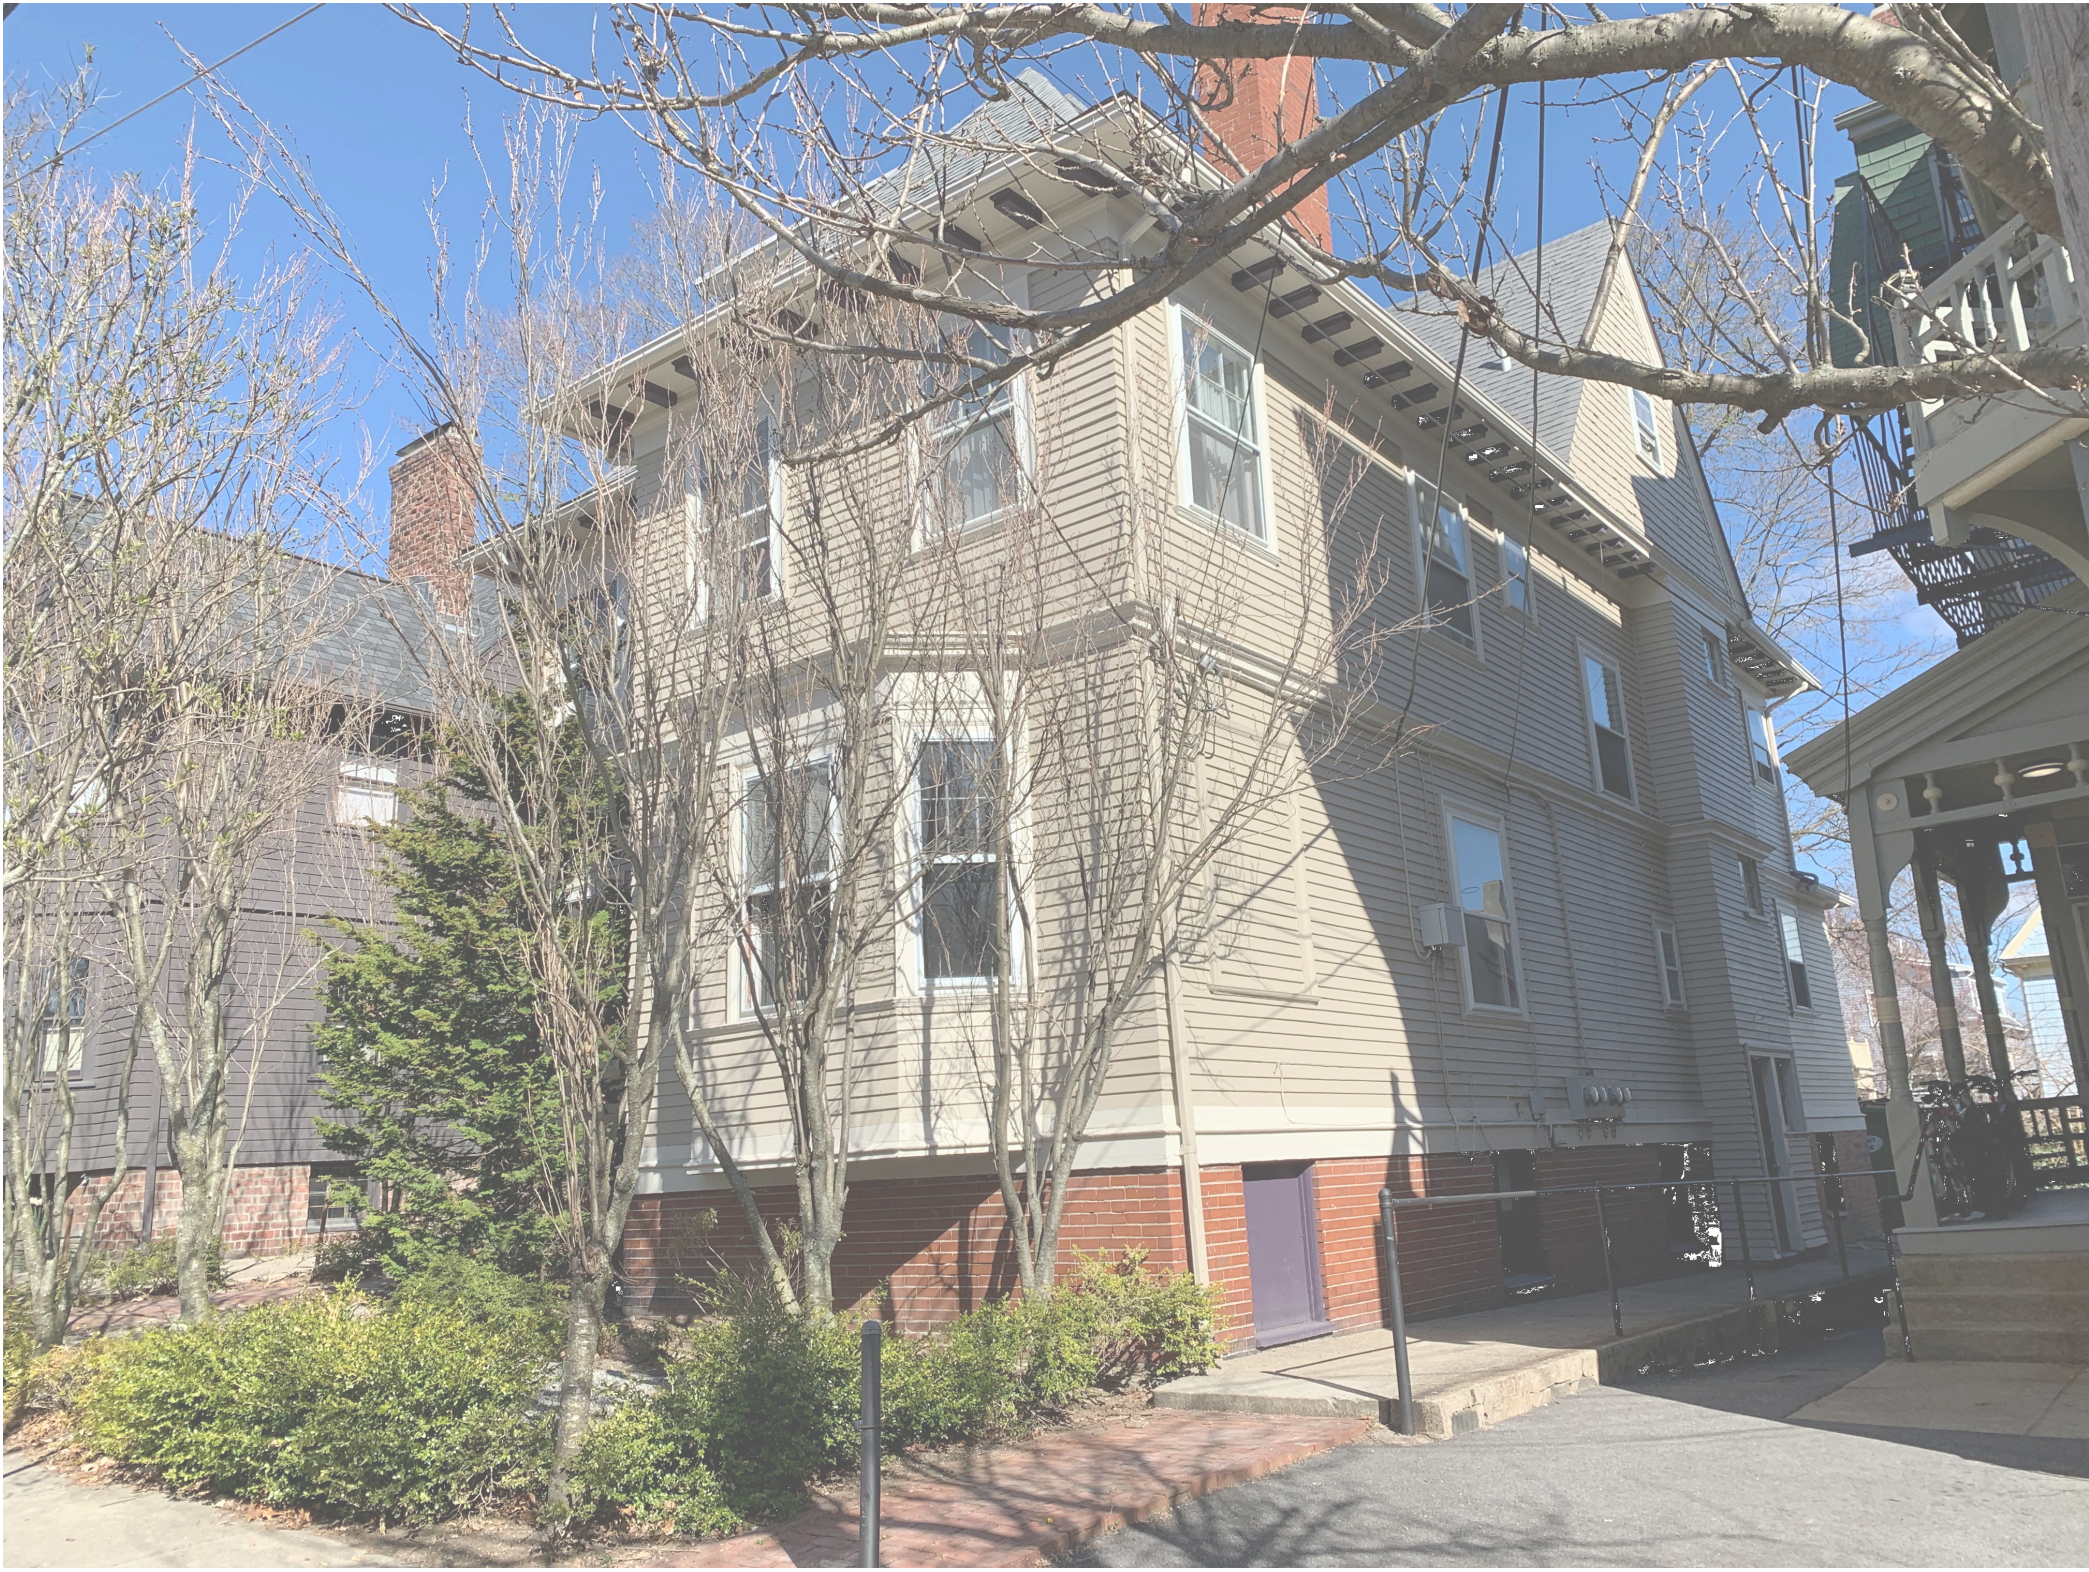
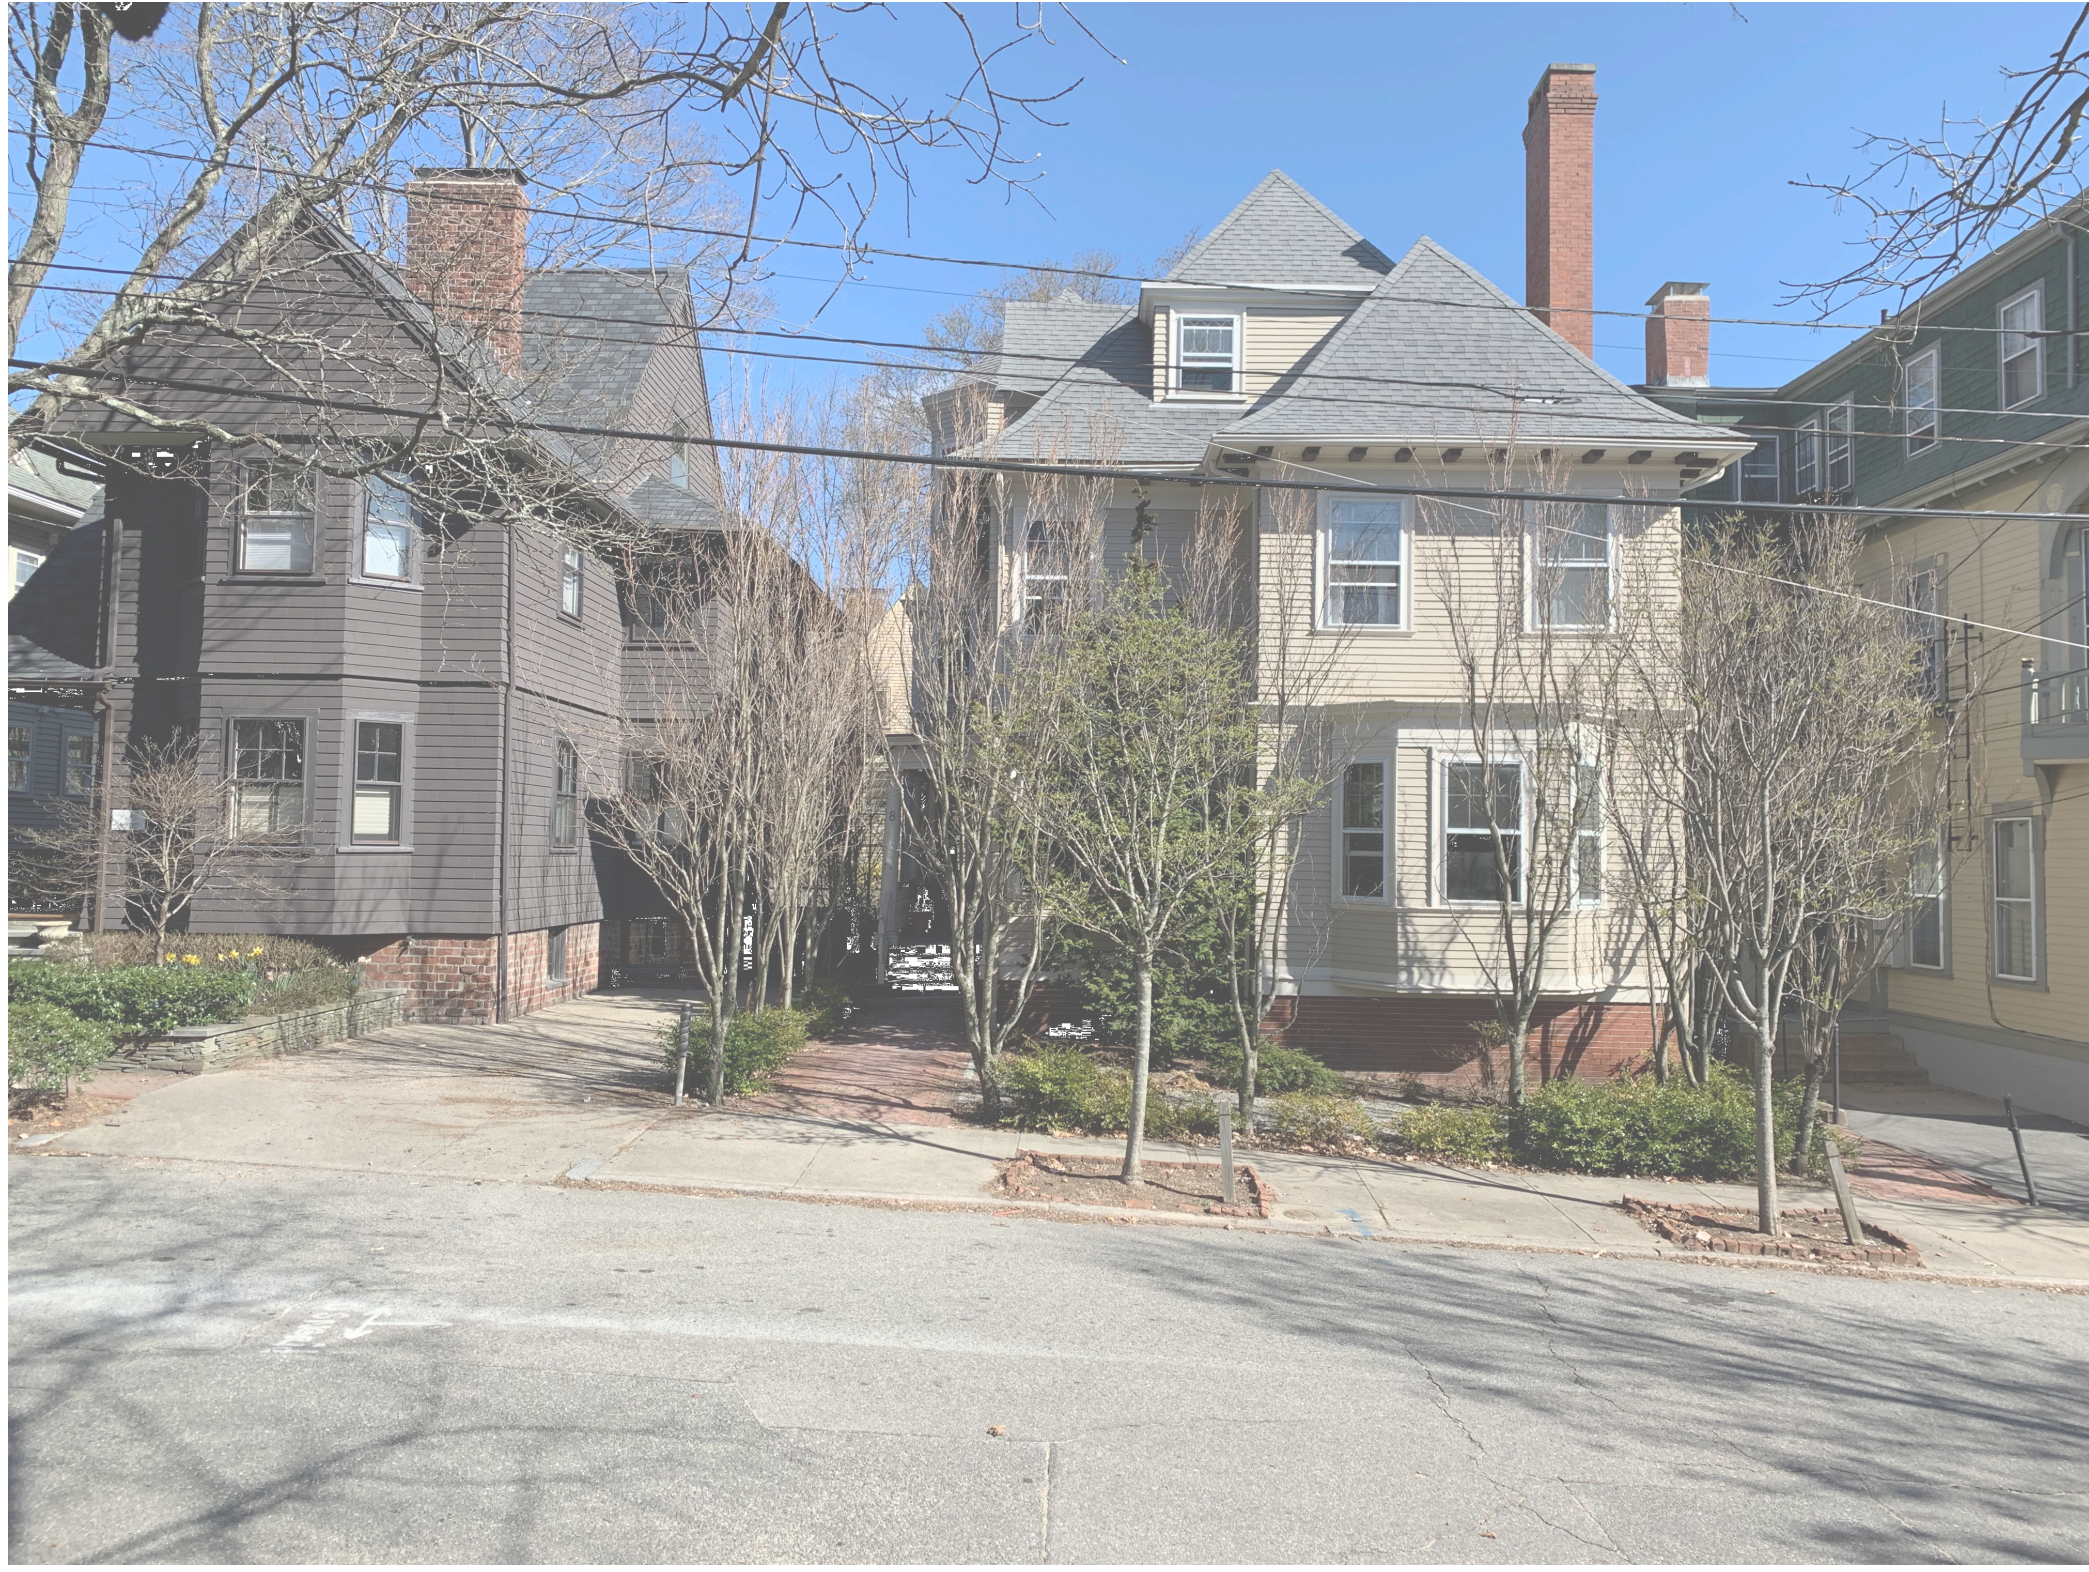
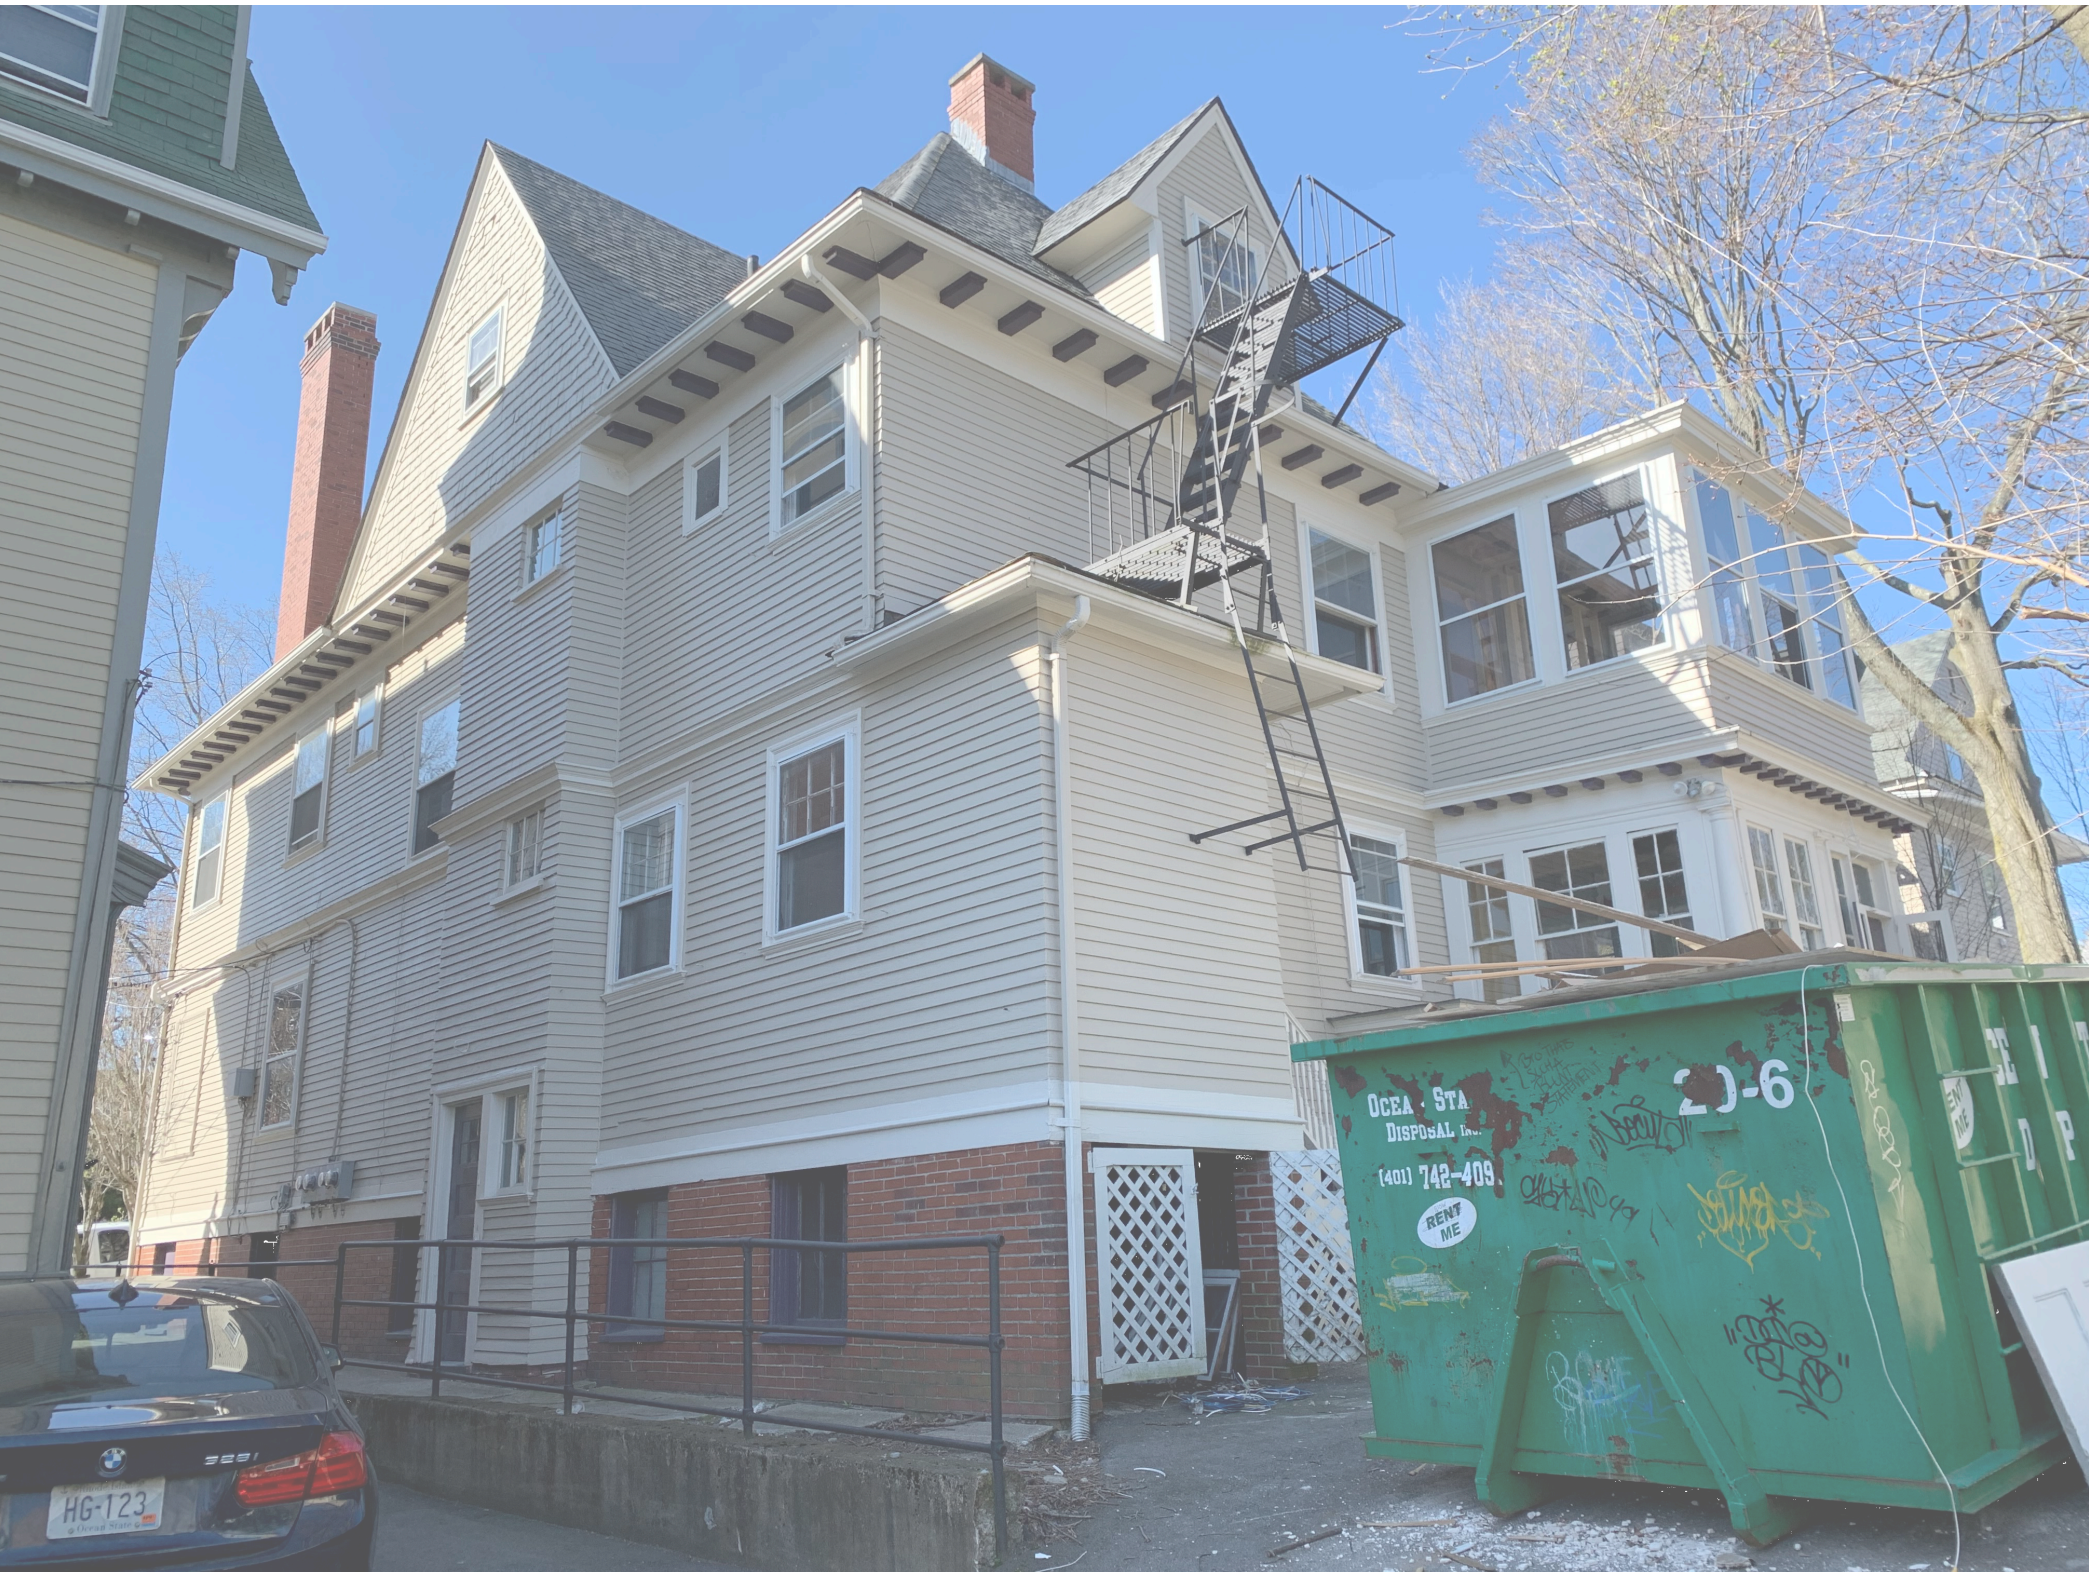
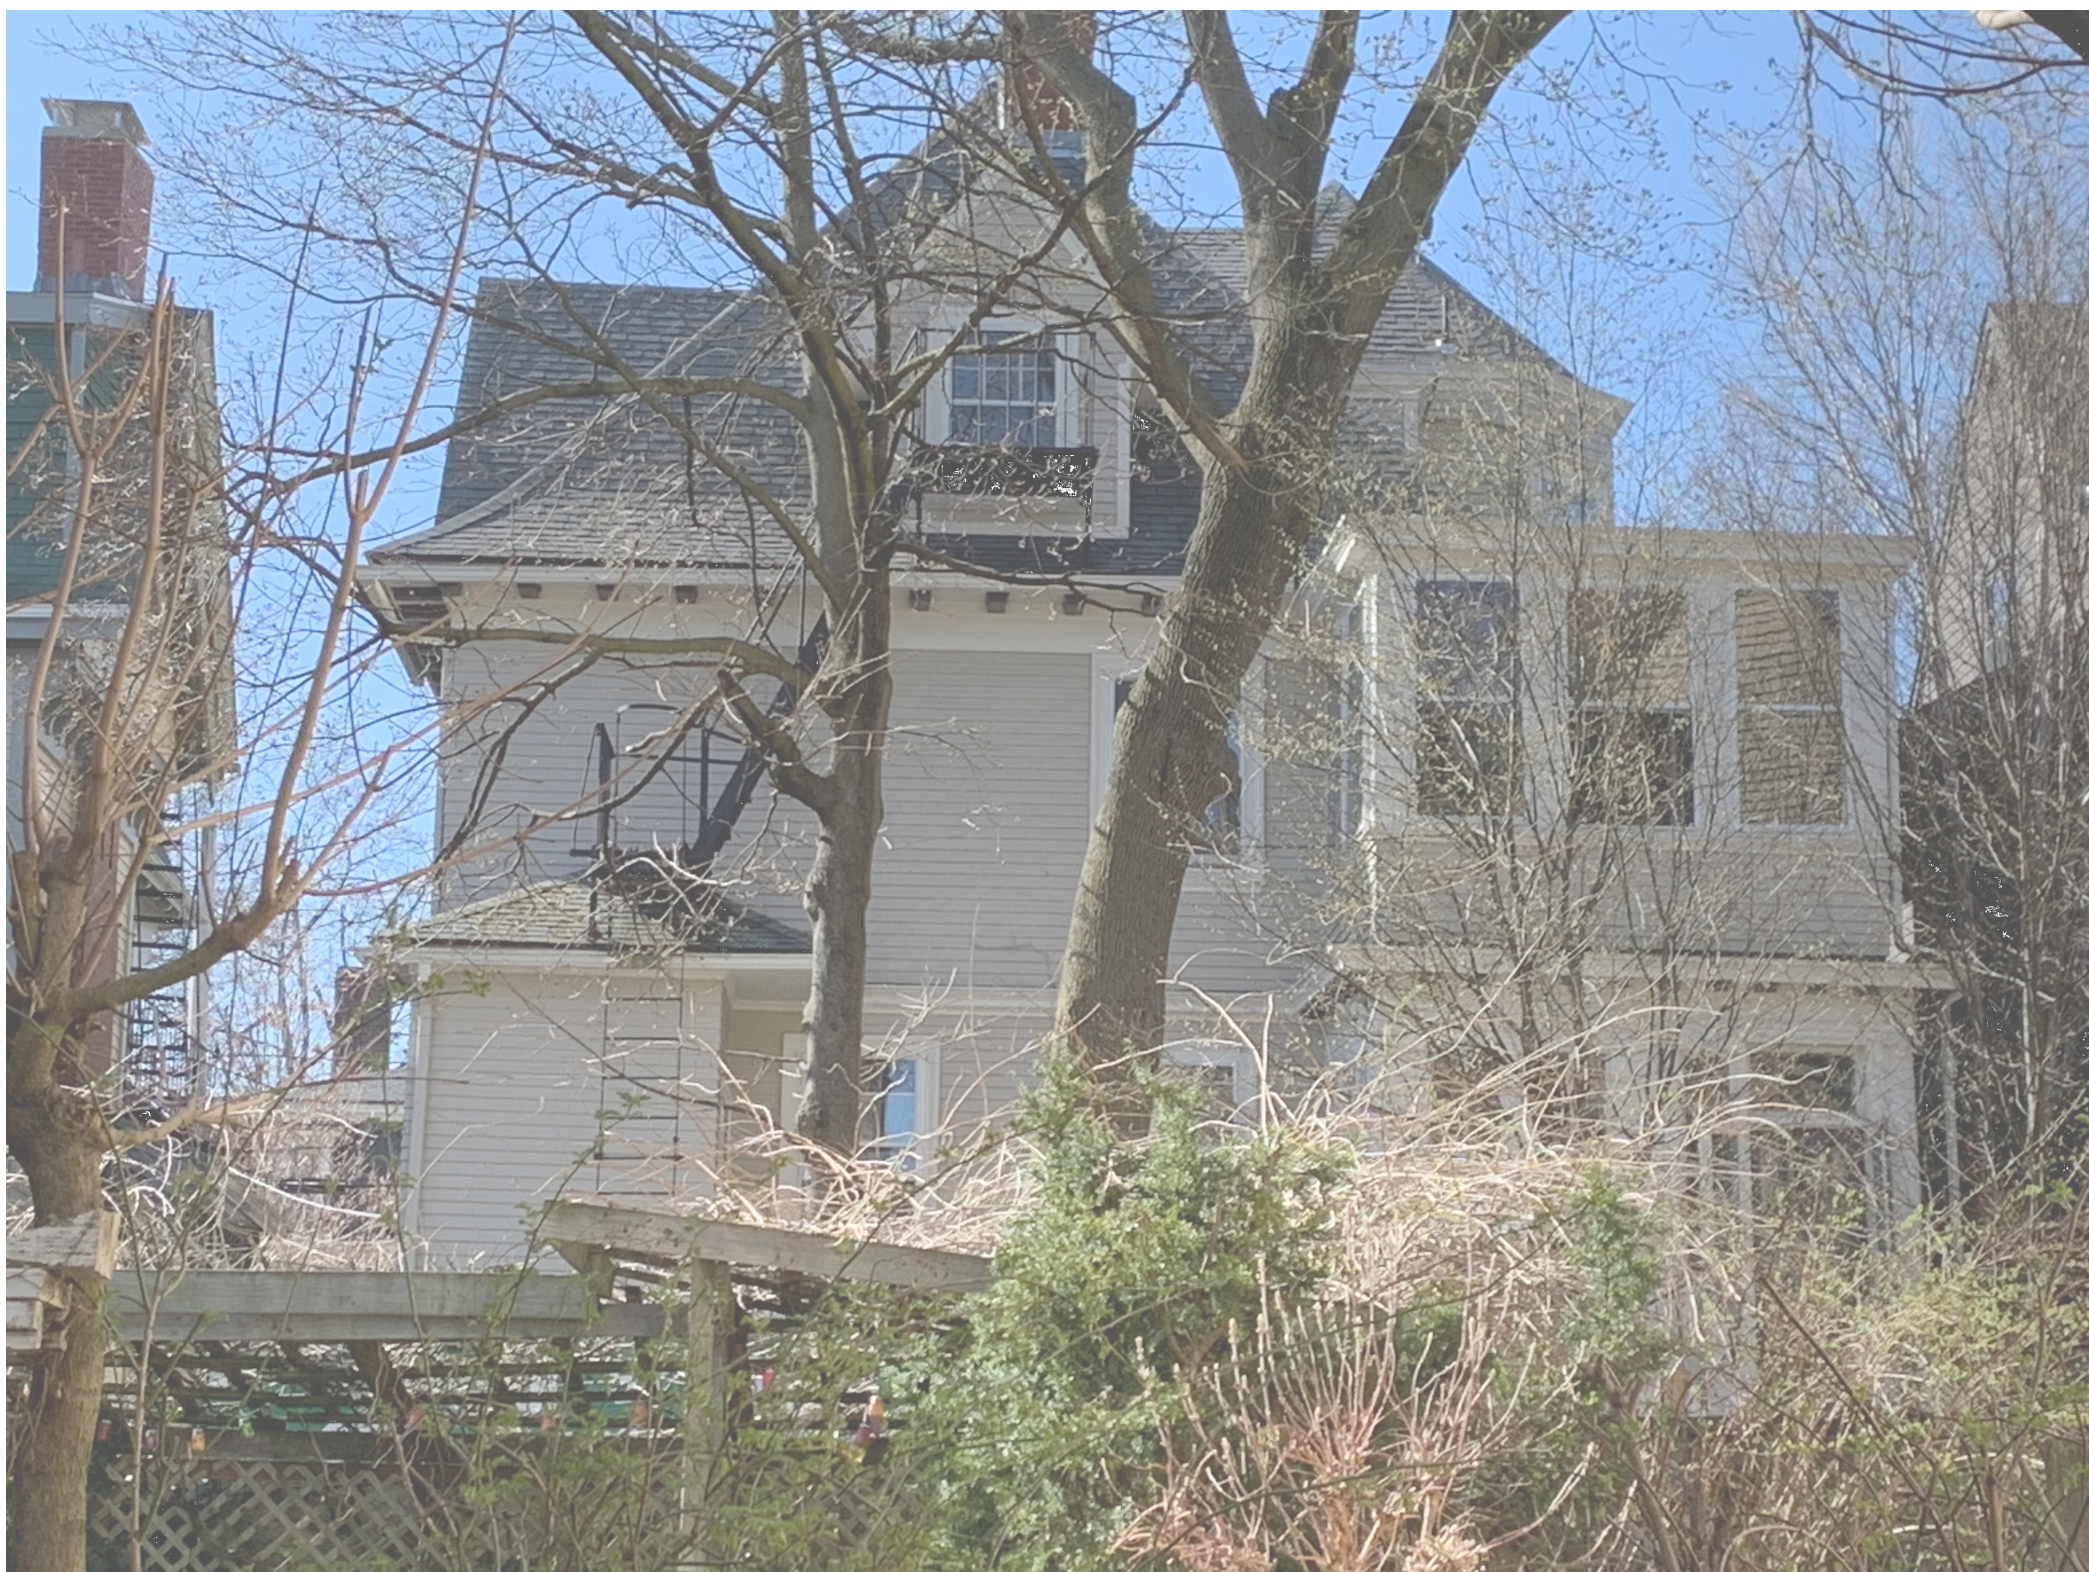
Existing Conditions

Window Number	Window Type	Condition
1	B	Peeling Lead Paint, Moderate Distress
2	B	Peeling Lead Paint, Moderate Distress
3	A	Peeling Lead Paint, Sash Cords Need Repair, Moderate Distress
4	A	Peeling Lead Paint, Sash Cords Need Repair, Moderate Distress
5	A	Peeling Lead Paint, Moderate Distress
6	A	Peeling Lead Paint, Moderate Distress
7	A	Peeling Lead Paint, Moderate Distress
8	A	Peeling Lead Paint, Moderate Distress
9	A	Peeling Lead Paint, Moderate Distress
10	A	Peeling Lead Paint, Sash Cords Need Repair, Moderate Distress
11	B	Peeling Lead Paint, Moderate Distress
12	A	Peeling Lead Paint, Moderate Distress
13	A	Peeling Lead Paint, Moderate Distress
14	A	Peeling Lead Paint, Moderate Distress
15	A	Peeling Lead Paint, Moderate Distress
16	A	Peeling Lead Paint, Moderate Distress
17	A	Peeling Lead Paint, Sash Cords Need Repair, Moderate Distress
18	A	Peeling Lead Paint, Sash Cords Need Repair, Moderate Distress

19	A	Peeling Lead Paint, Sash Cords Need Repair, Moderate Distress
20	A	Peeling Lead Paint, Sash Cords Need Repair, Moderate Distress
21	A	Peeling Lead Paint, Moderate Distress
22	A	Peeling Lead Paint, Moderate Distress
23	A	Peeling Lead Paint, Moderate Distress
24	A	Peeling Lead Paint, Moderate Distress
25	A	Peeling Lead Paint, Moderate Distress
26	B	Currently only storm windows exist. Owner Proposes to install full replacement windows within existing opening to match condition of level one sun porch - see plans/schedules.
27	B	Currently only storm windows exist. Owner Proposes to install full replacement windows within existing opening to match condition of level one sun porch - see plans/schedules.
28	B	Currently only storm windows exist. Owner Proposes to install full replacement windows within existing opening to match condition of level one sun porch - see plans/schedules.
29	B	Currently only storm windows exist. Owner Proposes to install full replacement windows within existing opening to match condition of level one sun porch - see plans/schedules.

Window Number	Window Type	Condition
31	B	Currently only storm windows exist. Owner Proposes to install full replacement windows within existing opening to match condition of level one sun porch – see plans/schedules.
32	B	Currently only storm windows exist. Owner Proposes to install full replacement windows within existing opening to match condition of level one sun porch – see plans/schedules.
33	B	Currently only storm windows exist. Owner Proposes to install full replacement windows within existing opening to match condition of level one sun porch – see plans/schedules.
34	B	Currently only storm windows exist. Owner Proposes to install full replacement windows within existing opening to match condition of level one sun porch – see plans/schedules.
35	B	Currently only storm windows exist. Owner Proposes to install full replacement windows within existing opening to match condition of level one sun porch – see plans/schedules.

36	B	Currently only storm windows exist. Owner Proposes to install full replacement windows within existing opening to match condition of level one sun porch – see plans/schedules.
37	C	Currently only storm windows exist. Owner Proposes to install full replacement windows within existing opening to match condition of level one sun porch – see plans/schedules.
38	A	Peeling Lead Paint, Minor Distress
39	A	Peeling Lead Paint, Minor Distress
40	A	Peeling Lead Paint, Sash Cords Need Repair, Moderate Distress
41	A	Peeling Lead Paint, Minor Distress
42	B	Peeling Lead Paint, Minor Distress

30	B	Currently only storm windows exist. Owner Proposes to install full replacement windows within existing opening to match condition of level one sun porch - see plans/schedules.
