6. CASE 22.075, 32 JOHN STREET, Lucias Horton House, 1867 (COLLEGE HILL)

Project: Three Family Residence

Address: 32 John Street, Providence, RI 02906

NARRATIVE – Scope of Work

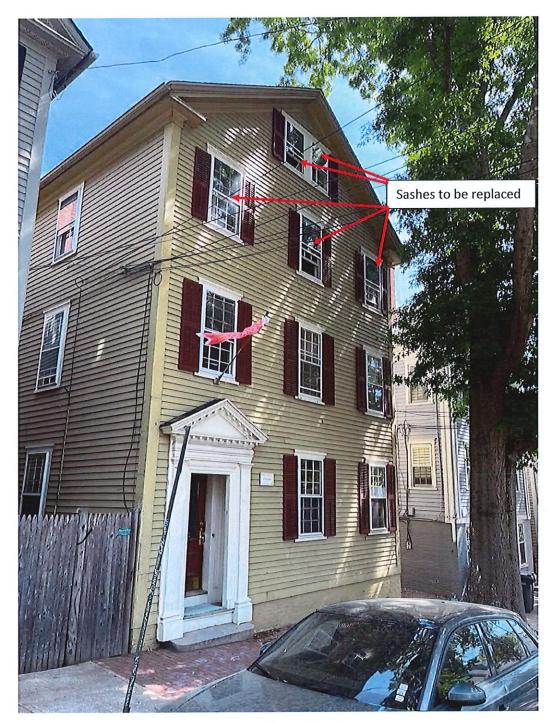
Figure 1 - South (street) Elevation

At present floors three and four contain fifteen (15) double hung units. The windows are in fair to poor condition. The current DH configurations: 9/9, 2/2 and 4/4.

Of the fifteen (15) units presented, we propose to replace the window sashes in their current configurations. They are all single pane glazed, double hung units. Sash configurations vary between 9/9, 2/2 and 4/4.

The new double hung sashes shall be Trimline Ultra Fit (Classic Clad) sash replacement kit. These are wood units, insulated glazing with aluminum clad exterior and vinyl jamb liners. Muntins to be simulated divided light. Exterior color to be white. New window screen to be half-window.
