PROJECT REVIEW

1. CASE 23.013, 438 BROADWAY, Pardon H. Brown House, c1845 (BROADWAY)

Project: Mixed Use Building

NARRATIVE – Scope of Work

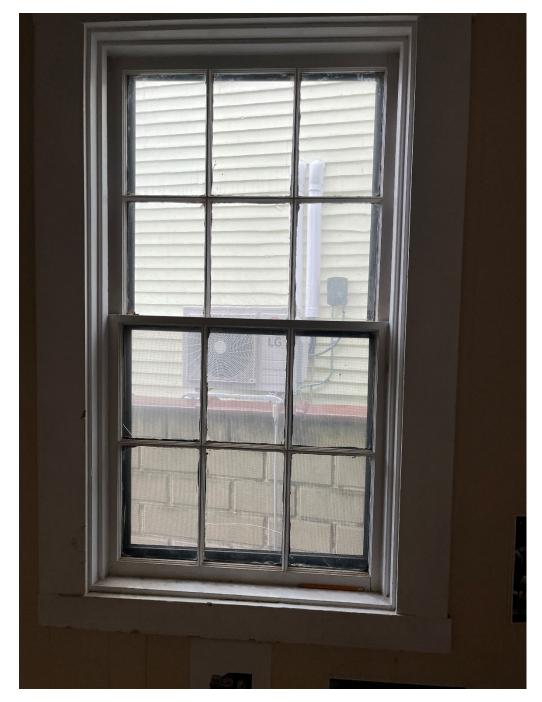
Figure 6 - interior Unit "E" - oldest units

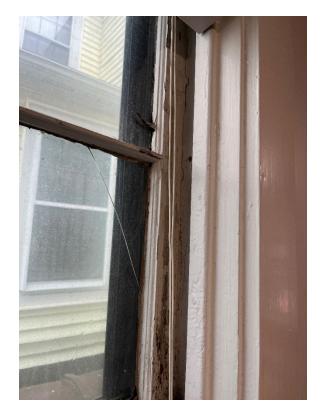
Figure 7 - detail @ unit "E"

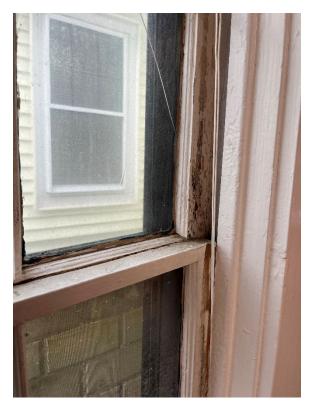
Figure 8 - Detail Unit "E"

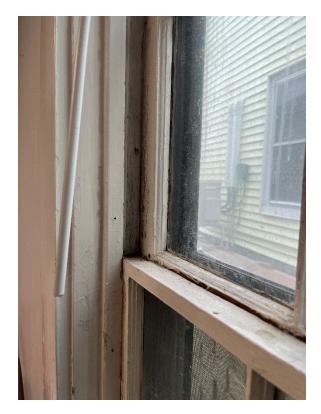
Figure 9 - Detail Unit "E"

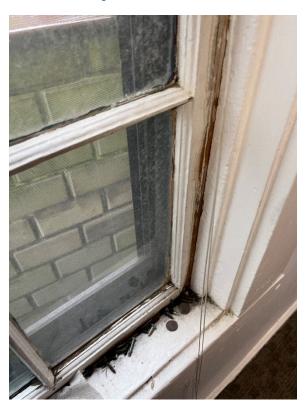
Figure 10 - Detail Unit "E"

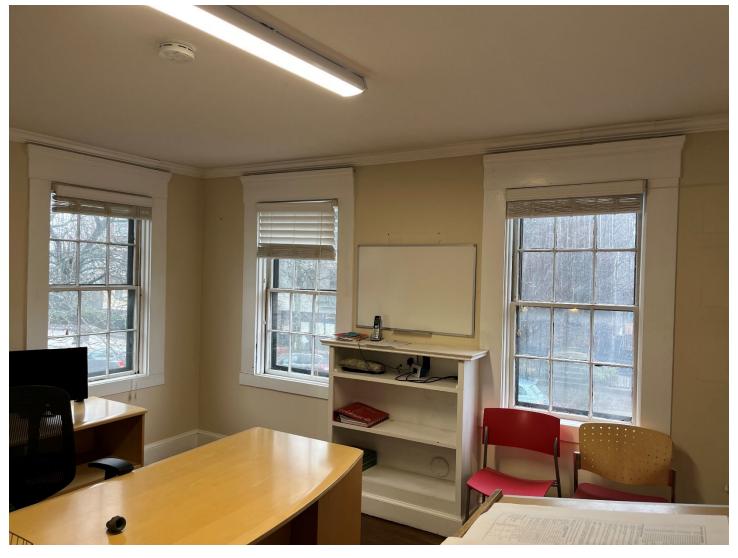
Figure 11 - Interior of "E" units, second floor, facing Broadway
