# Solar Energy Potential Report City Of Providence

Ms. Leah Bamberger, Director of Sustainability City of Providence 25 Dorrance Street Providence, RI 02903

February 2015 Revised March 2015 **Final June 2015**

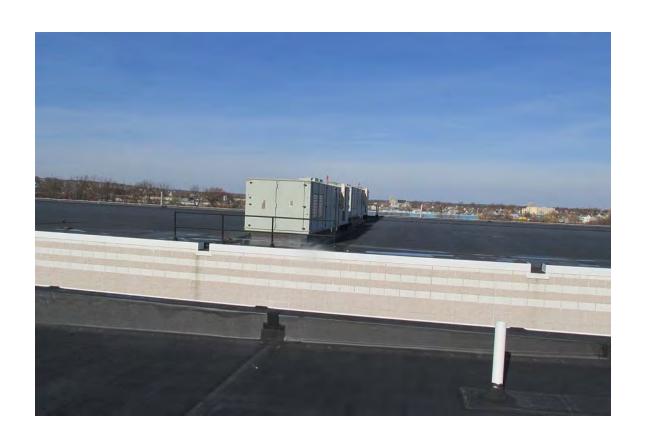
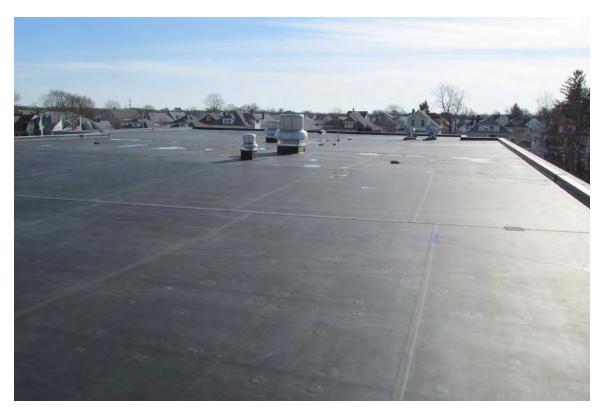
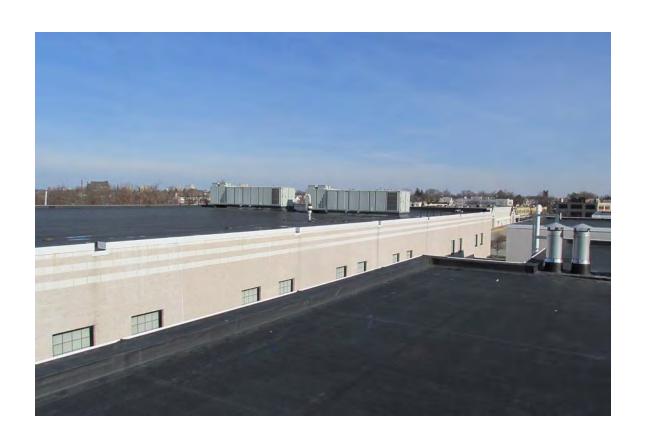
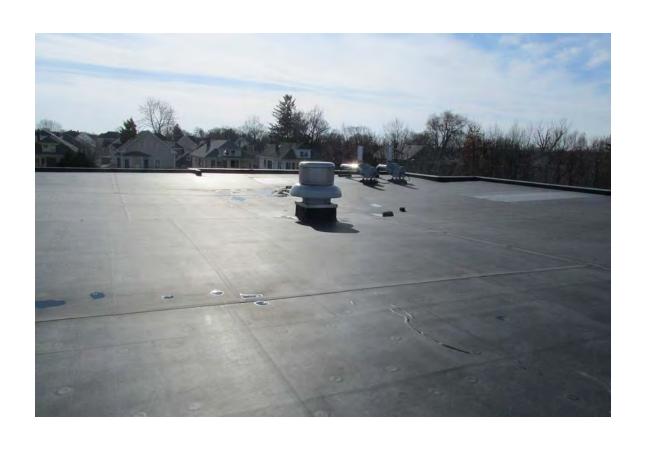
2. Roof St	tructure Condition					
	Poor	Comments:				
	Fair					
	Good					
	X Excellent					
3. Roofing	System Type (i.e. mo	embrane, bu	ilt-up, grave	l ballast)		
	Black Membrane, E	PDM, fully a	dhered			
4 D ('	0 1 0 12

o. Estimat	8 years	Cooling Syste	JIII			
	o years					
7. Estimat	ted Remaining Useful	Life				
	12-17 years

8. Observable Required Repairs
none
9. Roof Access (i.e. hatch, stairs, ladder)
walk-out full size door from 2nd floor northwest hall to lower roof. Fixed wall mounted
ladder to upper roofs.
40.0 % analysis (MandaRan)
10. Security against Vandalism
Locked door from 2nd floor hall, fixed ladder to upper roof
11. Roof Pitch and Orientation
low pitch towards interior drains on Main Bldg. scuppers on gymnasium
12. Obstructions (i.e., piping, conduits, HVAC Units, Skylights)
vents, drains, HVACs on gymnasium
13. Existing Parapet (Req'd by zoning for bldgs 2 stories or less)
X Yes Height <u>8 inches</u>
No State of the st
14. Potential Shading (i.e., trees, roof obstructions taller than PV system, adjacent buildings)
None
Notes:
Notes:

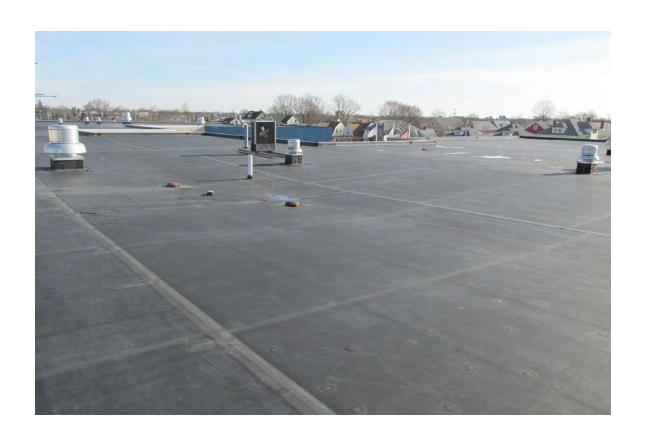
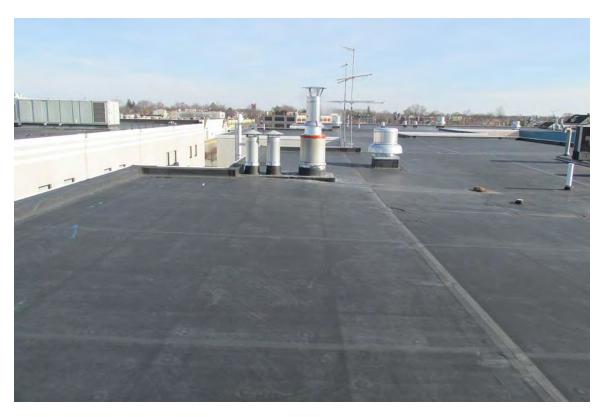
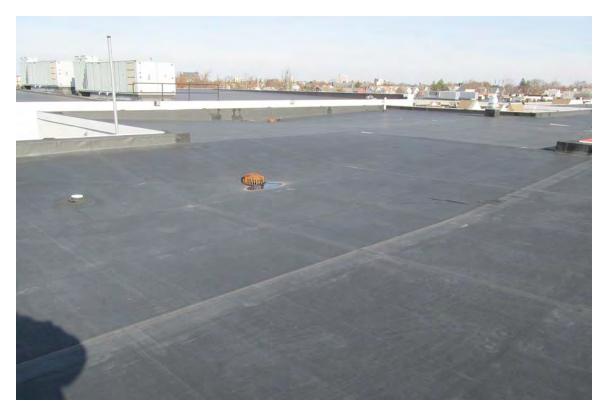
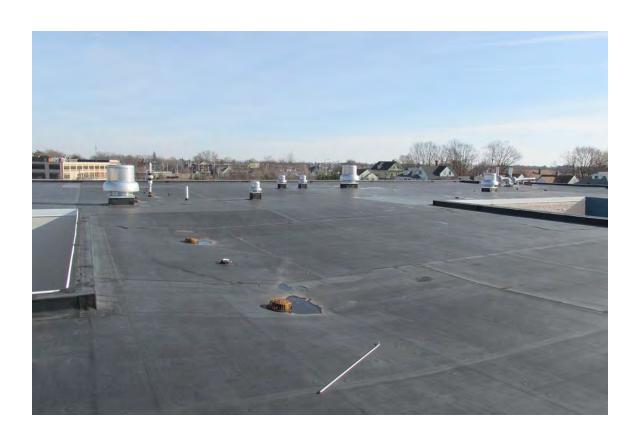
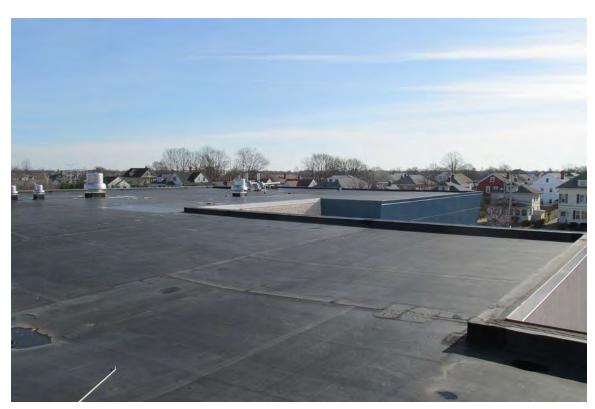
4. Rooting	System Condition					
		Comments:				
	Fair					
	Good					
	X Excellent					
5. Roof St	urface Durability (i.e. s					
	firm (possibly OSB	or plywood s	substrate ov	er rigid insula	ation)	
6 Estimat	L ted/Reported Age of F	Poofing Syste

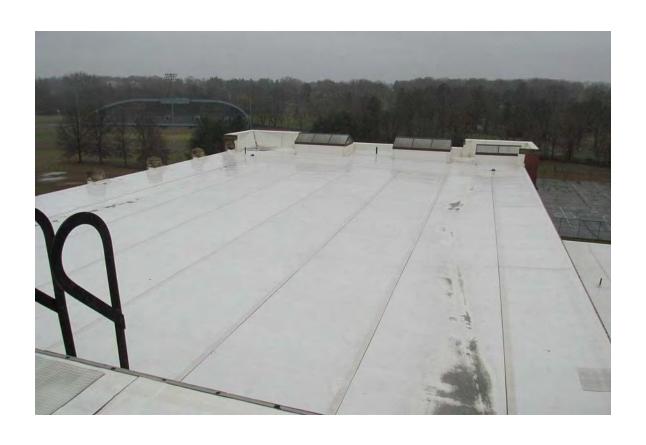
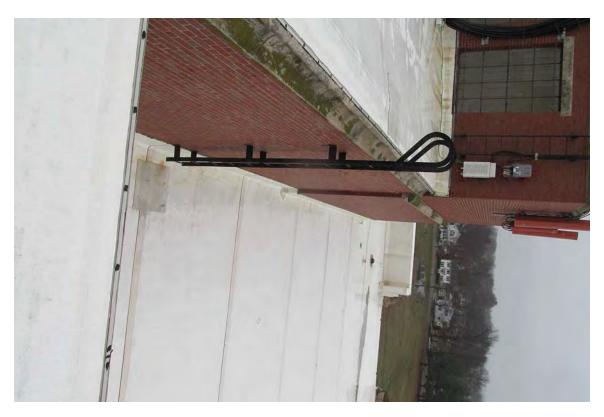
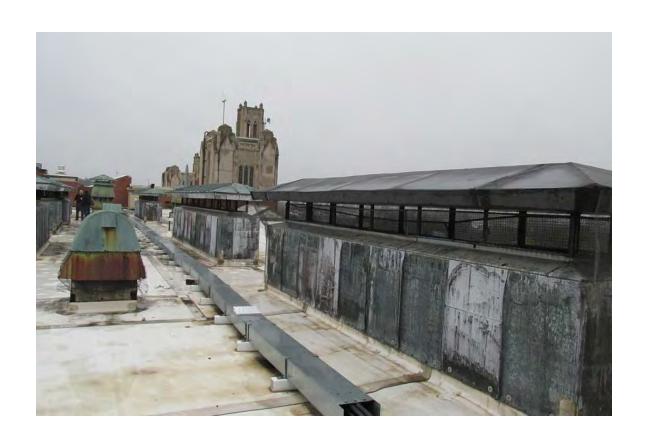
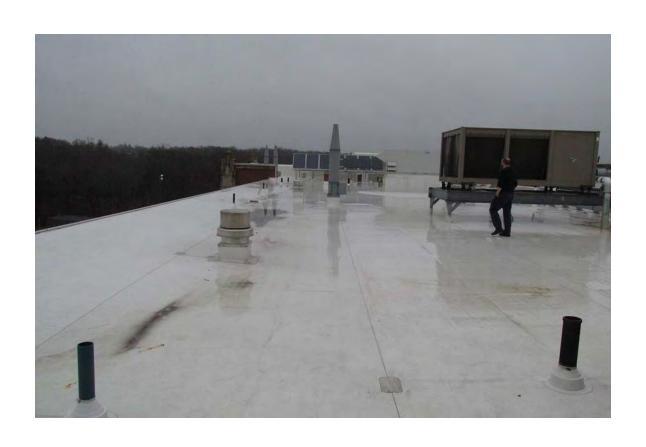
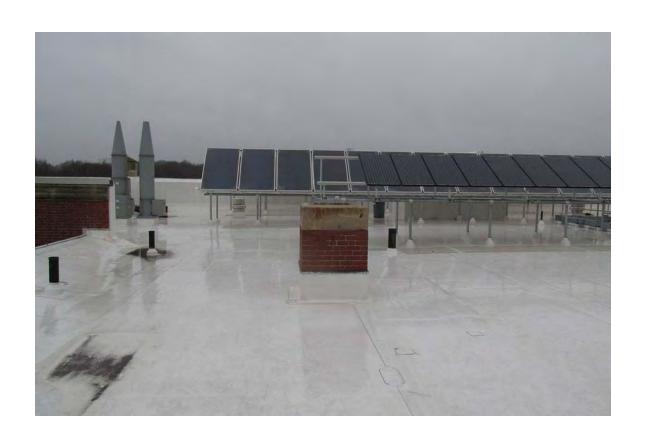
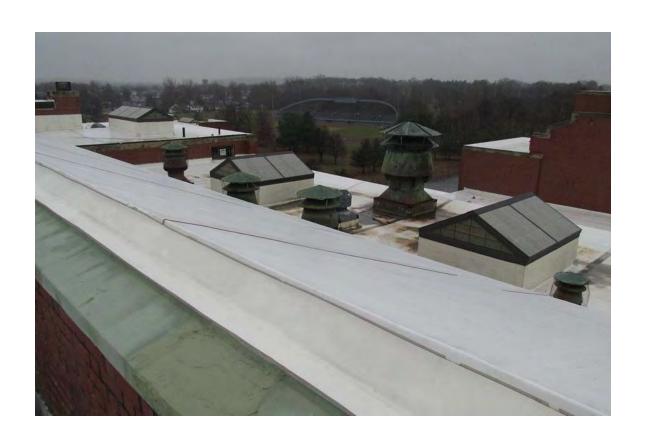
2. Roof St	ructure Condition					
	Poor	Comment	s:			
	X Fair					
	Good					
	Excellent					
3. Roofing	System Type (i.e. n			l ballast)		
	White membrane	(EPDM), fu	lly adhered

4. Roofing	System Condition					
	Poor	Comment	S:			
	X Fair	visually	observed activ	e leaks in lib	orary	
	Good					
	Excellent					
5. Roof St	urface Durability (i.e.	soft or har	d)			
	soft (rigid insulatio	n substrate	, probably no p	olywood or C	OSB)

7. Estimat	Led Remaining Usefu	ıl Life				
	17 to 22 years	-				
	,

8. Observable Required Repairs
Leaks appear to be related to clogged roof drains over library. Other leaks may require membrane repairs.
9. Roof Access (i.e. hatch, stairs, ladder)
ladders from old greenhouse to door leading directly onto roof. Various fixed wall mounted ladders to various roofs
10. Security against Vandalism
access doors to greenhouse floor is locked.
11. Roof Pitch and Orientation
low pitch towards interior drains.
12. Obstructions (i.e., piping, conduits, HVAC Units, Skylights)
none on gymnasium, main building has various skylights, vents, conduits, wiring troughs. Existing PV & H/W solar panels located on the north end of the north wing.
13. Existing Parapet (Req'd by zoning for bldgs 2 stories or less)
Yes Height
X No
14. Potential Shading (i.e., trees, roof obstructions taller than PV system, adjacent buildings)  none
Hone
Notes:

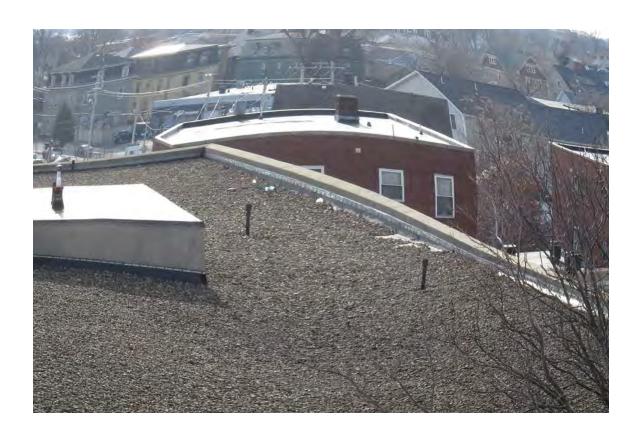
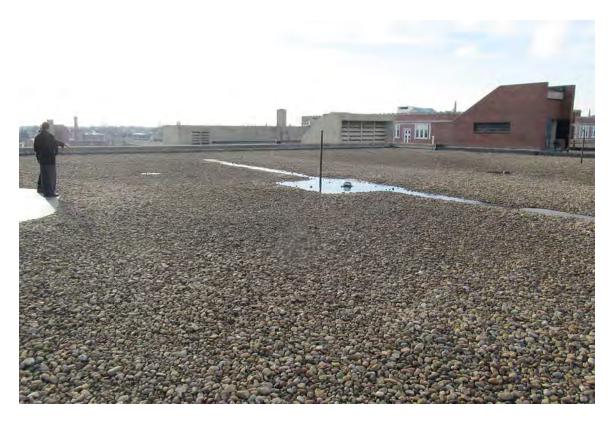
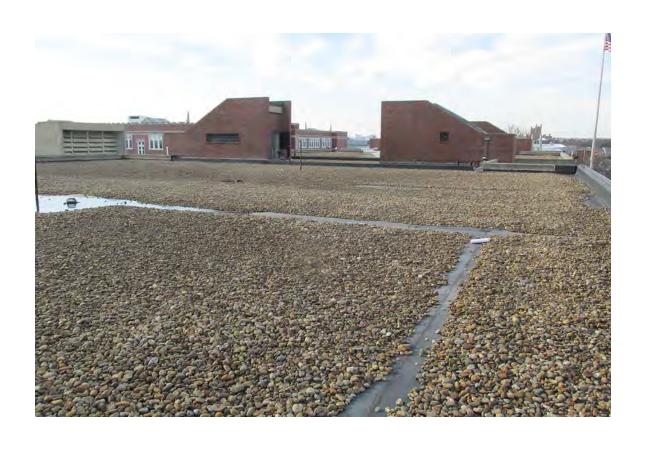
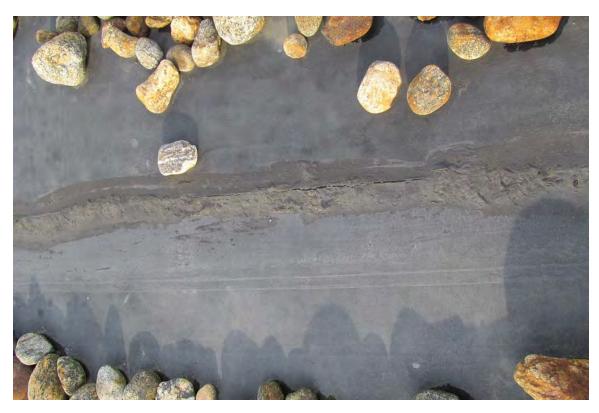
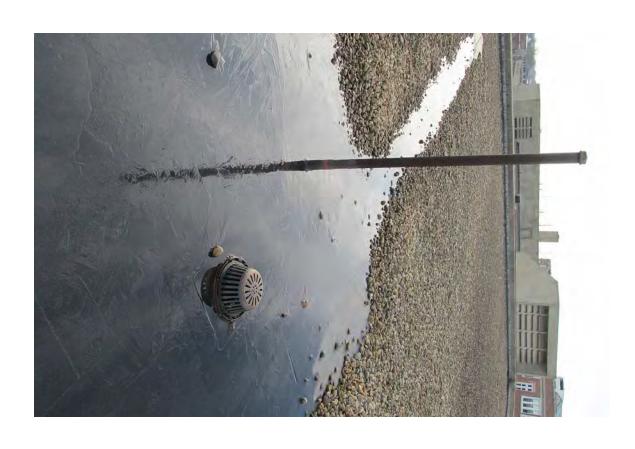
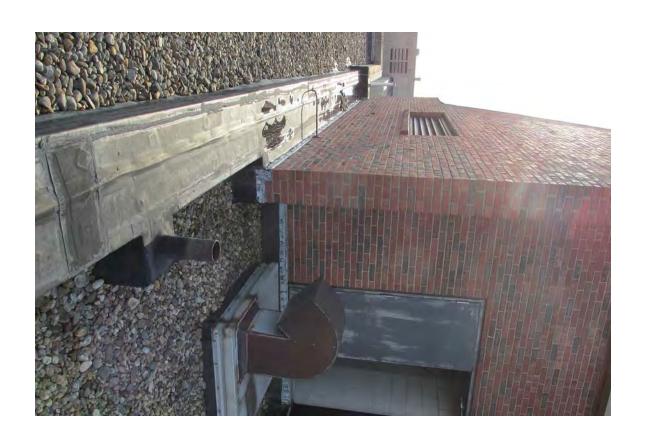
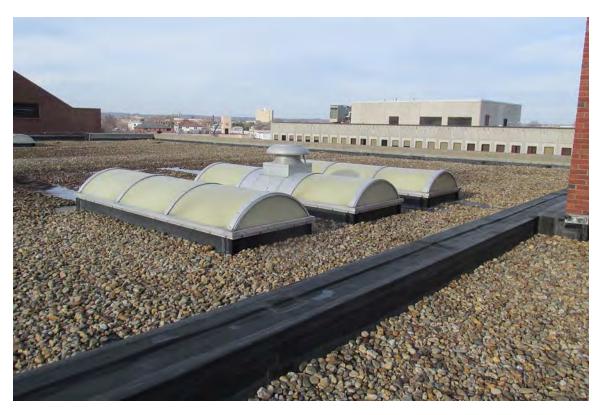
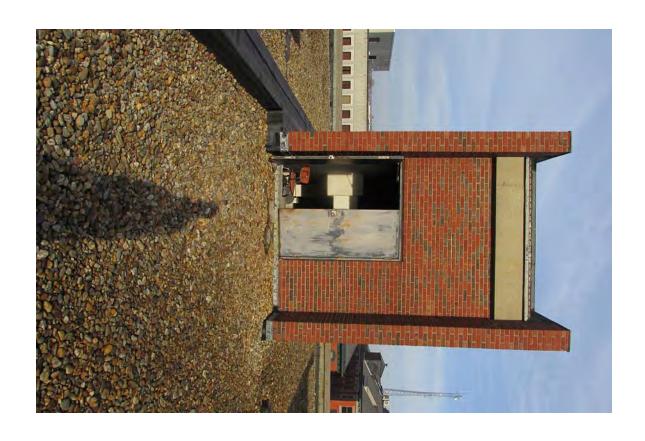
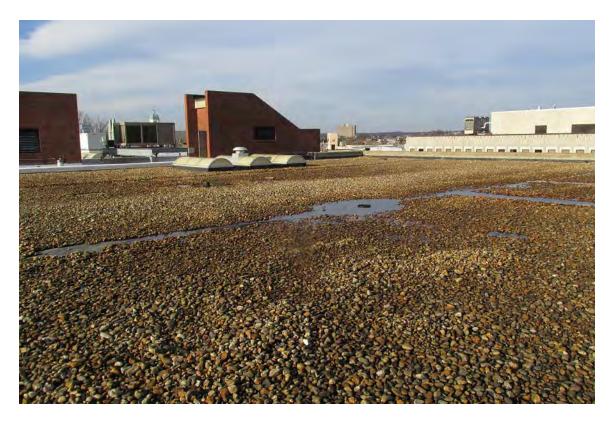
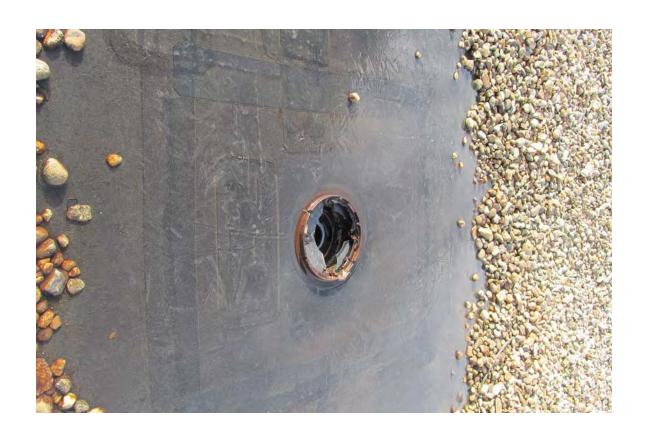
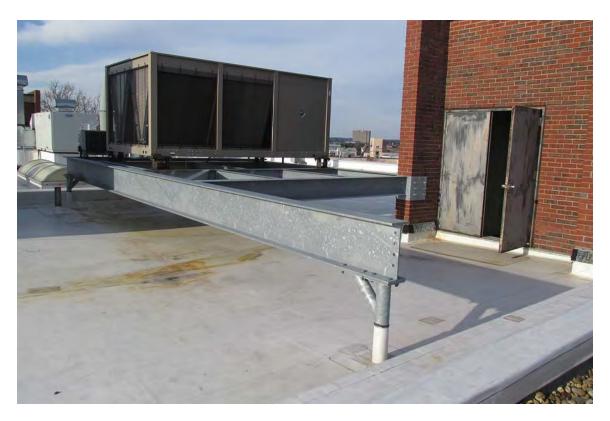
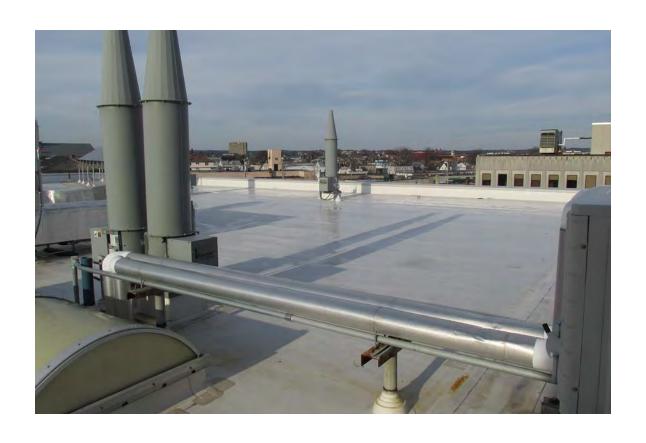
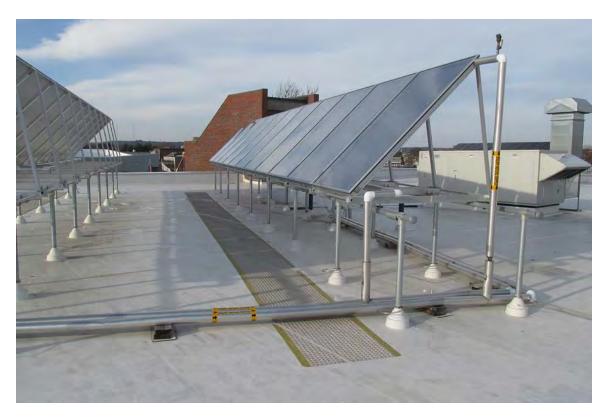
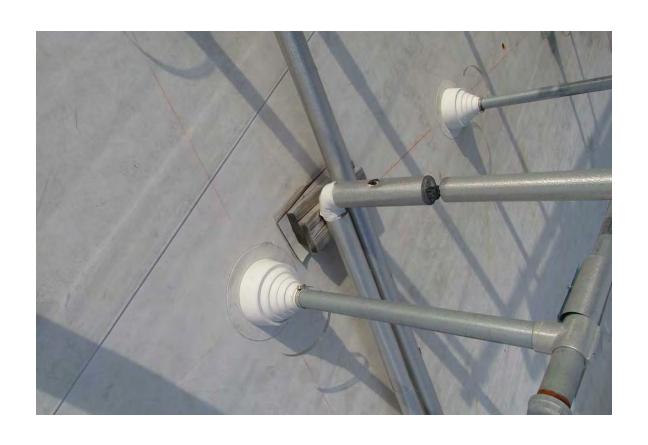
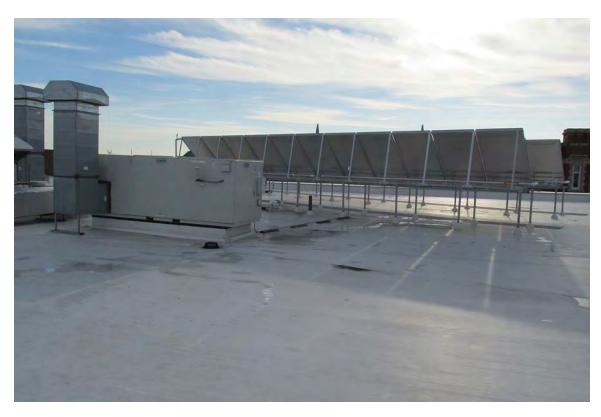
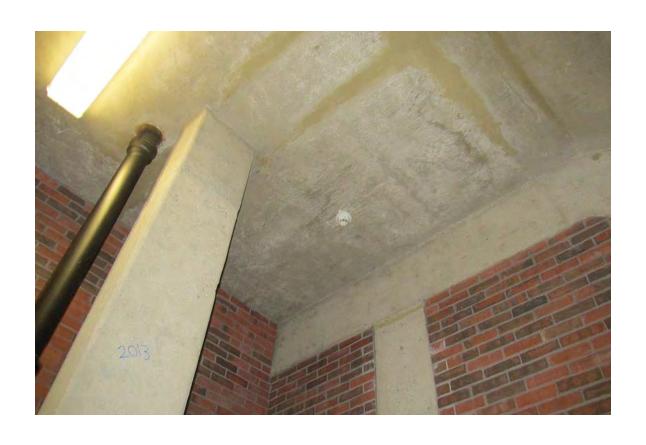
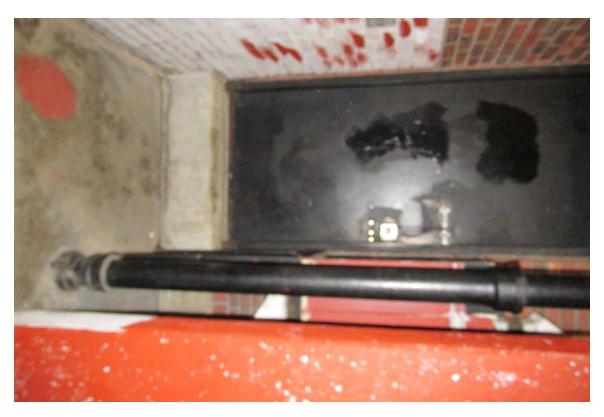
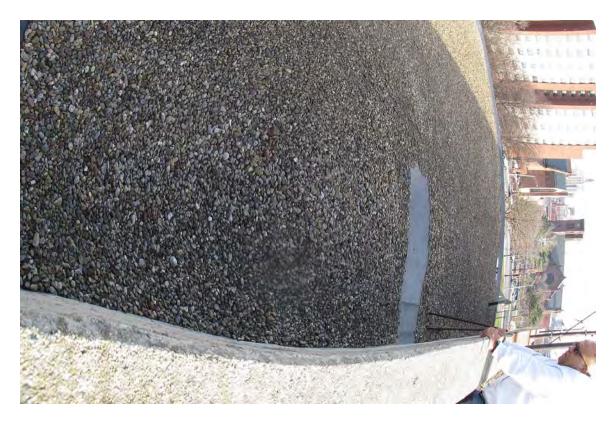
1. Roof St	tructure & Deck Type (i.e., stee	el, wood, concre	te)			
	concrete deck (assumed)					
2. Roof St	tructure Condition					
2	Poor Commer	nte:				
	Fair	113.				
	X Good					
	Excellent					
3 Roofing	System Type (i.e. membrane,	huilt-un grave	l hallast)

o. rtoomig	black membrane with stone			excent west wing wh	nich has a	
	newer white membrane,EPD	• •		moor wing wi	non nao a	
	·	,				
4. Roofing	System Condition					
	Poor Commer					
	X Fair West w	ing roof is in ex	cellent cond	lition		
	Good					
	Excellent

13. Existing Parapet (Req'd by zoning for bldgs 2 stories or less)
X Yes Height 20 in.
No
14. Potential Shading (i.e., trees, roof obstructions taller than PV system, adjacent buildings)
Stair towers
Notes:
Campus has (3) buildings:

- Main School
- Auditorium (very little useable space)
- Gymnasium (couldn't open door to get on roof)

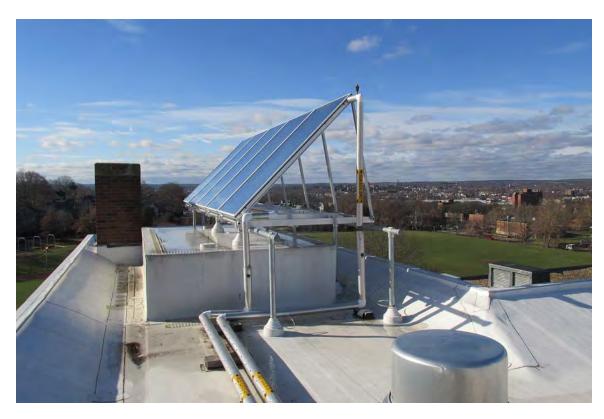
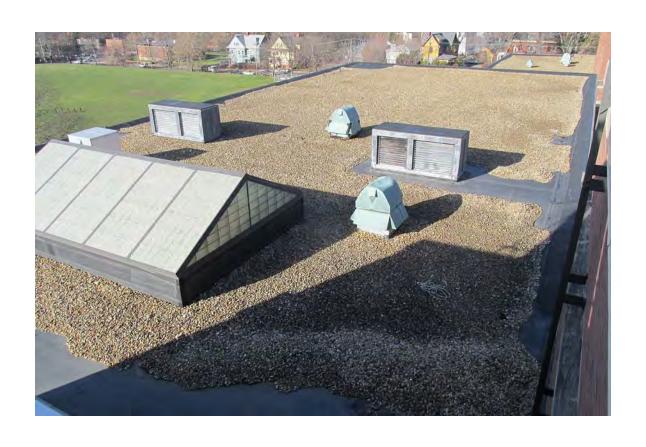
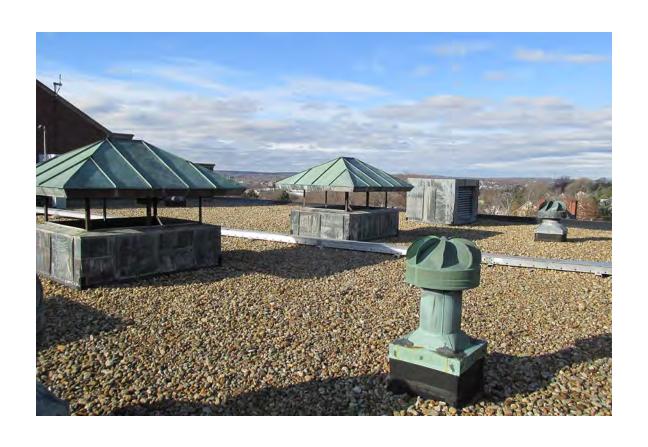
6. Estimat	ed/Reported Age of Ro		stem			
	white membrane- 3-5	•				
	ballasted roof- 10-15	years				
7. Estimat	ted Remaining Useful L	_ife				
	white membrane- 15	•				
	ballasted roof- 5-10 y	years

8. Observable Required Repairs
None
9. Roof Access (i.e. hatch, stairs, ladder)
fixed wall mounted ladder from upper hallway in science wing to penthouse, then door
directly onto roof.
10. Security against Vandalism
10. Security against Vandalism
fixed ladder has a lockable gate over it.
11. Roof Pitch and Orientation
low pitch towards interior drains.
low piter towards interior drains.
12. Obstructions (i.e., piping, conduits, HVAC Units, Skylights)
Vents, HVAC, skylights. Existing PV & H/W solar on science wing roof.
13. Existing Parapet (Req'd by zoning for bldgs 2 stories or less)
Yes Height
X No
14. Potential Shading (i.e., trees, roof obstructions taller than PV system, adjacent buildings)
None
Notes:

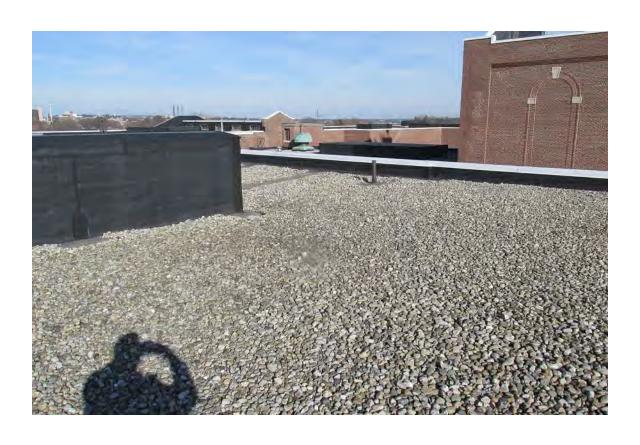
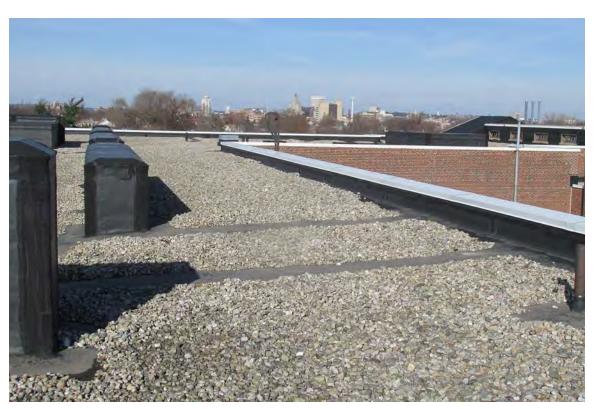
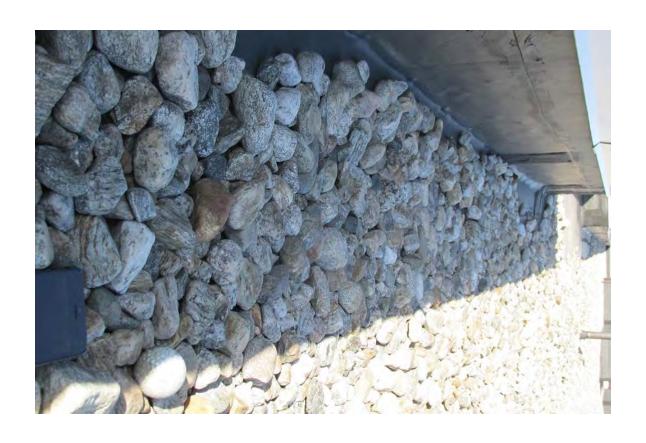
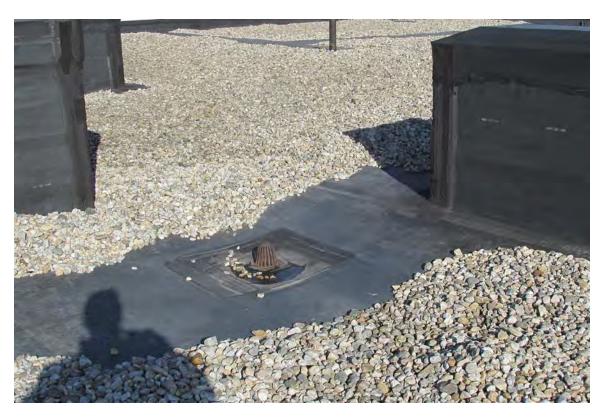
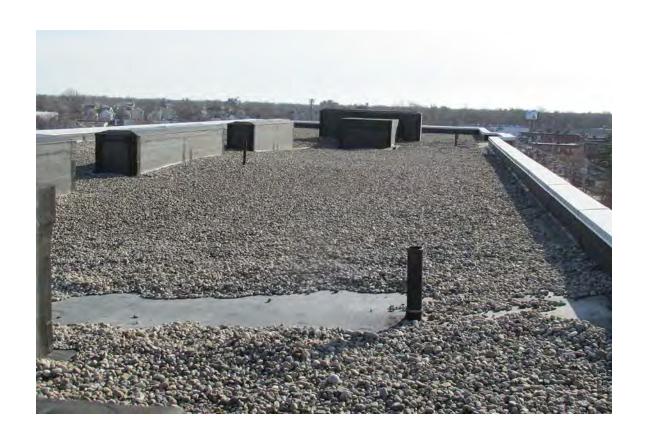
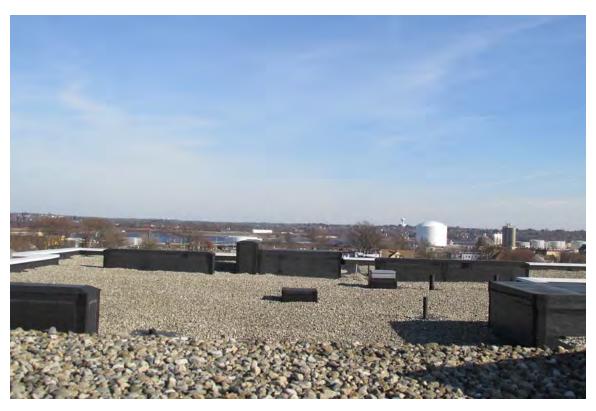
3. Roofing	System Type (i.e. membran	e, built-up, grave	l ballast)		
	Black membrane with grav	el ballast.			
4. Roofing	System Condition				
	Poor Comme	ents:			
	Fair				
	X Good				
	Excellent

8. Observable Required Repairs
Seams are opening up in various locations, possible leaks.
9. Roof Access (i.e. hatch, stairs, ladder)
climbed through window onto lower roof, then up fixed wall mounted ladders to upper
roofs.

11. Roof Pitch and Orientation
low pitch towards interior drains
12. Obstructions (i.e., piping, conduits, HVAC Units, Skylights)
Vents, drains, and what may be old vent and/or skylight structures.

13. Existing Parapet (Req'd by zoning for bldgs 2 stories or less)
X Yes Height 16 in.
No
14. Potential Shading (i.e., trees, roof obstructions taller than PV system, adjacent buildings)
None on upper roofs, auditorium has tall projection to the south.
Notes:
Charlotte Woods Elementary School is located to the south. Building appears to have a flat roof clear of
obstructions and may be a potential site.
assertables and may be a potential site.

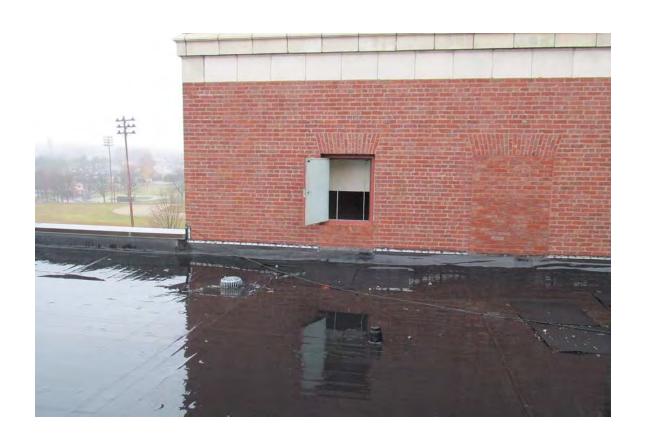
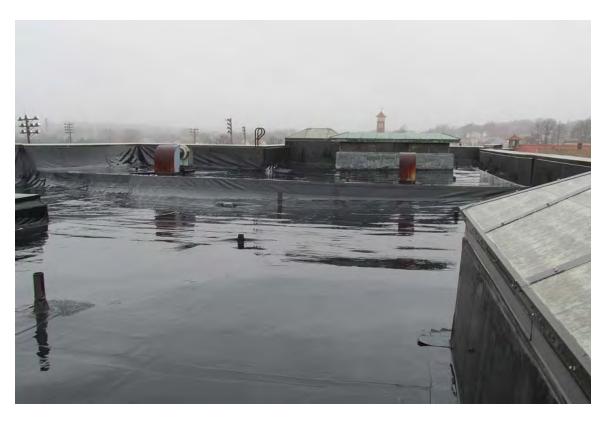
6. Estimat	ted/Reported Age of Roofing	Svstem			
	approx. 5-10 years	-,			
7. Estimat	ted Remaining Useful Life				
	5-10 years based on comm	nents above.

8. Observable Required Repairs
Reported leaks, refer to above comments.
9. Roof Access (i.e. hatch, stairs, ladder)
fixed ladder in Boys restroom on 4th floor. Ladder leads to small door which opens directly
onto lower roof. Fixed wall ladders provide access to upper roof.
10. Security against Vandalism
Boys Room is kept locked and ladder has locked cage.
11. Roof Pitch and Orientation
Low pitch towards interior drains.
12. Obstructions (i.e., piping, conduits, HVAC Units, Skylights)
Skylights, drains, vents.
13. Existing Parapet (Req'd by zoning for bldgs 2 stories or less)
X Yes Height 36 in.
No
14. Potential Shading (i.e., trees, roof obstructions taller than PV system, adjacent buildings)
None
Notes:

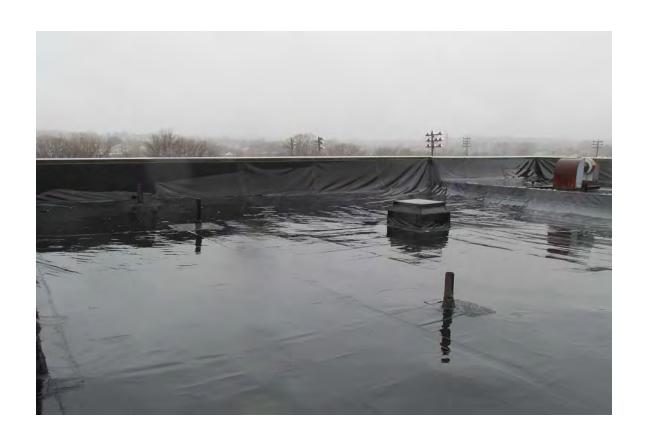
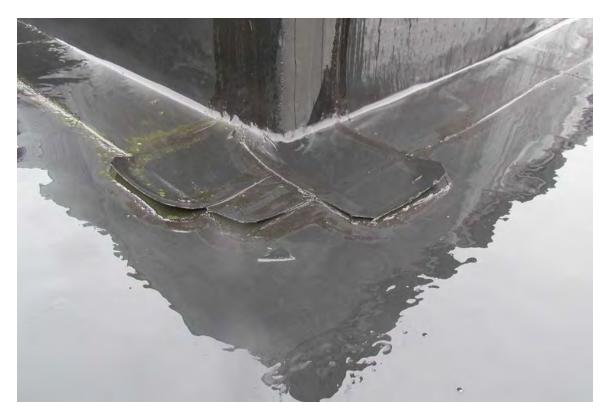
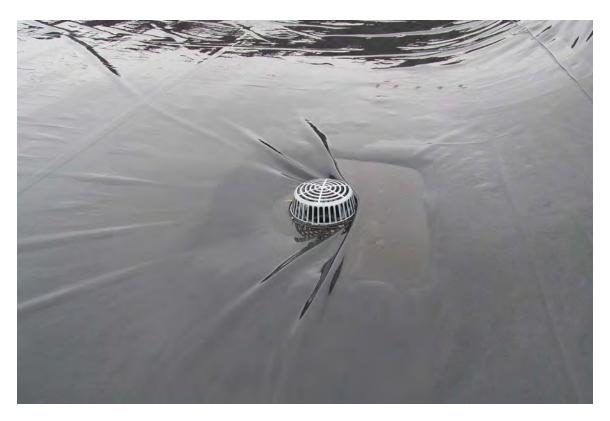
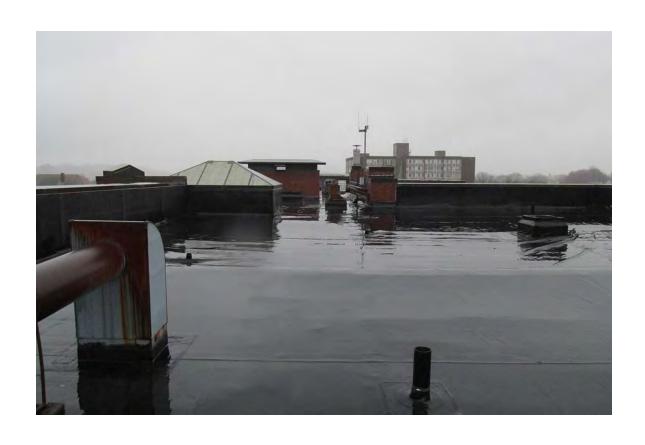
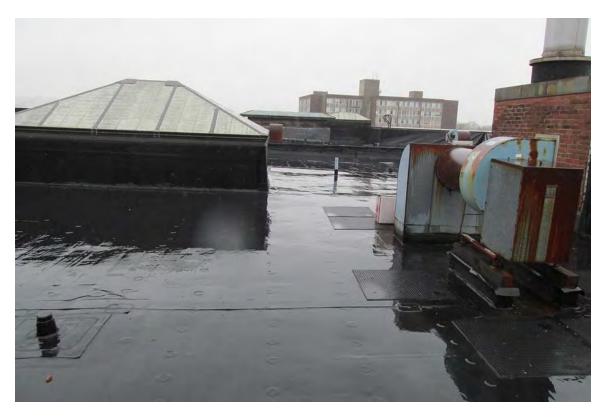
4. Rooting	System Condition				1
	X Poor Comme		on indication		avina francisci
	Manuel	seams are show		n of membrane m failure	oving from wind.
		Scarris are snow	ring signs of	ialiare.	
E Doof C	Excellent	, o rd)

5. R001 S	urface Durability (i.e. soft or h	,	Many places t	falt like areaking a	nd giving way
	hard, possibly plywood or ( under footsteps.	Job substrate. IV	nany places i	ieit like cracking a	nd giving way
	under rootsteps.

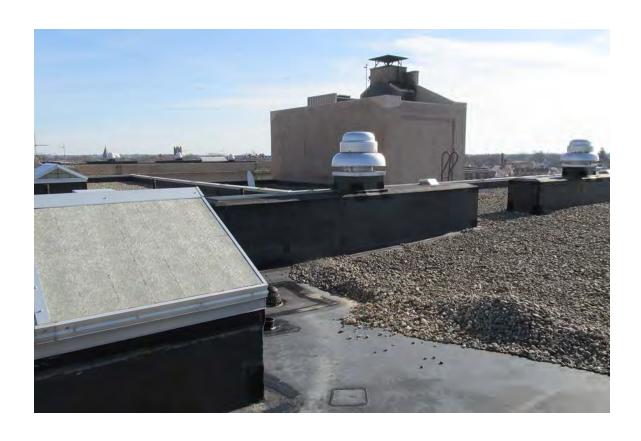
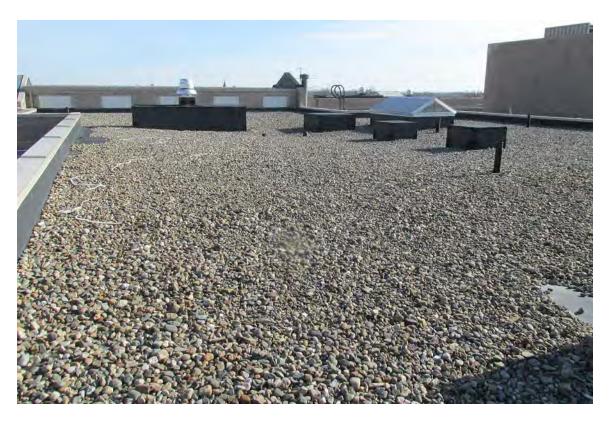
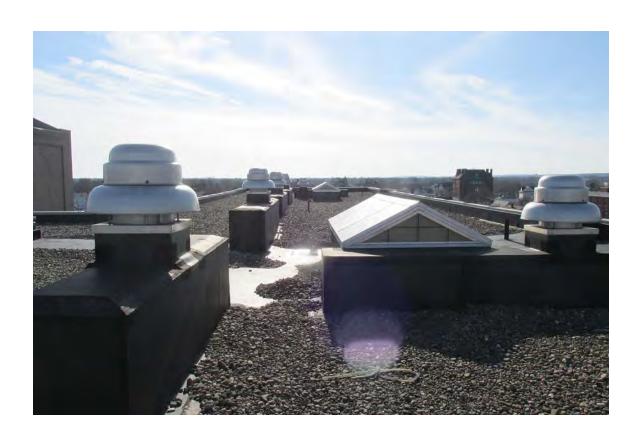
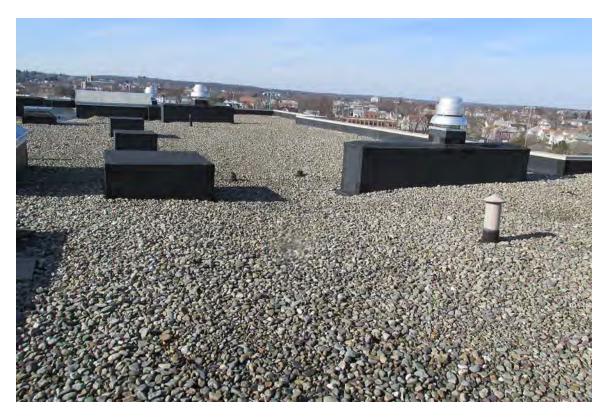
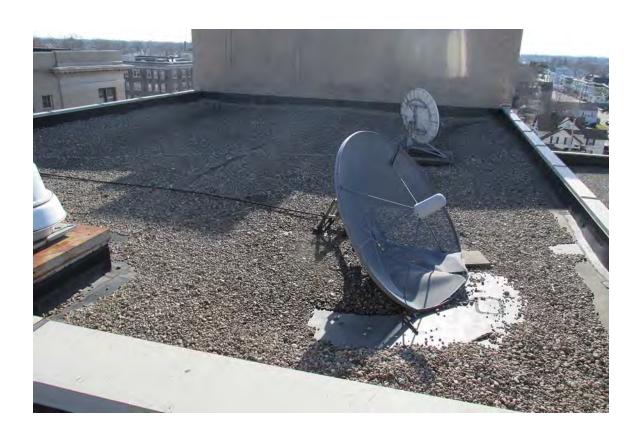
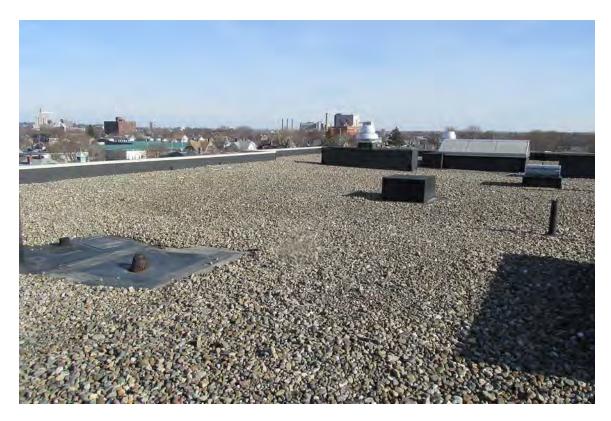
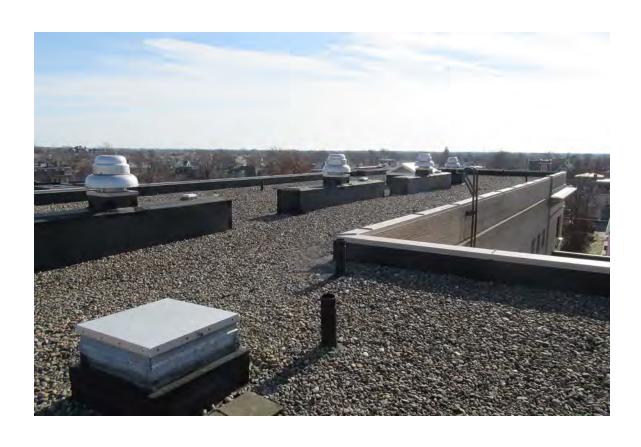
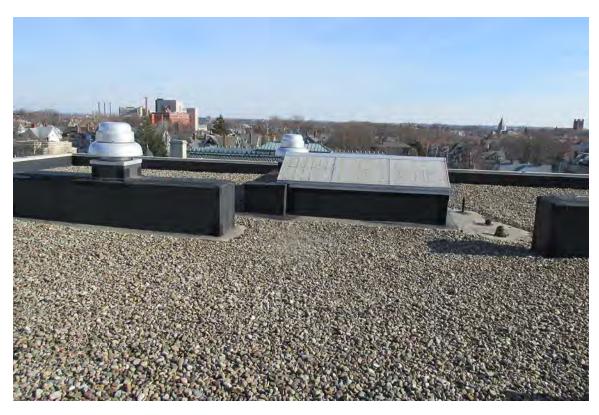
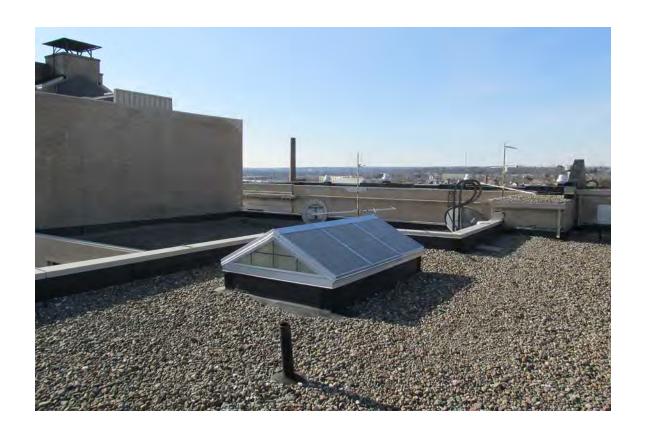
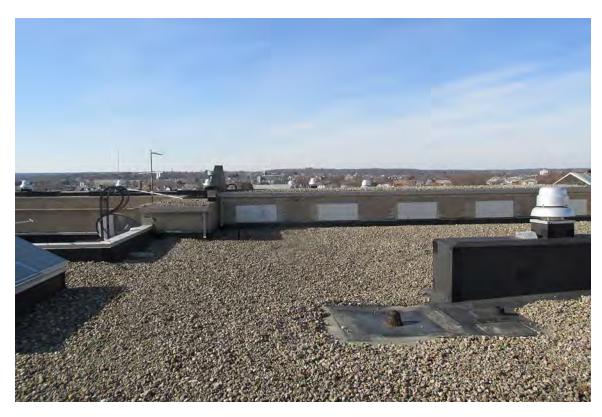
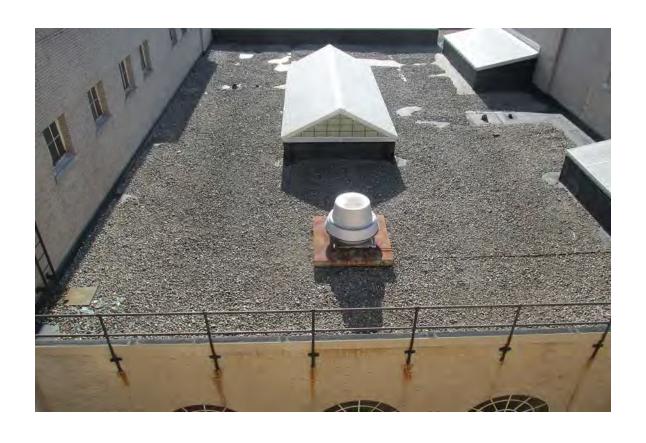
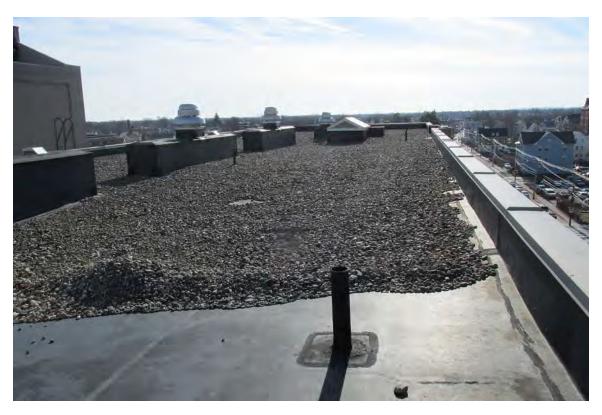
-		_			
_							
Site ID	8						
Name	Gilbert Stuart Middle Sc						
Address	188 Princeton Avenue (						
Use	Middle School Sto	ories 3	Year Built	1930			
1 Roof S	tructure & Deck Type (i e	steel wood concre	ete)				
	oof Structure & Deck Type (i.e., steel, wood, concrete)  Building is similar to Nathaniel Greene Middle School, assume concrete roof						
	Danamy to the	amamor Oroono mia	210 CO.1001, a				
2 Roof S	L tructure Condition

2. KUUI 3		mments:					
	Fair	mments.					
	X Good						
	Excellent						
3. Roofing	g System Type (i.e. mem	brane, built-up, grave	el ballast)				
•	Black membrane with gravel ballast						
4 Roofing	Lg System Condition

8. Observable Required Repairs				
None				
9. Roof Access (i.e. hatch, stairs, ladder)				
climbed through window onto lower roof, then up fixed wall mounted ladders to upper				
roofs.

14. Potential Shading (i.e., trees, roof obstructions taller than PV system, adjacent buildings)  None on upper roofs, auditorium has tall projection to the south.				
None on upper roots, additionant has tall projection to the south.				
Notes:

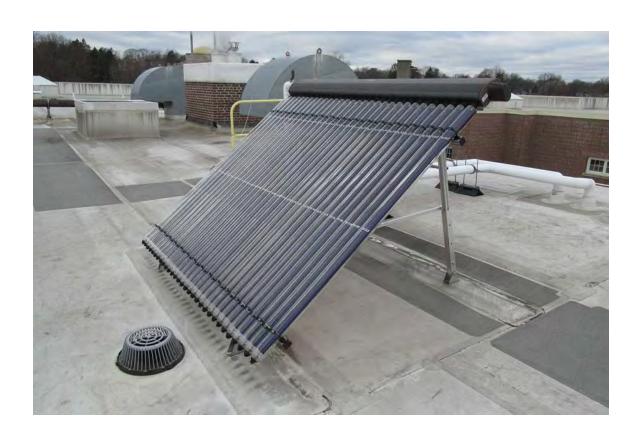
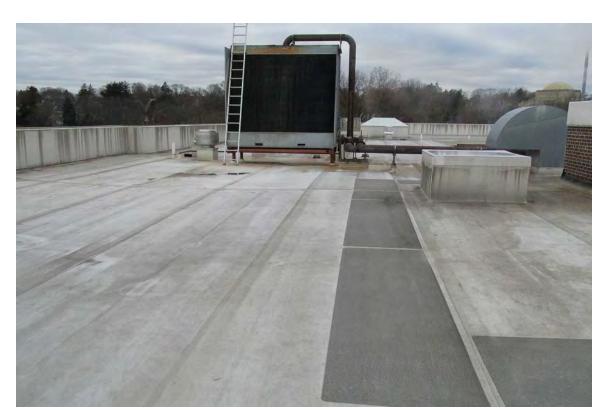
7. Estimat	7. Estimated Remaining Useful Life						
	15-20 years

8. Observable Required Repairs
None, some drains are clogged.
9. Roof Access (i.e. hatch, stairs, ladder)
Short fixed ladder in closet, through door directly onto lower roof, fixed wall mounted ladders to upper main roof.
10. Security against Vandalism
Closet door kept locked.
11. Roof Pitch and Orientation
Low pitch towards interior drains.
12. Obstructions (i.e., piping, conduits, HVAC Units, Skylights)
Vents, drains, skylights, HVAC units. Existing tube solar panel system (assume hot water)
13. Existing Parapet (Req'd by zoning for bldgs 2 stories or less)
X Yes Height 3'-6" ± No
14. Potential Shading (i.e., trees, roof obstructions taller than PV system, adjacent buildings)
None
Notes:
Major renovations occurred in 2009 (\$33M). School is like new interior and exterior.
