# Solar Energy Potential Report City Of Providence

Ms. Leah Bamberger, Director of Sustainability City of Providence 25 Dorrance Street Providence, RI 02903

February 2015 Revised March 2015 **Final June 2015**

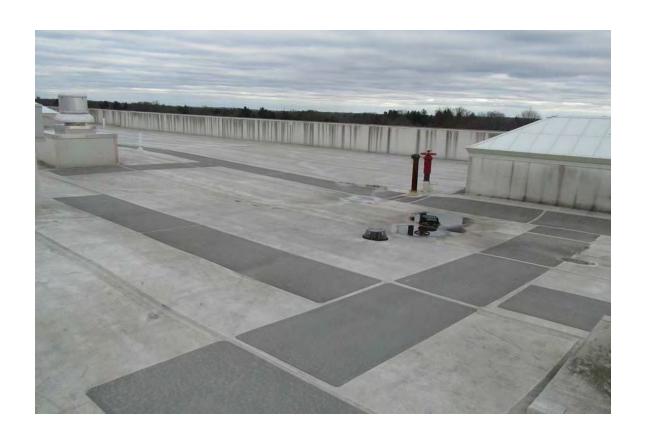
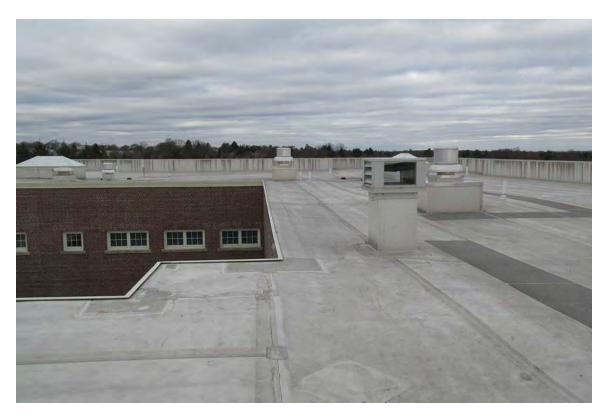
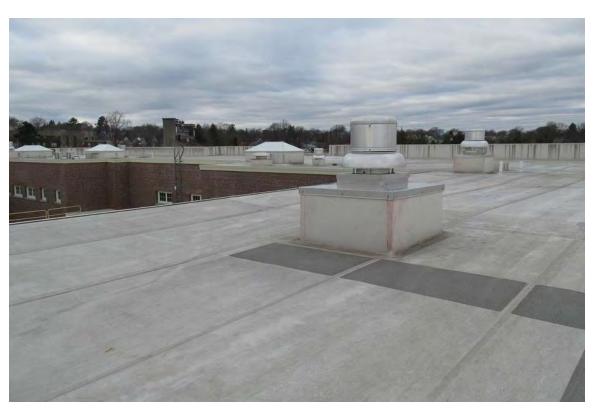
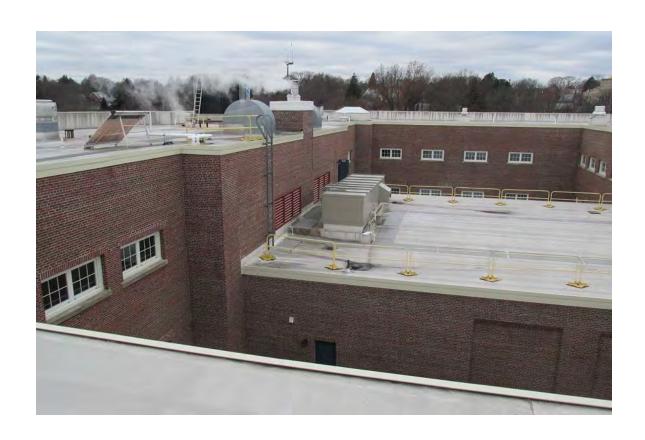
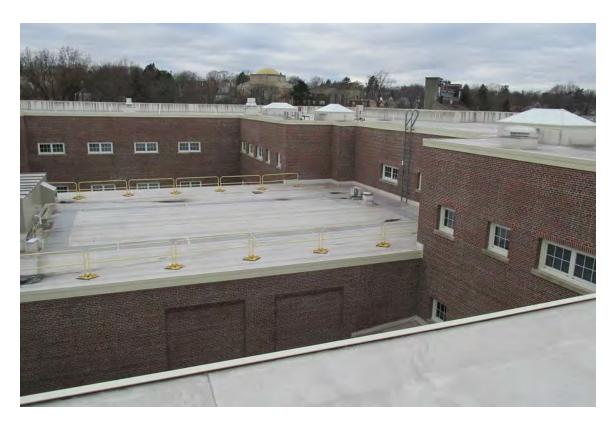
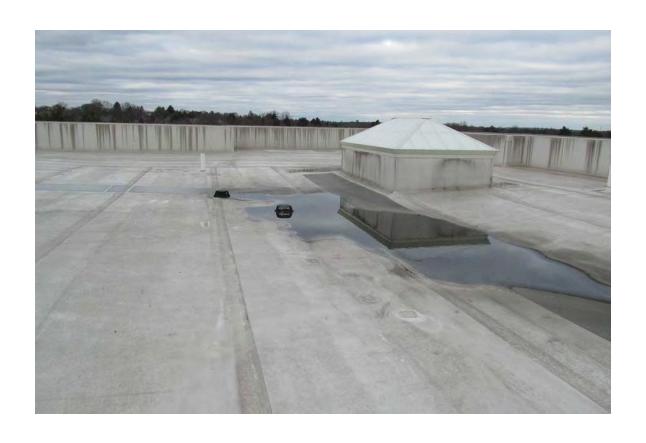
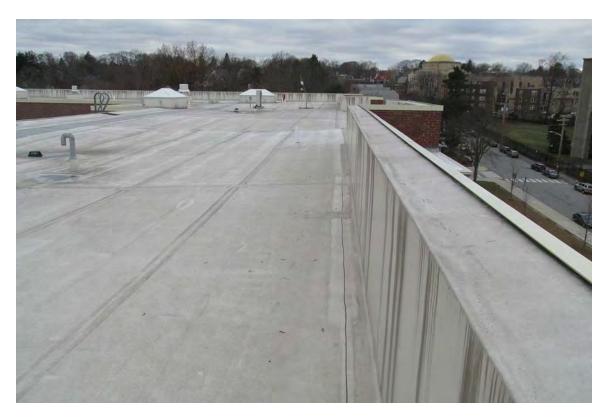
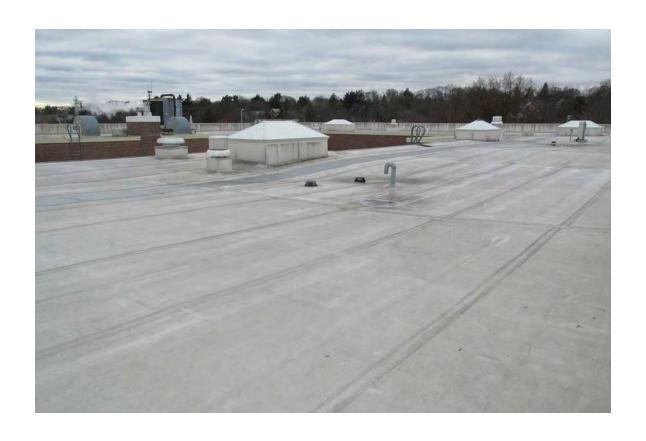
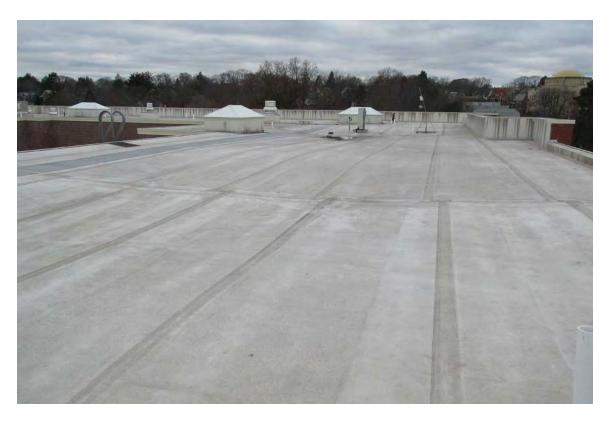
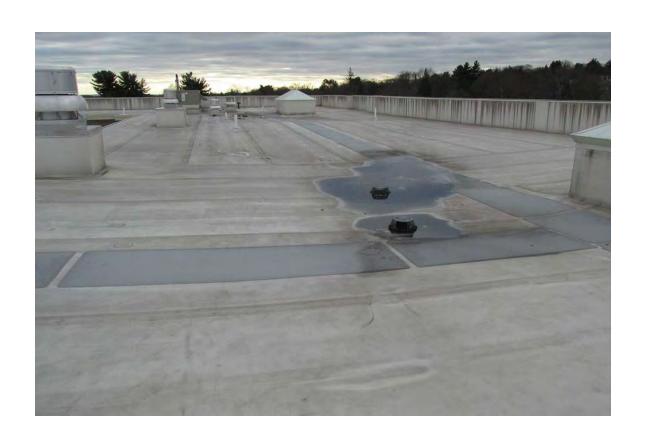
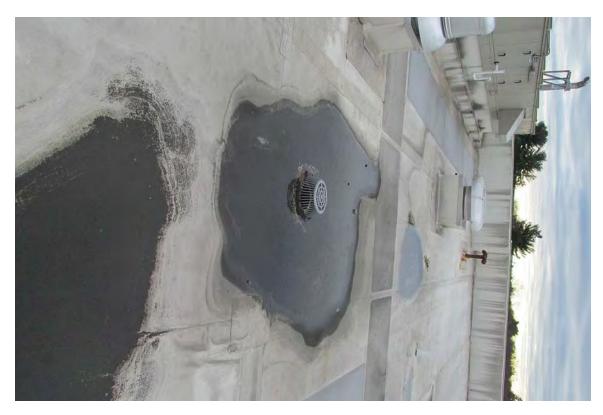
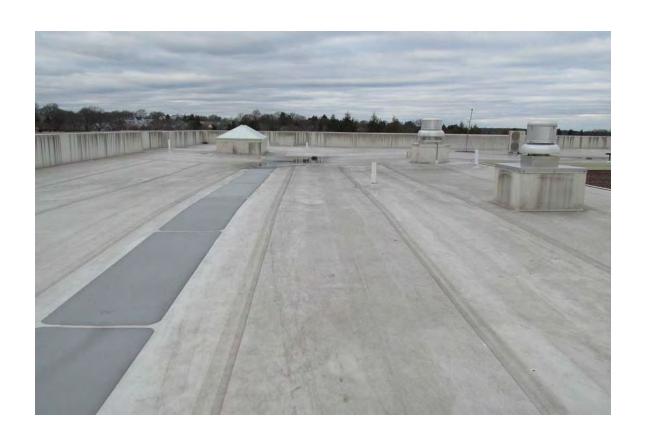
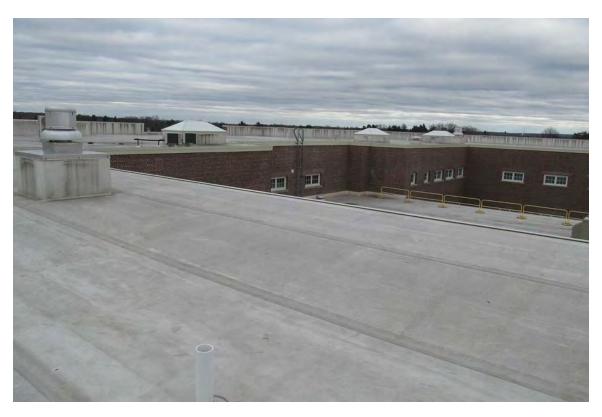
1. Roof St	tructure & Deck Type (i	i.e steel.	. wood. concre	ete)			
	unknown	,	,,				
2 Roof St	L tructure Condition						
2. 1(00) 0		Comment	<u> </u>				
	Fair	JOHII II <del>C</del> HI	5.				
	X Good						
	Excellent

3. Roofing	System Type (i.e. me	mbrane,	built-up, grave	l ballast)			
	White membrane, El	PDM, fully	y adhered				
4. Roofing	System Condition						
		Comment	e.				
	Fair	JOHIII CITE	<b>3.</b>				
	Good						
	X Excellent

8. Observable Required Repairs
None, some drains are clogged.
9. Roof Access (i.e. hatch, stairs, ladder)
Short fixed ladder in closet, through door directly onto lower roof, fixed wall mounted ladders to upper main roof.
10. Security against Vandalism
Closet door kept locked.
11. Roof Pitch and Orientation
Low pitch towards interior drains.
12. Obstructions (i.e., piping, conduits, HVAC Units, Skylights)
Vents, drains, skylights, HVAC units. Existing tube solar panel system (assume hot water)
13. Existing Parapet (Req'd by zoning for bldgs 2 stories or less)
X Yes Height 3'-6" ± No
14. Potential Shading (i.e., trees, roof obstructions taller than PV system, adjacent buildings)
None
Notes:
Major renovations occurred in 2009 (\$33M). School is like new interior and exterior.

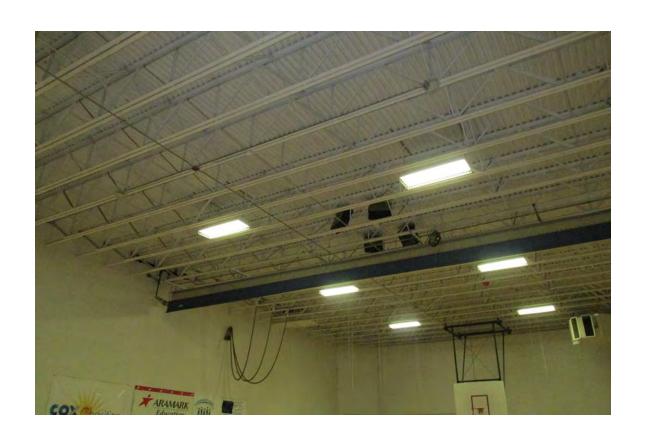
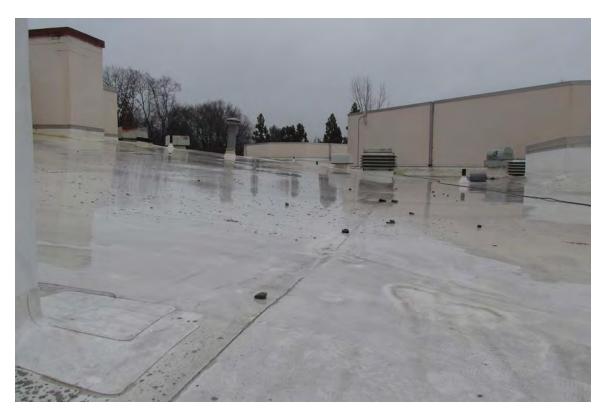
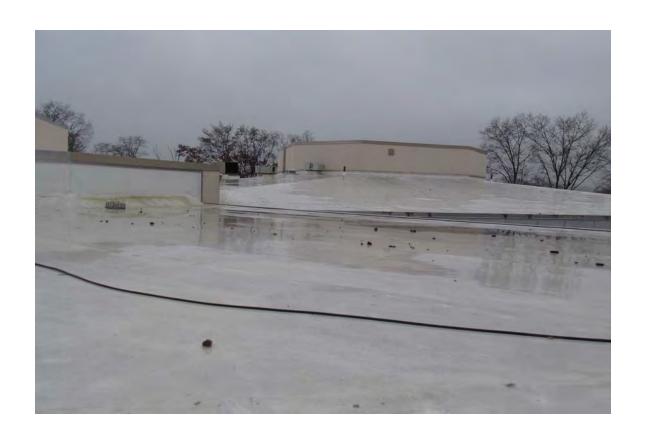
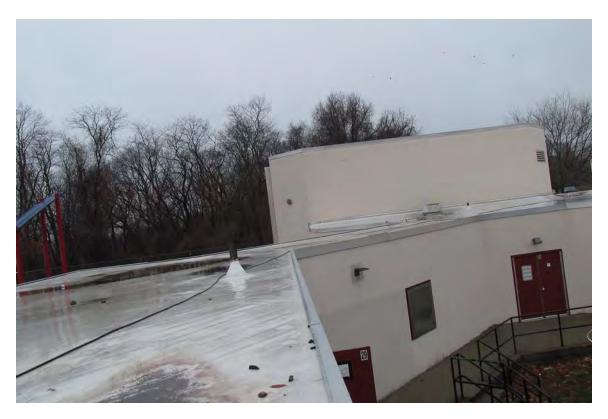
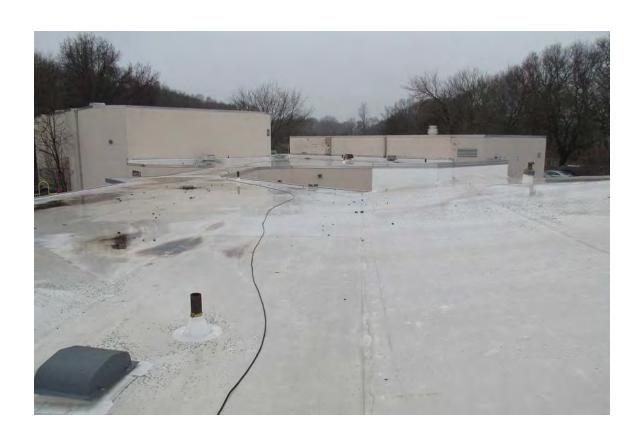
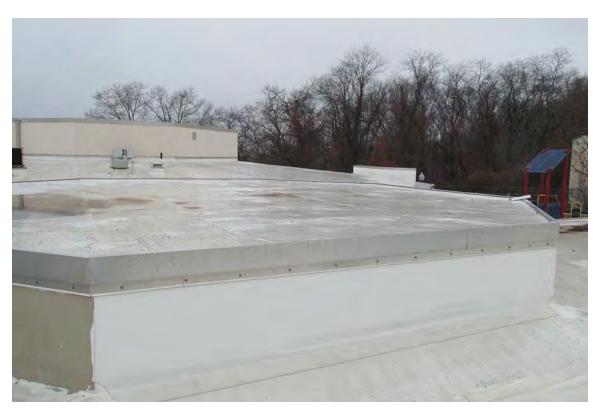
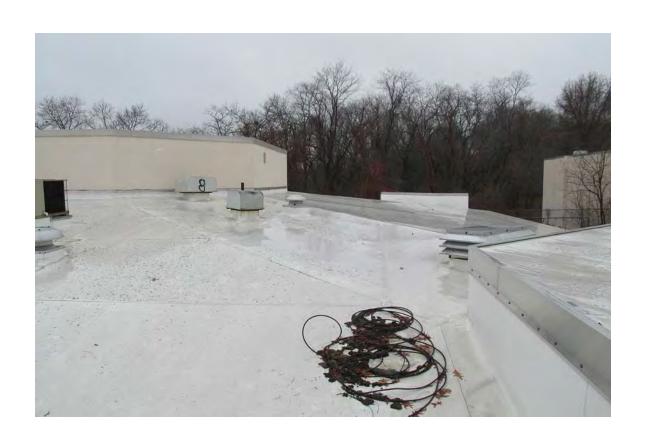
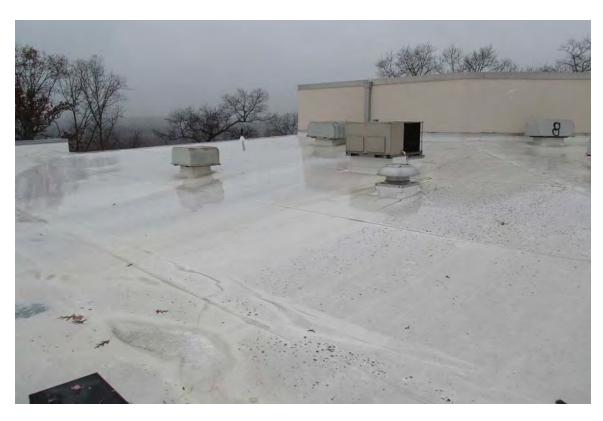
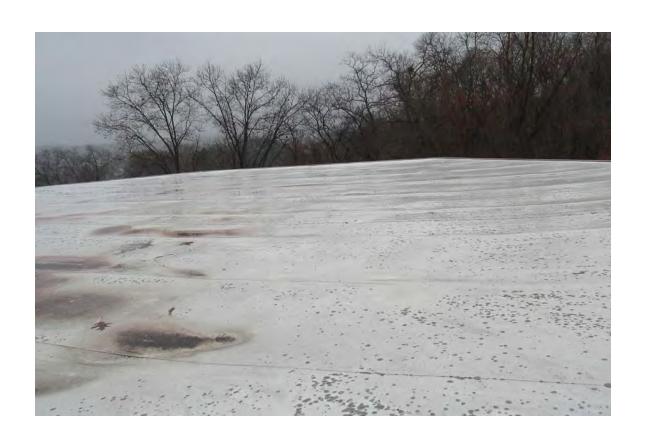
2. Roof St	tructure Condition				
	Poor Commer	nts:			
	Fair				
	X Good				
	Excellent				
3. Roofing	System Type (i.e. membrane	, built-up, grave	el ballast)		
	White membrane, EPDM, fu	lly adhered.			
4 Doofing	Cyctom Condition

4. Rooning	System Condition	-1			
	Poor Commer		drain standi	ing water	
		areas that don't	urairi, Stariui	ing water	
	X Good				
5 Poof S	Excellent Excellent	urd)

8. Observable Required Repairs
Standing water due to improper pitch. Clogged drain grates.
O. Poof Access (i.e. hotely stairs, ladder)
9. Roof Access (i.e. hatch, stairs, ladder)
No access, used 10 foot step ladder.

12. Obstructions (i.e., piping, conduits, HVAC Units, Skylights)
each wing has a center raised flat roof (4 foot high), various vents, conduits, cables and chimneys.

13. Existing Parapet (Req'd by zoning for bldgs 2 stories or less)  Yes Height  X No
14. Potential Shading (i.e., trees, roof obstructions taller than PV system, adjacent buildings)
Building is one story and has tall tress to the south, east, and west.
Dullating to one story and has tall tress to the south, east, and west.
Notes:

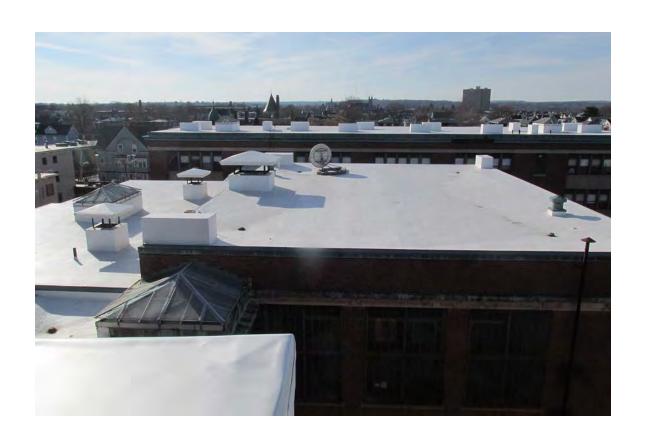
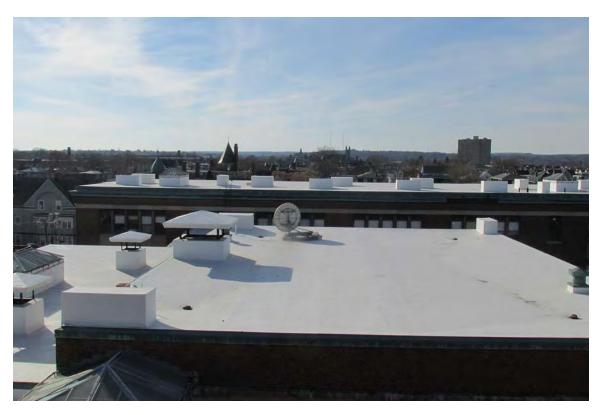
7. Estima	ted Remaining Useful Life				
	17-22 years

8. Observable Required Repairs
None to roof, did observe large vertical crack in chimney.
9. Roof Access (i.e. hatch, stairs, ladder)
Fixed interior ladder in custodian closet, through roof hatch. Typical each wing. Fixed
exterior ladders to lower roofs.
10. Security against Vandalism
Custodial closet is kept locked.
11. Roof Pitch and Orientation
Low pitch towards interior drains.
12. Obstructions (i.e., piping, conduits, HVAC Units, Skylights)
Old roof vent structures, skylights, vent stacks.
13. Existing Parapet (Req'd by zoning for bldgs 2 stories or less)
Yes Height
X No
14. Potential Shading (i.e., trees, roof obstructions taller than PV system, adjacent buildings)
None
Notes:

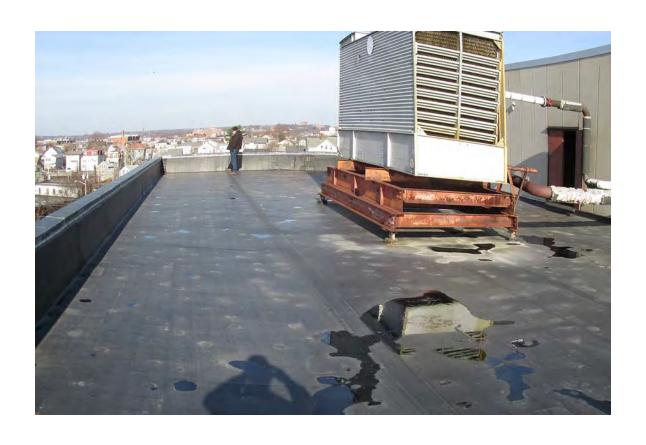
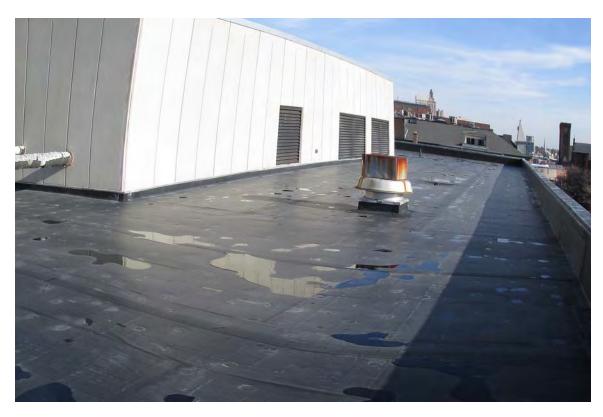
1. Roof S	tructure & Deck Type	(i.e., steel	. wood. concre	ete)			
1. 11001 0	Possibly steel joists	•		·	f in mechanic	al penthouse.	
						р	
2 Poof S	L tructure Condition

2. K001 S		Cammant	•				
	Poor Fair	Comment	S:				
	X Good						
	Excellent						
3. Roofing	System Type (i.e. m	embrane.	built-up. grave	el ballast)			
	Black membrane, E						
	,	, ,					
4 Poofin	L g System Condition

7. Estima	ted Remaining Useful	Life					
	17-22 years

8. Observable Required Repairs
None
9. Roof Access (i.e. hatch, stairs, ladder)
Walk-out door from Mechanical Penthouse
10. Security against Vandalism
Building is secure, must be buzzed in and sign in at front desk.
11. Roof Pitch and Orientation
low pitch to interior drains.
12. Obstructions (i.e., piping, conduits, HVAC Units, Skylights)
HVAC unit, vents, and roof drains
13. Existing Parapet (Req'd by zoning for bldgs 2 stories or less)
X Yes Height <u>28 in.</u>
No
14. Potential Shading (i.e., trees, roof obstructions taller than PV system, adjacent buildings)
none
Notes:

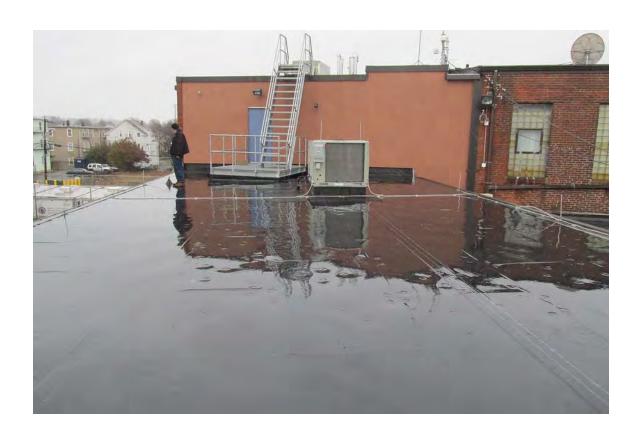
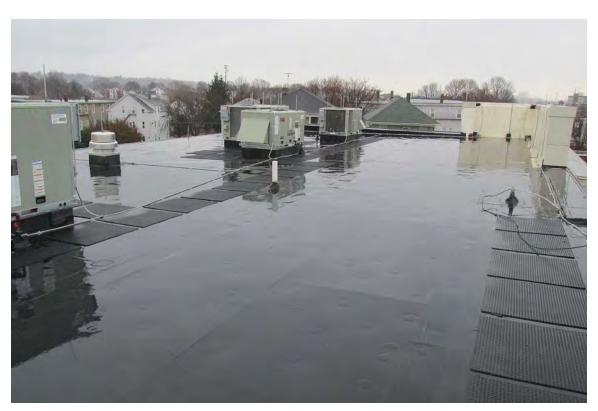
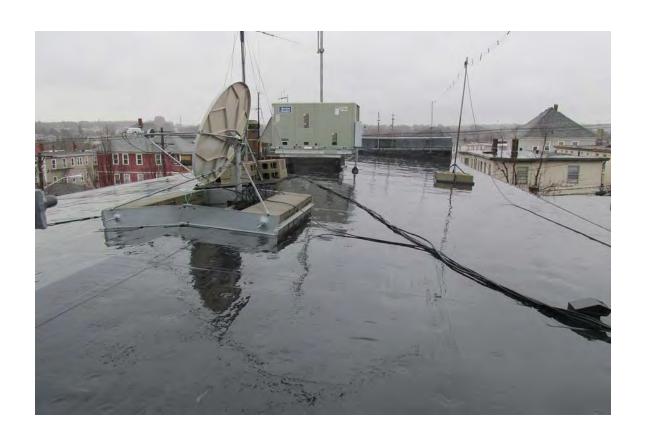
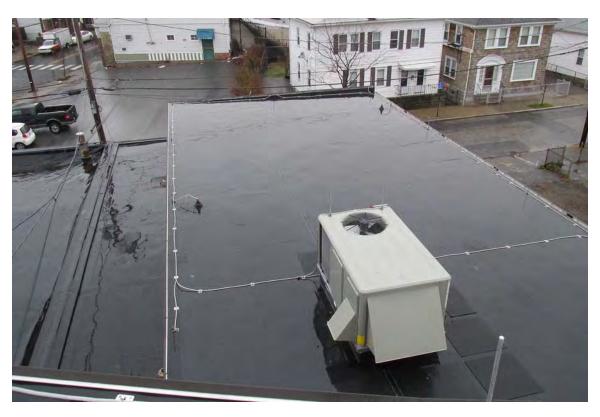
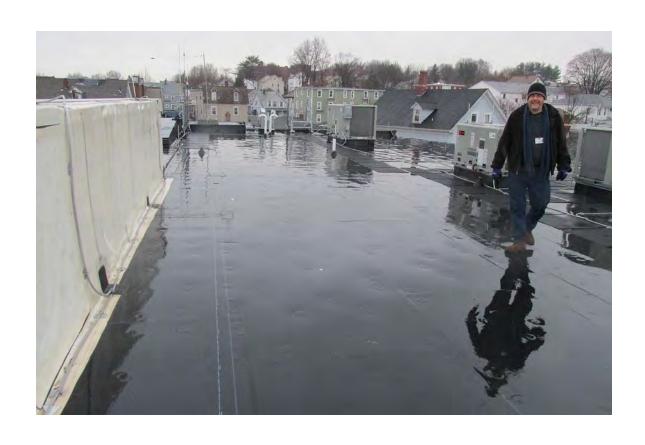
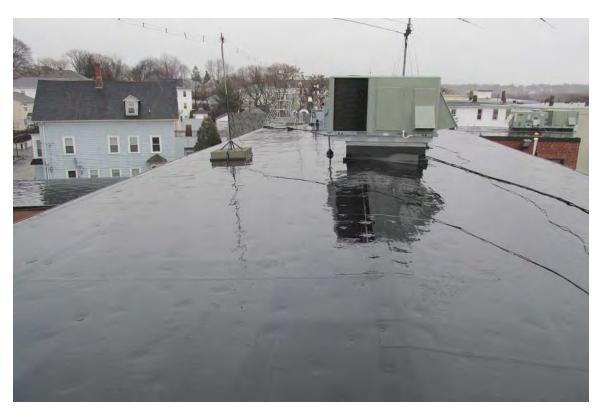
2. R001 S1	tructure Condition					1
	Poor	Commen	ts:			
	Fair					
	Good					
	X Excellent	_				
3. Roofing	System Type (i.e. m			el ballast)		
	Black membrane, E	PDM, full	y adhered.			
1 Poofing	System Condition

4. Rooning	System Condition	0				
		Commen	is:			
	Fair					
	Good					
	X Excellent	4				
5. Roof S	urface Durability (i.e.	soft or har	d)			
	hard/firm					
6 Estimat	Lad/Dapartad Aga of [	Poofing Cu	votom

o. ⊏sumai	ted/Reported Age of F	Cooling 5)	/SIGIII			1
	1 year					
7. Estimat	ted Remaining Useful	Life				
	19-24 years	·				
	, , , , , , ,

8. Observable Required Repairs
None
9. Roof Access (i.e. hatch, stairs, ladder)
Ladder Stair to walk-out door onto roof
10. Security against Vandalism
Facility is gated and secure.
11. Roof Pitch and Orientation
low pitch to edge gutters.
12. Obstructions (i.e., piping, conduits, HVAC Units, Skylights)
None on lower roof. Upper roof has HVAC units
13. Existing Parapet (Req'd by zoning for bldgs 2 stories or less)
Yes Height
X No
14. Potential Shading (i.e., trees, roof obstructions taller than PV system, adjacent buildings)
Upper roof and original building taller than lower roof.
Notes:

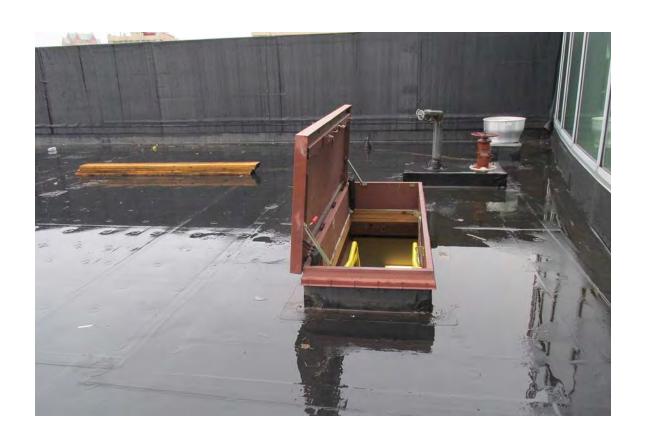
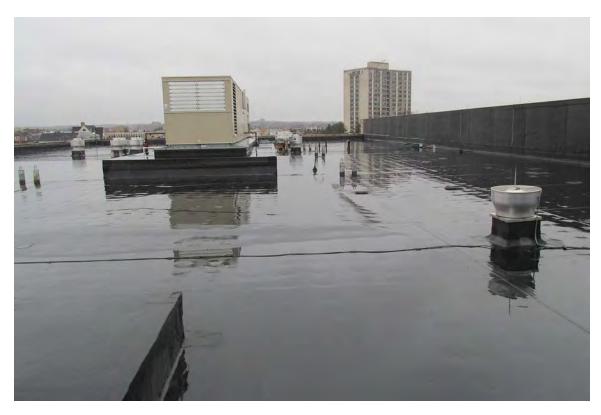
o. ⊏sumat	ted/Reported Age of F		em			
	12 years (assuming	g original)				
7. Estimat	ted Remaining Useful	Life				
	8-13 years					
	o io youro

8. Observable Required Repairs
Clogged drain grates
9. Roof Access (i.e. hatch, stairs, ladder)
Each wing is accessed via at ship ladder at the top landing of the stair towers. Roof hatches provide direct access to roof.
10. Security against Vandalism
Access into building is secure.
11. Roof Pitch and Orientation
Low pitch towards interior drains.
12. Obstructions (i.e., piping, conduits, HVAC Units, Skylights)
Vents, conduits, cables, HVAC units, exhaust fans.
13. Existing Parapet (Req'd by zoning for bldgs 2 stories or less)
X Yes Height <u>22 in.</u>
No 14. Potential Shading (i.e., trees, roof obstructions taller than PV system, adjacent buildings)
None
Notes:

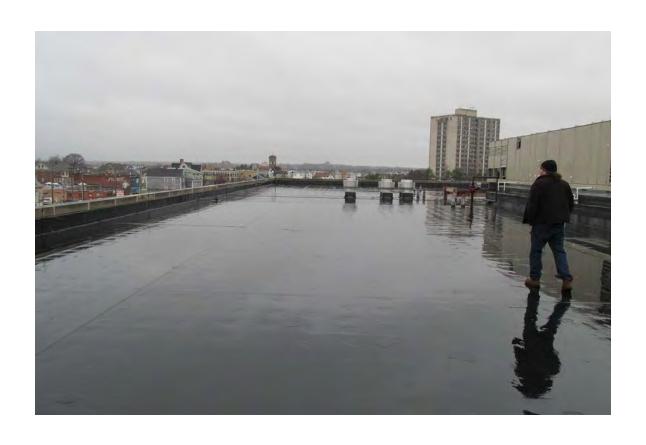
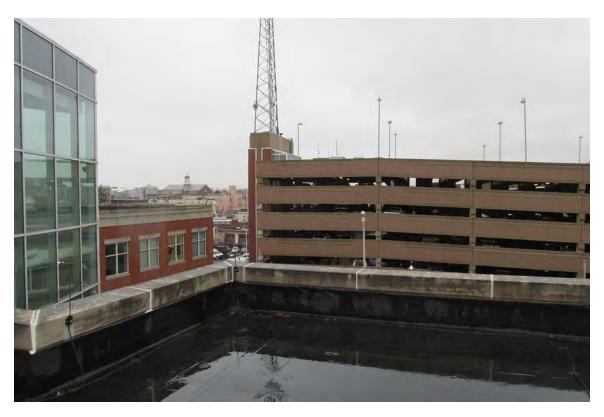
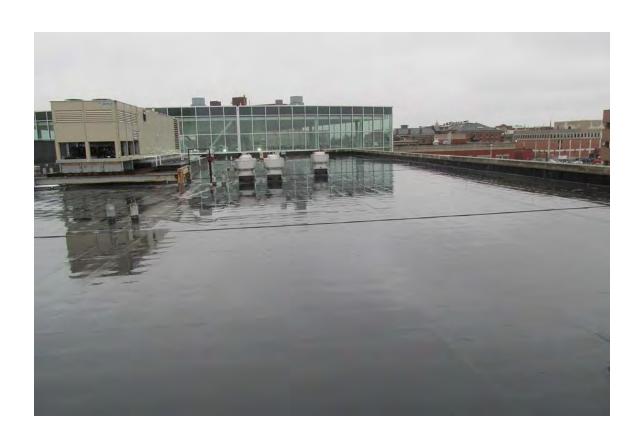
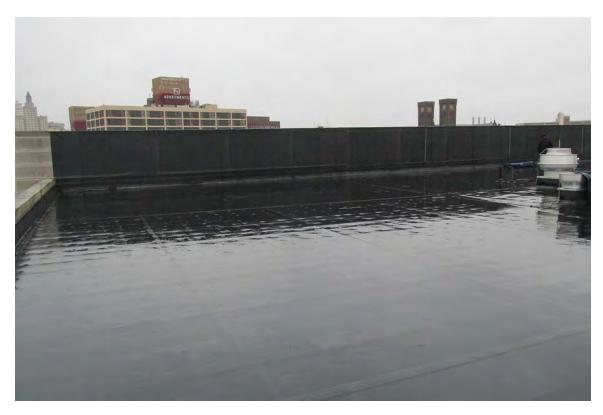
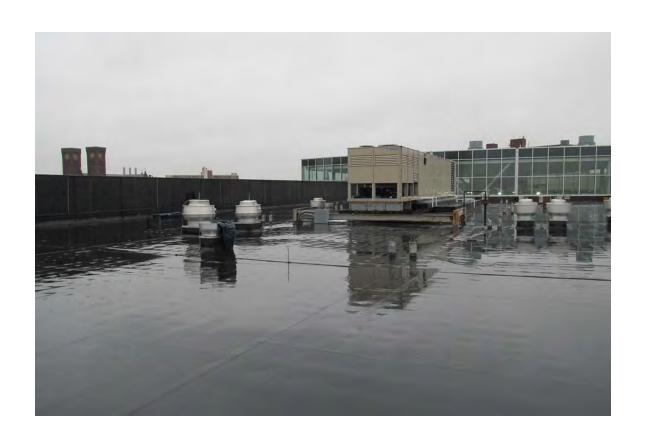
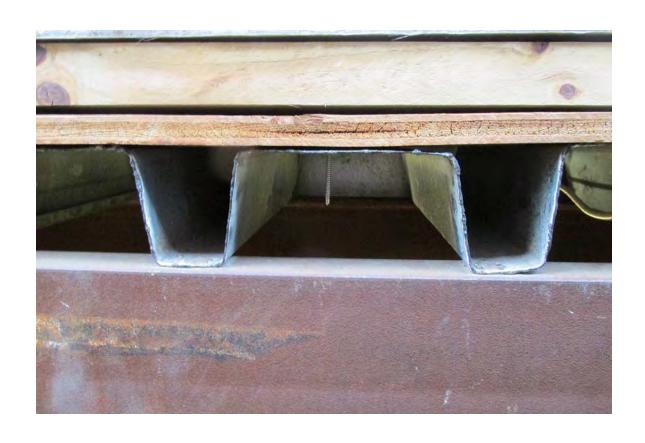
2. Roof St	tructure Condition					
	Poor	Comments:				
	Fair					
	Good					
	X Excellent					
3. Roofing	System Type (i.e. m	embrane, bu	uilt-up, grave	el ballast)		
	Black membrane, E				ation	
	,	, ,	,	J

4. Roofing	System Condition					
		Comments:				
	Fair					
	Good					
	X Excellent					
5. Roof St	urface Durability (i.e.	soft or hard)				
	firm/hard					
C Fatimat	Lad/Danawtad Aga of [	Doofing Cyat

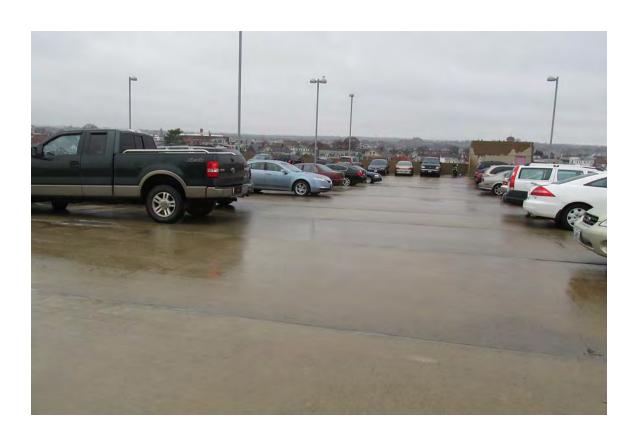
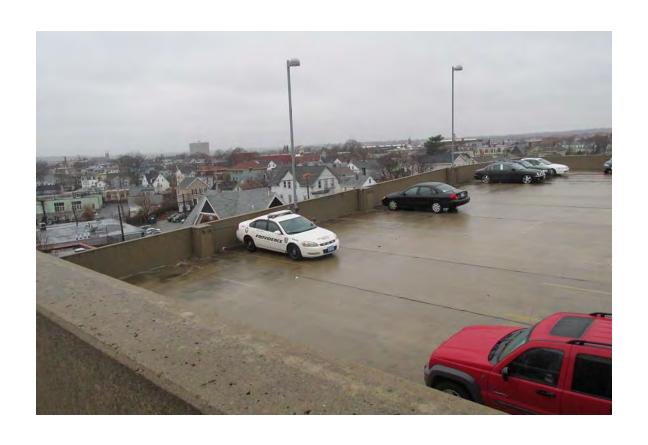
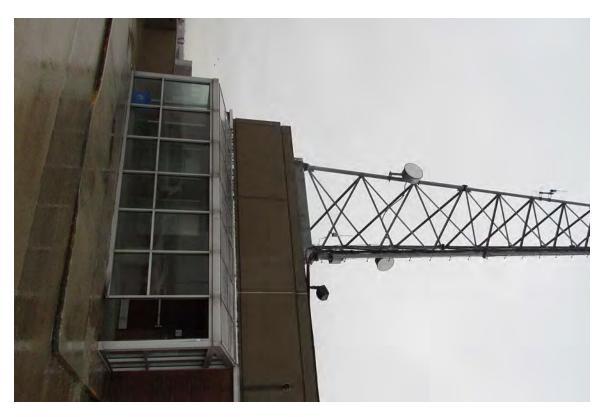
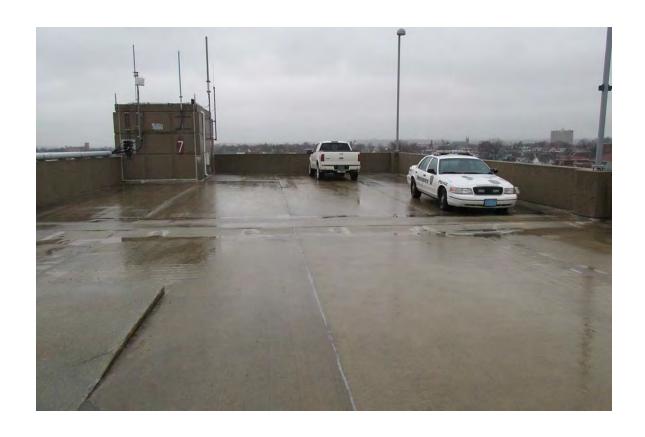
1. Roof S	tructure & Deck Type	(i.e., steel	L wood, concre	ete)			
	Precast Concrete F	•					
		3					
2 Roof S	Ltructure Condition						
2. 1(00) 0	Poor	Commen	to:				
	Fair	Commen	15.				
	X Good						
	Excellent

3. Roofing	System Type (i.e. m	embrane.	built-up, grave	l ballast)			
`	No roof, just the co			,			
	. ,	·	J				
4 Roofing	L g System Condition						
4. 1 <b>.</b> 1.		Commen	te:				
	Fair	Commen					
	Good						
	Excellent

7. Estima	ted Remaining Useful	Life					
	NA

8. Observable Required Repairs
None
9. Roof Access (i.e. hatch, stairs, ladder)
Parking garage deadends at roof level. Must turn around to exit.
10. Security against Vandalism
10. Security against Vandalism
Garage was open and free to public at time of inspection.
11. Roof Pitch and Orientation
deck pitches towards interior drains
deck pitches towards interior drains
12. Obstructions (i.e., piping, conduits, HVAC Units, Skylights)
None
13. Existing Parapet (Req'd by zoning for bldgs 2 stories or less)
X Yes Height 36 in.
No
14. Potential Shading (i.e., trees, roof obstructions taller than PV system, adjacent buildings)
Elevator/Stair Tower with large communication tower is located on the south end of the
building.
Notes:
Parking spaces would need to be given up if solar were to be installed on the upper roof level.

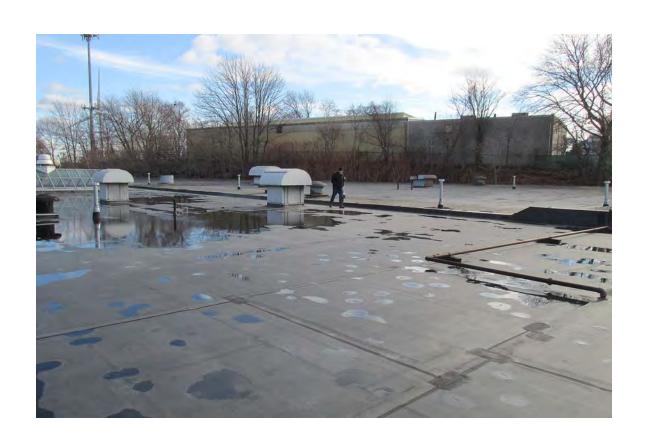
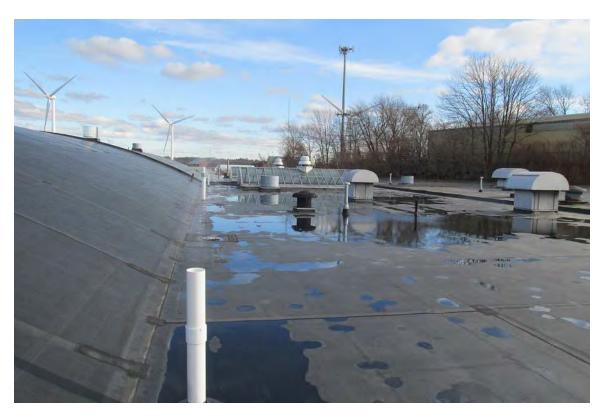
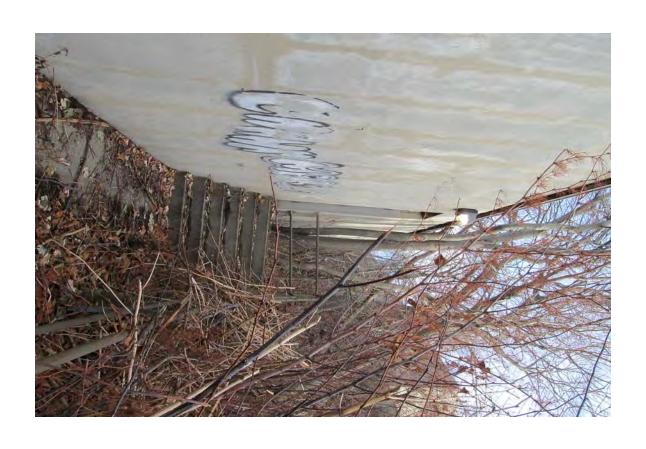
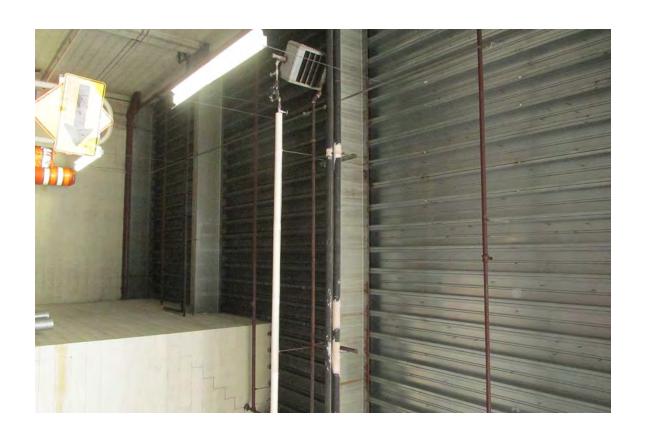
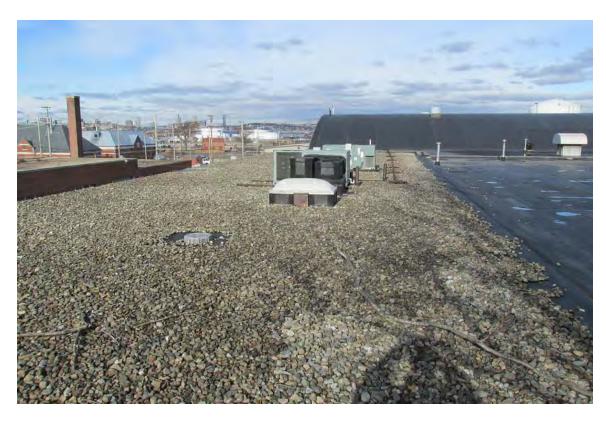
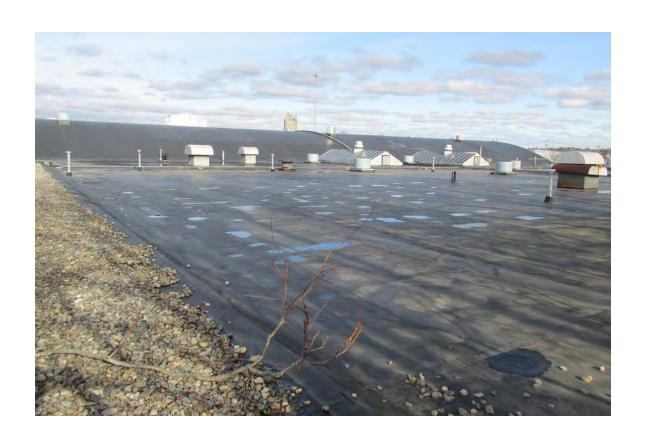
4.5. (0)					
1. Roof St	tructure & Deck Type (i.e		ete)		1
	Steel Beams and Stee	el deck			
2. Roof St	tructure Condition				
	Poor Co	omments:			
	Fair				
	X Good				
	Excellent

3. Roofing	System Type (i.e. mem	nbrane, built-up, grav	el ballast)		
	Black membrane, EPI	DM, fully adhered. St	one ballast o	nly on the west end	approx. 30
	feet.				
4 Roofing	System Condition

4. 1.0011110		ommonto:			1
		omments: some recent repair pa	atches were c	hserved	
	X Good	ome recent repair pe	atorios word c	bbscivea.	
	Excellent				
5 Roof Si	urface Durability (i.e. sof	t or hard)

8. Observable Required Repairs			
Standing water due to poor drainage, clogged drain grates			
9. Roof Access (i.e. hatch, stairs, ladder)			
No direct access, used a ladder up against the rear of the building.

10. Security against Vandalism			
Embankment and trees up against the south side of the building appear to provide access			
for vandals and animals (fresh raccoon tracks were observed). Graffiti was found on the			
arched roof.			
L 11. Roof Pitch and Orientation			
Low pitch towards interior drains. Some areas are not draining and vegetation was observed in at least one area.			
observed in at least one area.

12. Obstructions (i.e., piping, conduits, HVAC Units, Skylights)			
Skylights, vents, exhaust fans, pipes, and conduits			
Okylighto, vonto, oxhadot fario, pipoo, and conduito

13. Existing Parapet (Req'd by zoning for bldgs 2 stories or less)			
Yes Height			
X No			
14. Potential Shading (i.e., trees, roof obstructions taller than PV system, adjacent buildings)			
Large trees along the south side of the building.			
Large trees along the south side of the ballating.			
Notes:

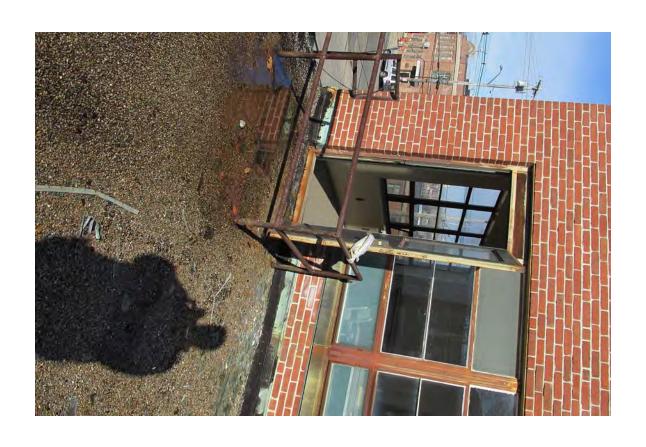
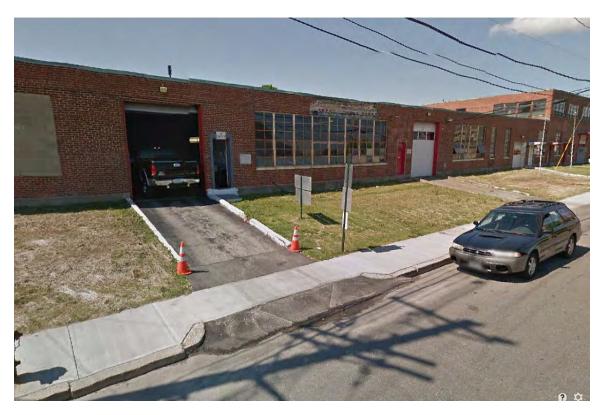
13. Existing Parapet (Req'd by zoning for bldgs 2 stories or less)
Yes Height
X No  14. Potential Shading (i.e., trees, roof obstructions taller than PV system, adjacent buildings)
None
Notes:
Roof is open and spacious however in very poor condition. In addition, building is in overall poor condition and several structural defiencies were observed.  - Face brick on the Ernest Street side has fallen off the building.  - Apparent significant settlement has occurred at the garage overhead door of the VIN station. Slab is cracked and settled, and significant cracking in the walls around the door were observed.
