5. **CASE 25.060, 66 WILLIAMS STREET, [Corliss-Carrington House](#), 1810-12 (COLLEGE HILL)**

CARRINGTON HOUSE

66 Williams Street, Providence

ATTACHMENT A: HDC Scope of Work

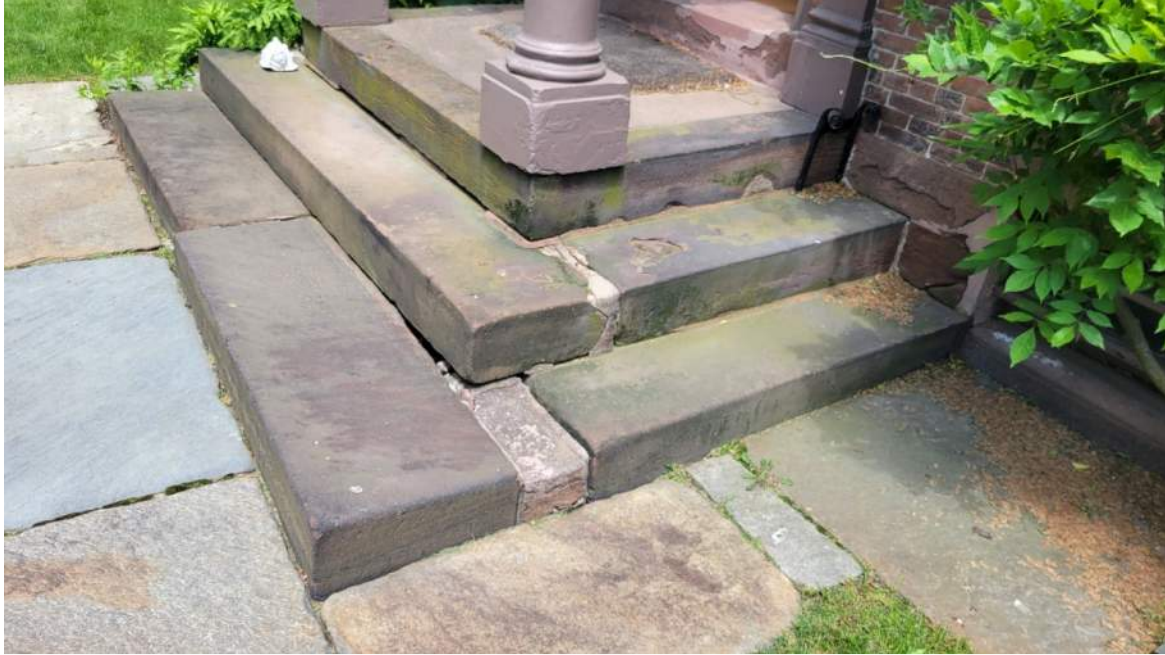
13. Brownstone deterioration and displacement at west portico

Masonry: Most of the work at the main house is related to masonry restoration, including restoration of the original brownstone, which exhibits considerable deterioration. Brownstone will be restored using new brownstone units to match the historic brownstone, as well as brownstone Dutchmen. Brownstone patching (as opposed to Dutchmen) will occur only at very small openings in the stone (less than 3"). At the front porch and west portico, where the brownstone stoops are significantly displaced and the stone is very deteriorated, the stoops will be disassembled and reset on top of new concrete structure (photos 19-24). Brownstone from these locations will be re-used to the greatest extent possible, however, a substantial amount of new stone at these locations will be required (see photos and drawings). Large existing brownstone units that are partially deteriorated will be cut down for salvage stone to be used for Dutchmen. Brick repointing will be completed where existing joints are deteriorated. New mortar will match existing in appearance, tooling, and composition.

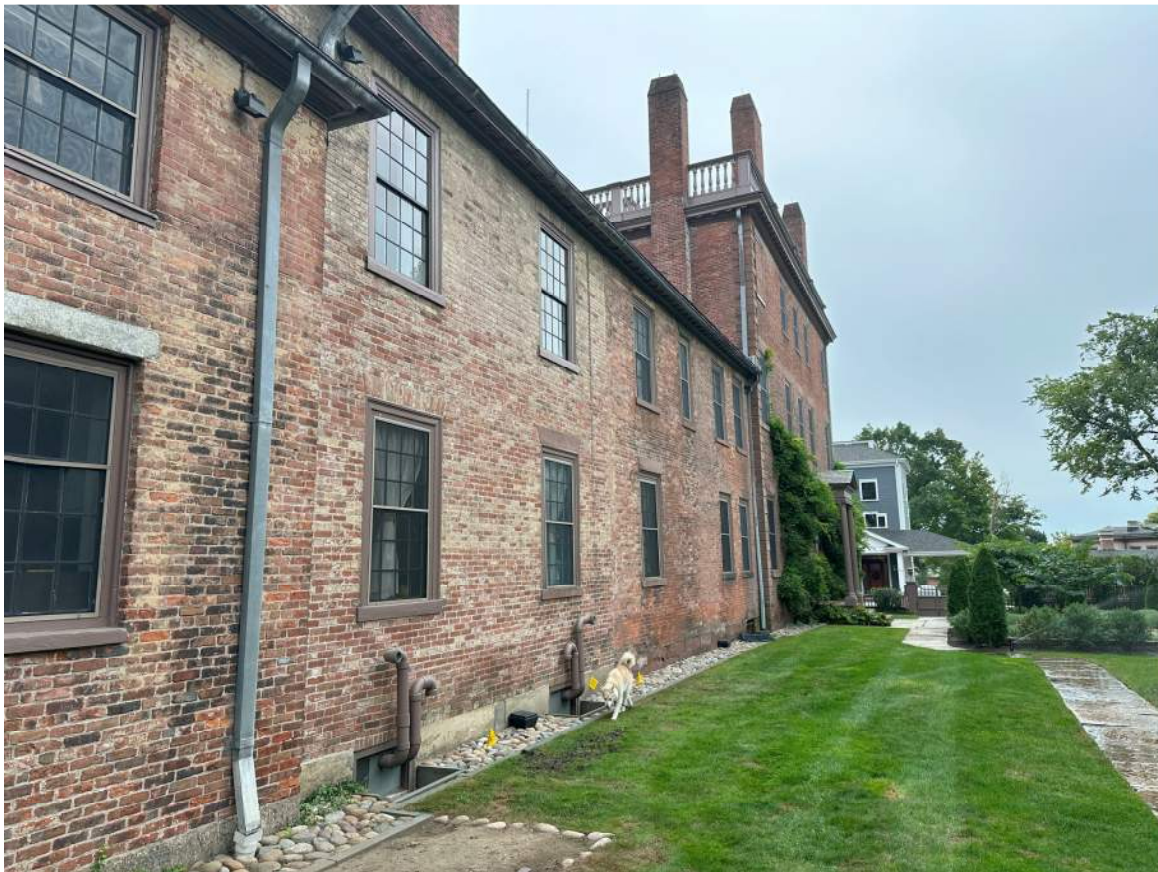
14. West elevation looking southeast

Windows: All wood double-hung windows will be restored and new, low-profile, aluminum storm windows in a color that matches the trim will be installed. One second floor window that has been filled in on the north elevation (facing the courtyard) will be recreated (photo 25), and one first floor window on the same elevation (not visible from the street) will be relocated. A first floor ell window facing the west yard (also not visible from the street) will be converted to a door (photo 14).

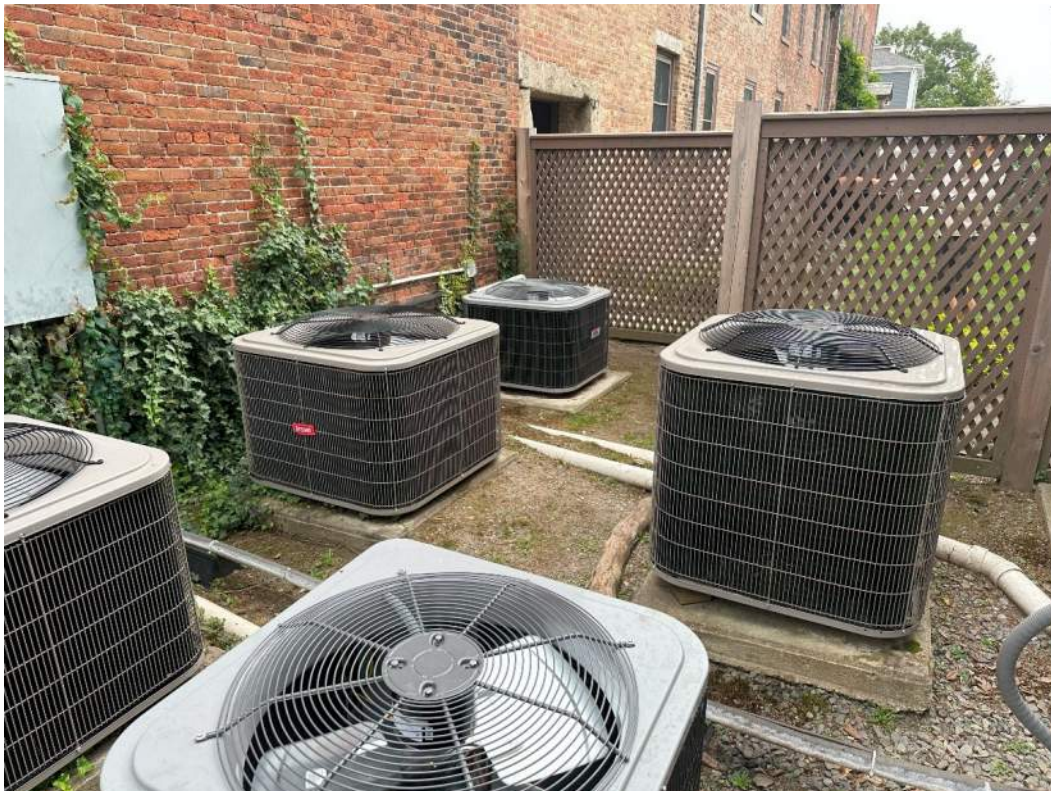
16. Mechanical enclosure at west end of carriage house

On the west end of the carriage house, there is currently a condenser enclosure that contains nine, large, grade-mounted condensers surround by a lattice enclosure (photos 15-16). The existing equipment will be replaced with more efficient equipment, and the number of required condensers may be reduced. New condensing units will occupy the following locations:

- New enclosed area at west end of carriage house. This area will be smaller than the existing enclosure and will be surrounded by a decorative brick wall to feel more like a garden element.
- One unit at north wall of new garage, concealed by landscaping.
- Two units within balustrade around widow's walk on main house, not visible from any public right of way (photo 38).

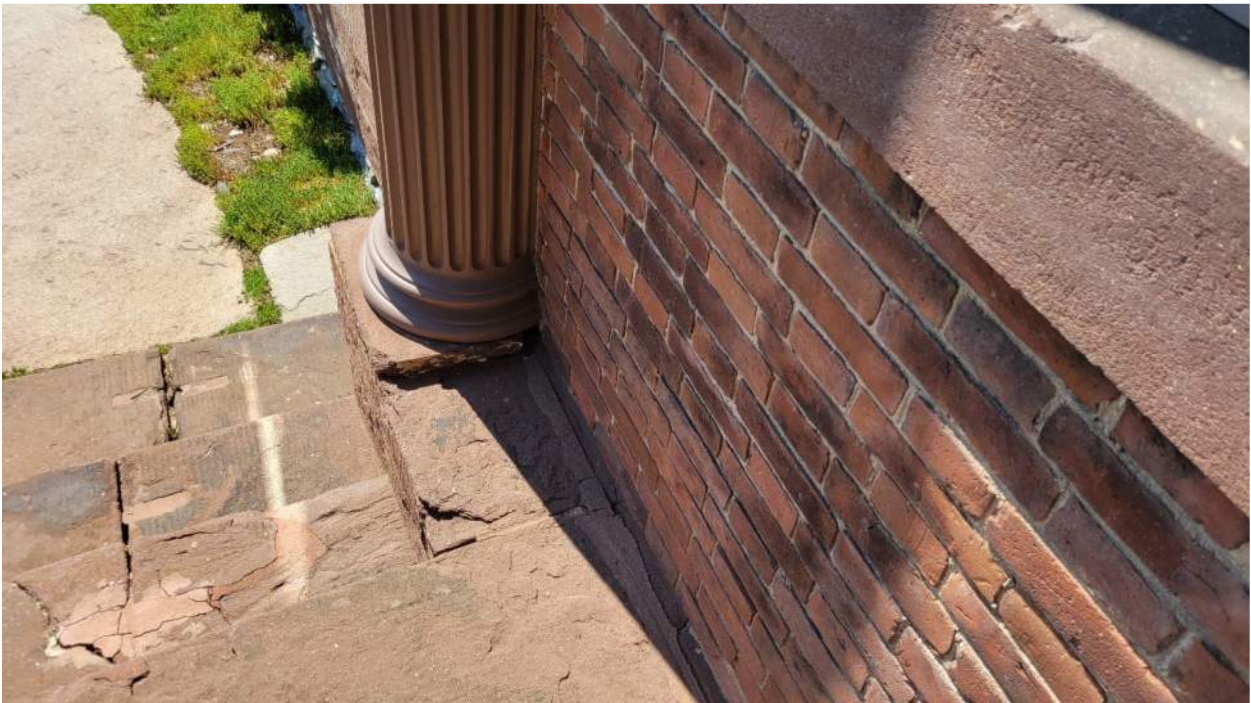
20. *Brownstone deterioration at front entrance porch*

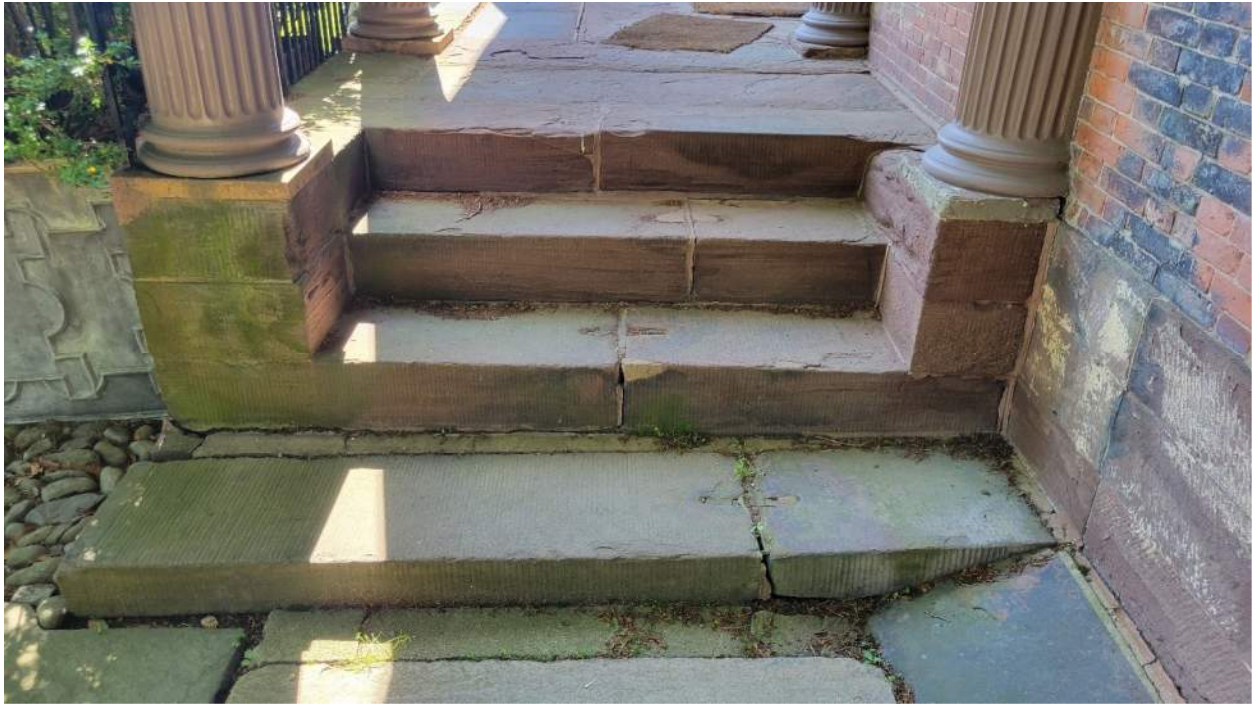
21. *Brownstone displacement at front entrance porch*

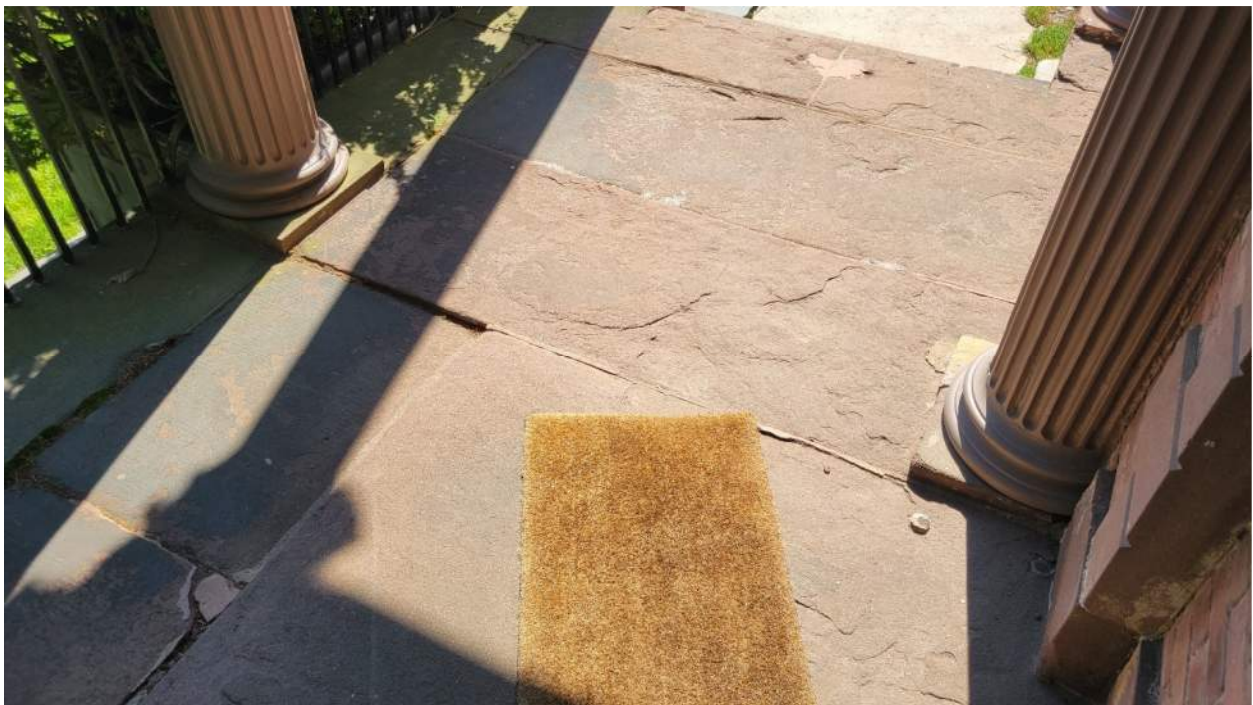
22. *Brownstone settlement at front porch*

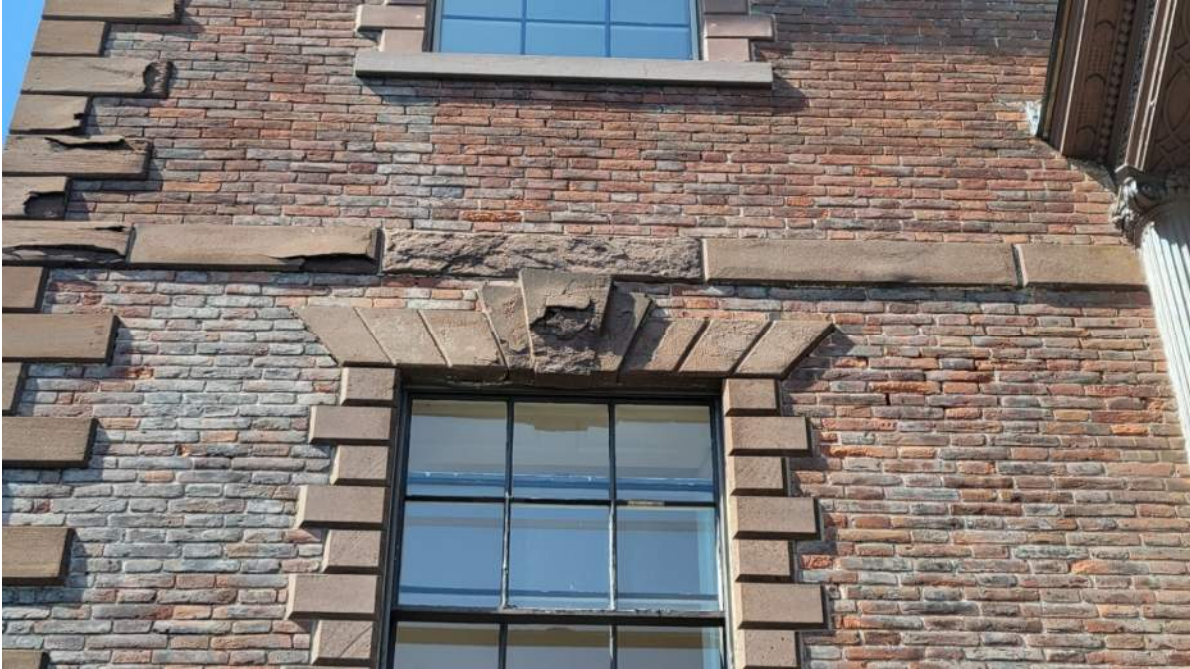
23. *Brownstone deterioration at south elevation trim*

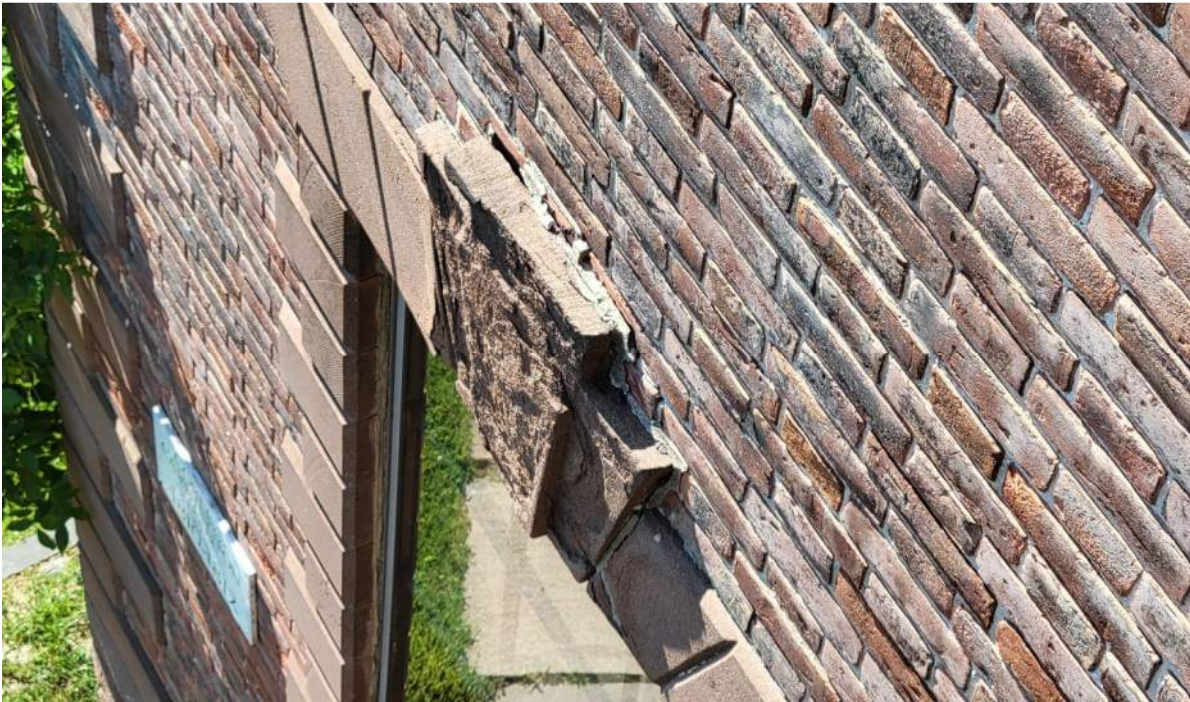
24. *Brownstone delamination at keystone*

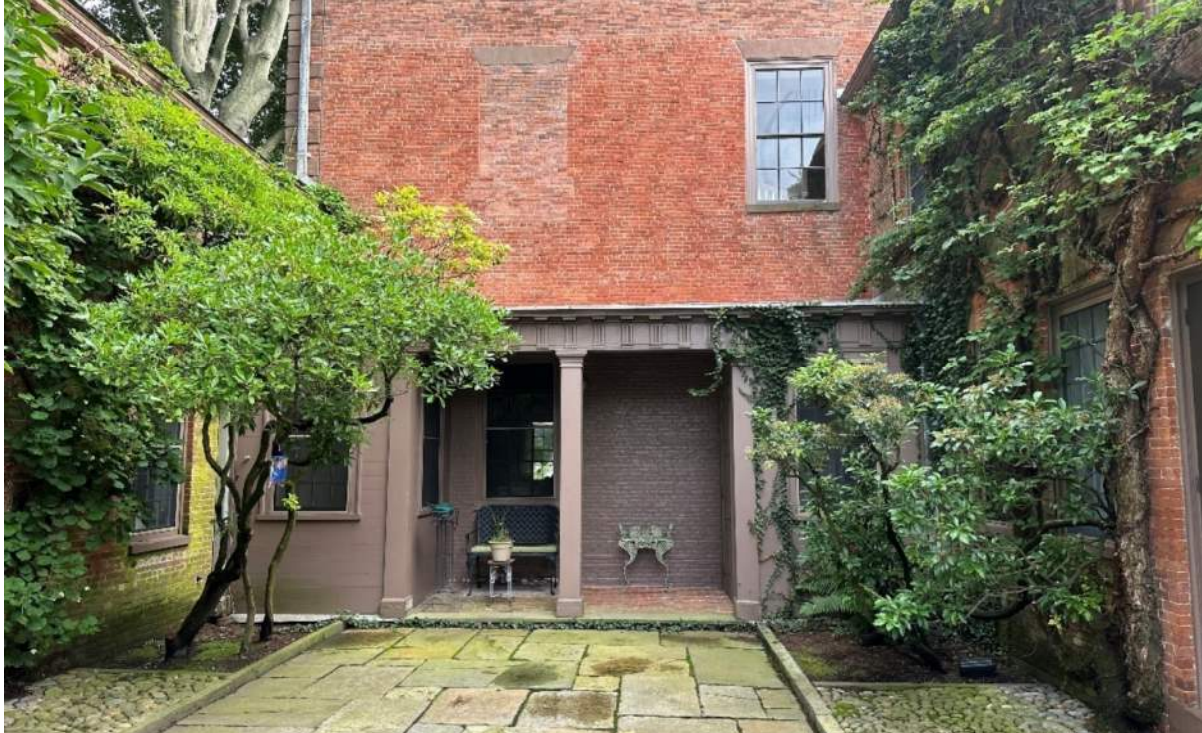
25. Rear (north) porch at main block (note second floor filled-in window to be recreated)

Rear Entrance: The owner desires to create an accessible entrance facing the courtyard. This will involve very minor re-grading and extending an existing wood enclosure on the rear porch to encompass a second bay. In the process, an original rear door will be re-opened (see north elevation drawing and photo 25). A historic photo (photo 26) indicates that this rear porch originally was enclosed over two bays, therefore, this change will return the rear porch to a configuration that is closer to its historic appearance.

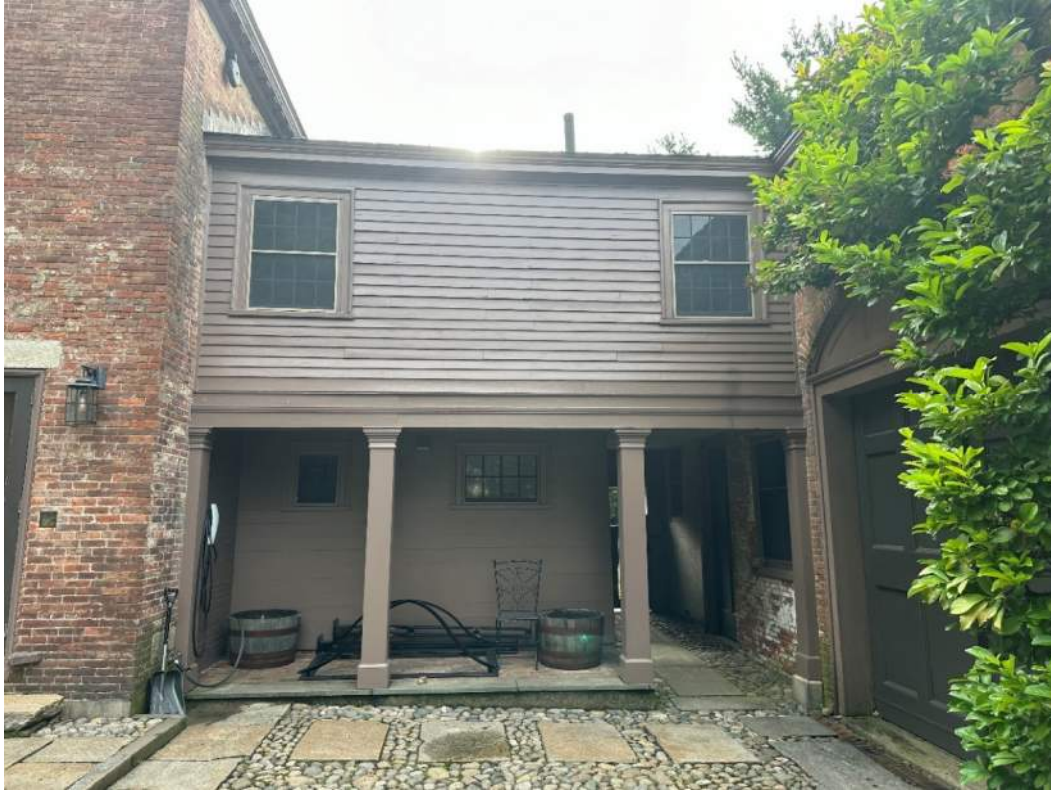
29. East elevation of connector

Rear Ell: A historic HABS photo from 1936 shows that the wood infill at the northernmost part of the rear ell formerly existed just behind the columns, as opposed to the current recessed condition. The 1930s condition will be recreated (see photos 29 and 30).

Within the passageway that leads from Power Street to the courtyard, an existing window will be converted to a door and a door that was bricked in will be reestablished (photo 32). There is also a passageway from the courtyard to the west garden. Within this passageway, an existing carriage house window will be converted to a door (photo 29).

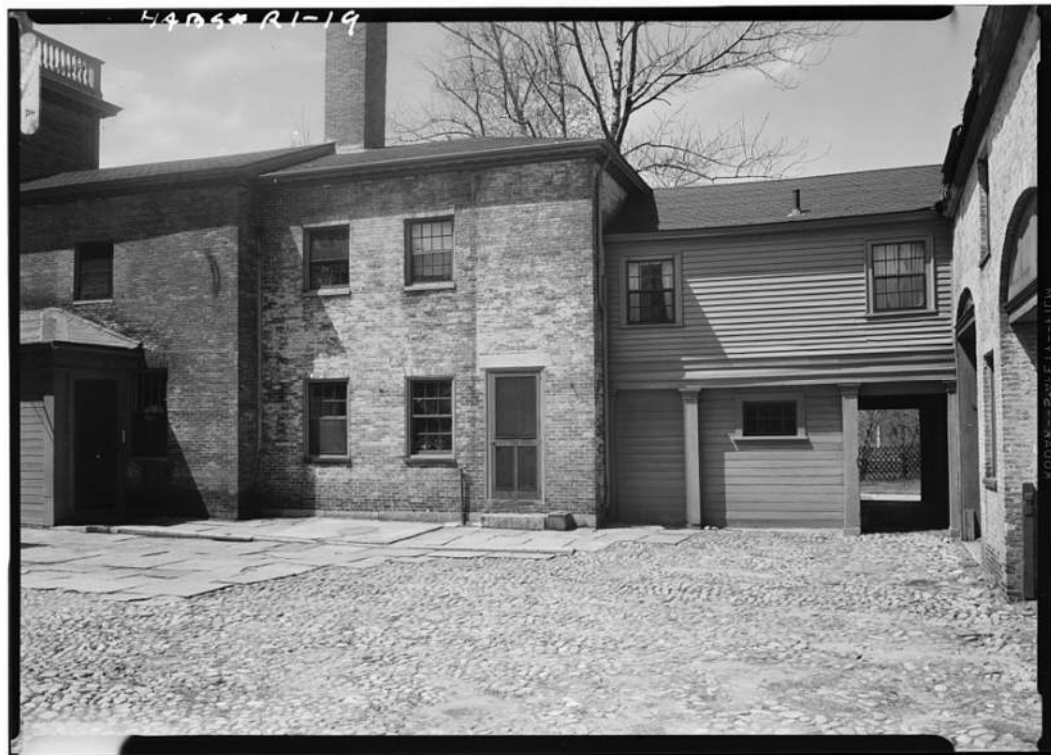
30. 1936 HABS photo of connector (note wood infill just behind columns)

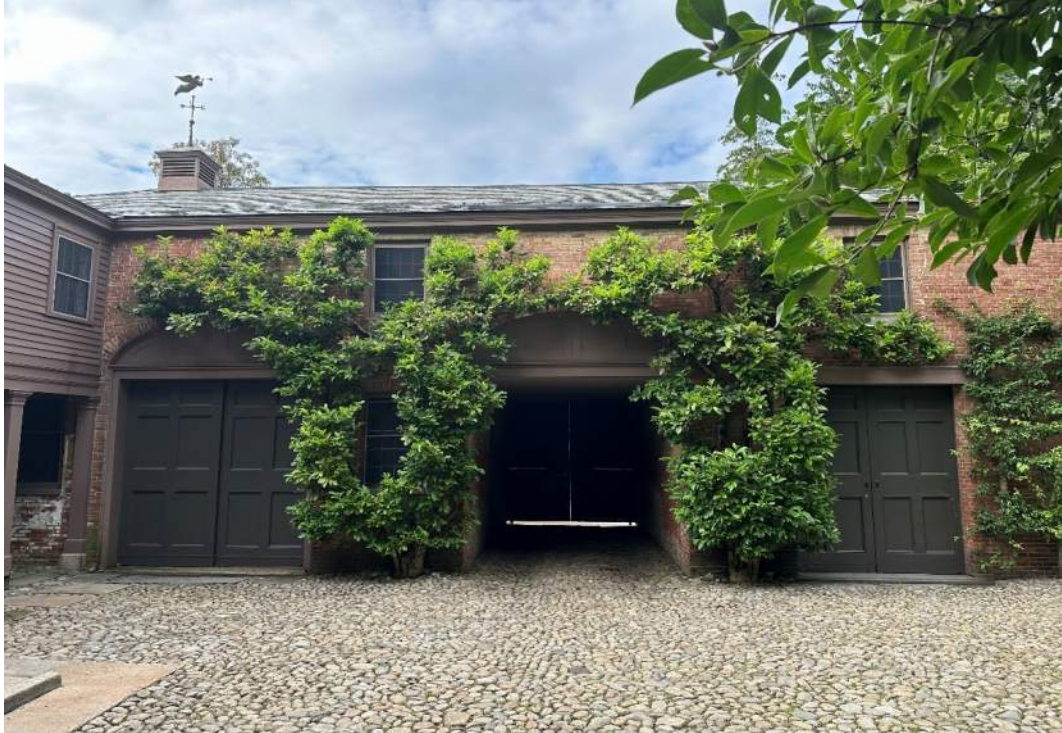
31. South elevation of carriage house

Like the main house, alterations to the carriage house will be minimal and will generally not be visible from public rights of way. There are four wood carriage doors that face the courtyard (photos 31, 33, 34, and 35). These will be modified with respect to how they operate, however, the material and overall configuration of the doors will remain as is. In each of these doors, the panel configuration will be preserved, and glass will be inserted into the upper panels (see elevations). The wood swinging carriage doors that provide access to the courtyard from Power Street will be replaced with a new, wood overhead door that replicates the configuration of the existing doors (photo 4). On the east end of the carriage house, two new windows will be added to the first floor (photo 35). These windows will match those on the south elevation of the carriage house, because they will open into the same interior space. This change will barely be visible from Power Street because it occurs behind the stone wall and will not be visible from Copley Lane.

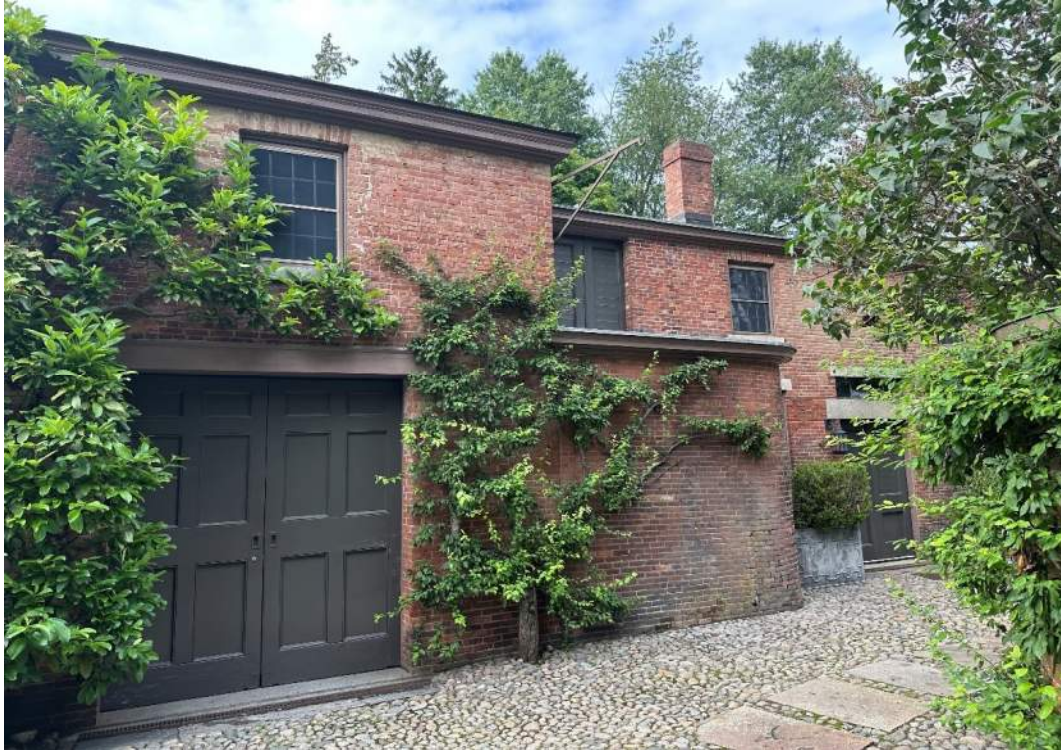
33. South elevation of carriage house and stable

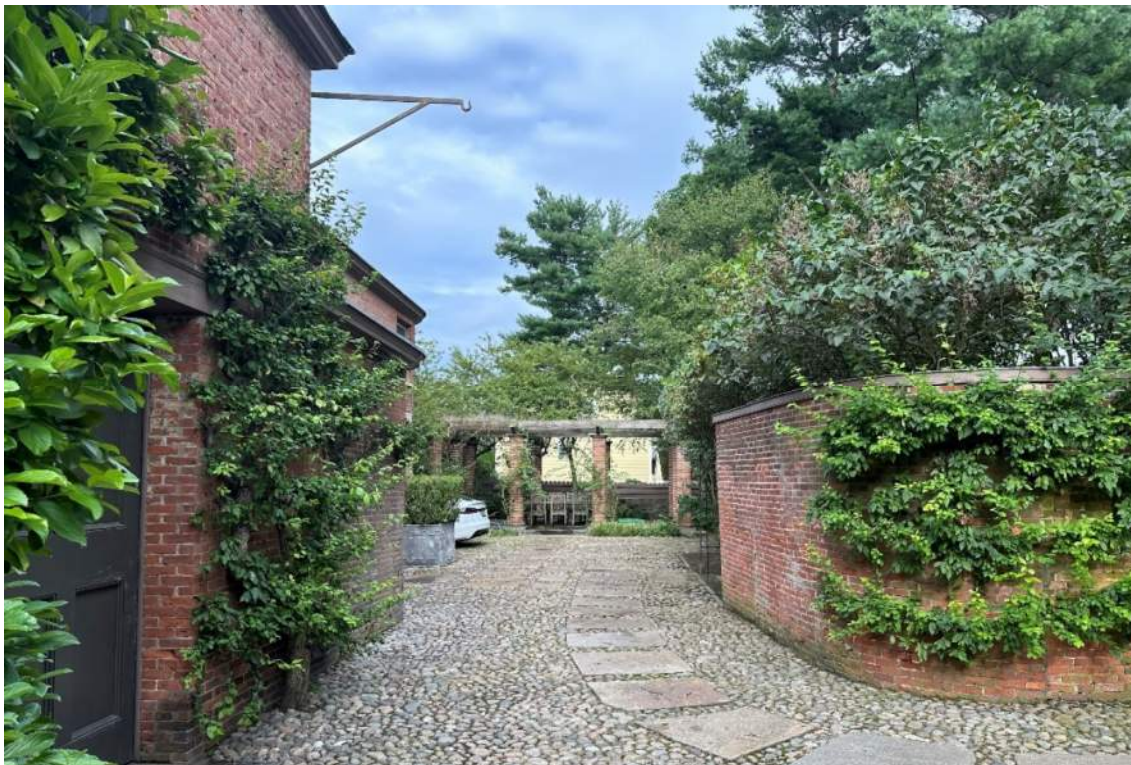
36. *Looking east toward 1970s pergola*

While the property is characterized by several historic outbuildings and appendages, it has never had a garage. A new garage is proposed to be located where a 1990s brick and wood pergola currently exists (photos 36 and 37). This location will impact the historic buildings and the site in the most minimal way possible and the proposed garage will visually complete the

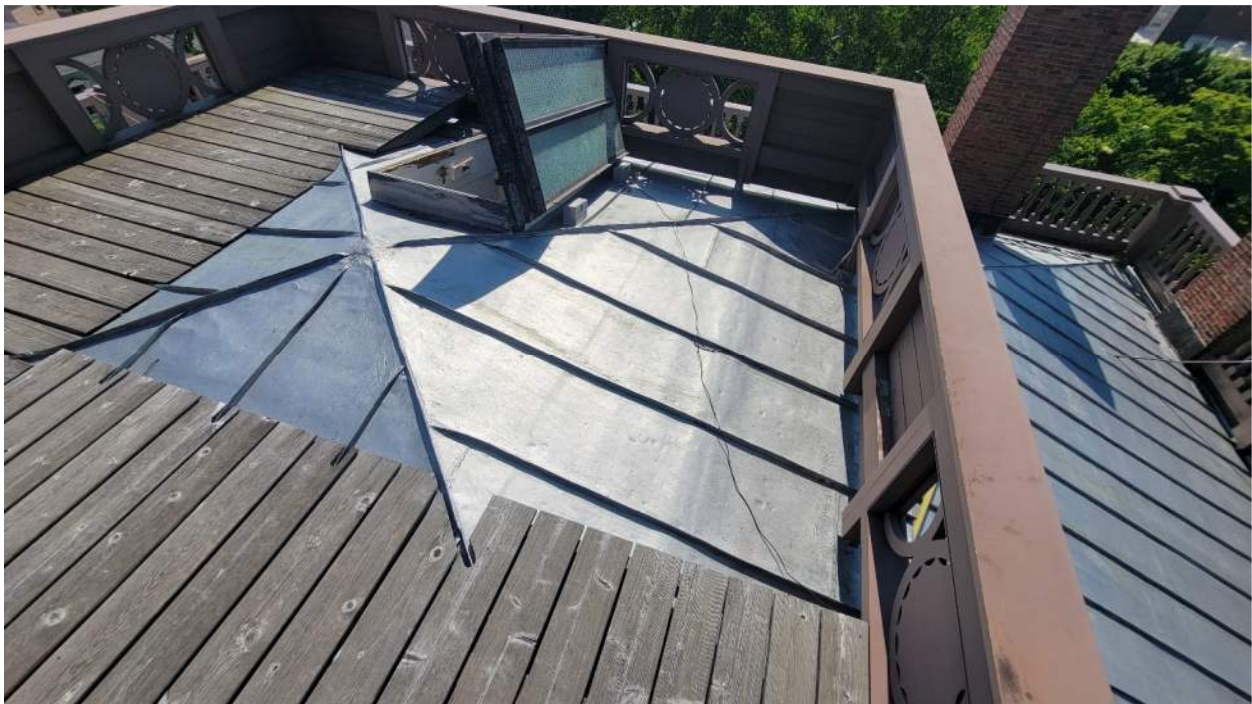
38. Widow's walk at main block (potential location for condensing units)

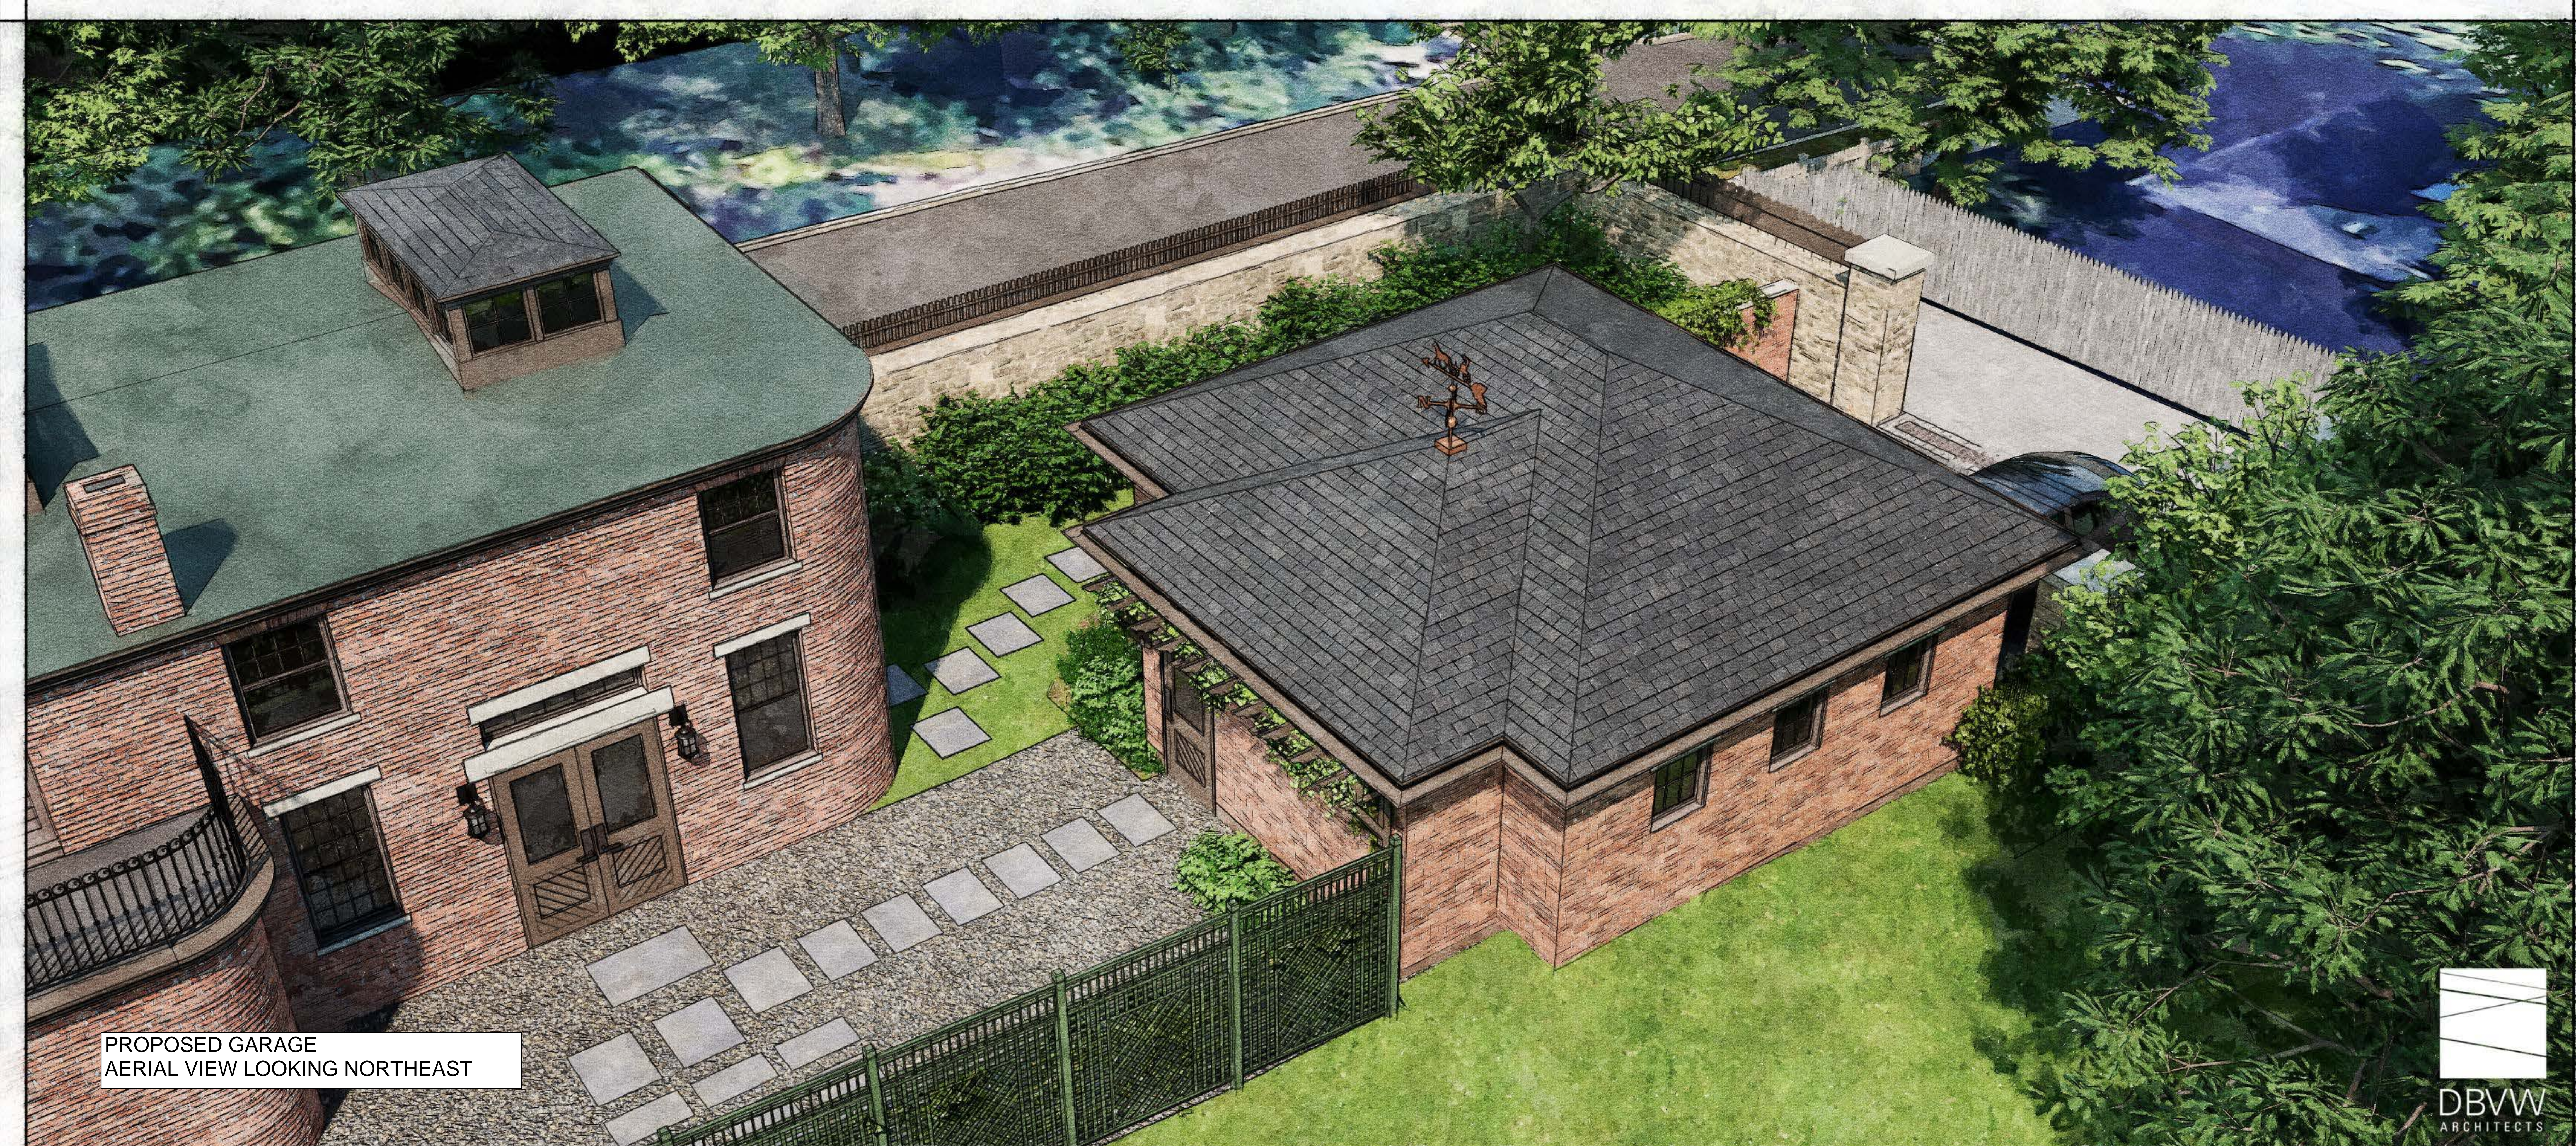
PROPOSED GARAGE
AERIAL VIEW LOOKING NORTHEAST

courtyard. Because vehicular access to the garage will be from Copley Lane (as required by zoning), which is approximately 30" below the grade of the courtyard, the garage will be very understated from the courtyard side. It is designed to be compatible with the historic buildings on site, but is clearly a product of its own time. The walls will be brick and the roof will be slate to match the existing carriage house. On Copley Lane, a new opening will be created in the stone wall to provide vehicular access to the garage (photo 10). Brick walls (no more than six feet in height) will extend from the edges of the new opening in the stone wall to the new garage, so the new garage access will not be perceived from within the historic confines of the property.

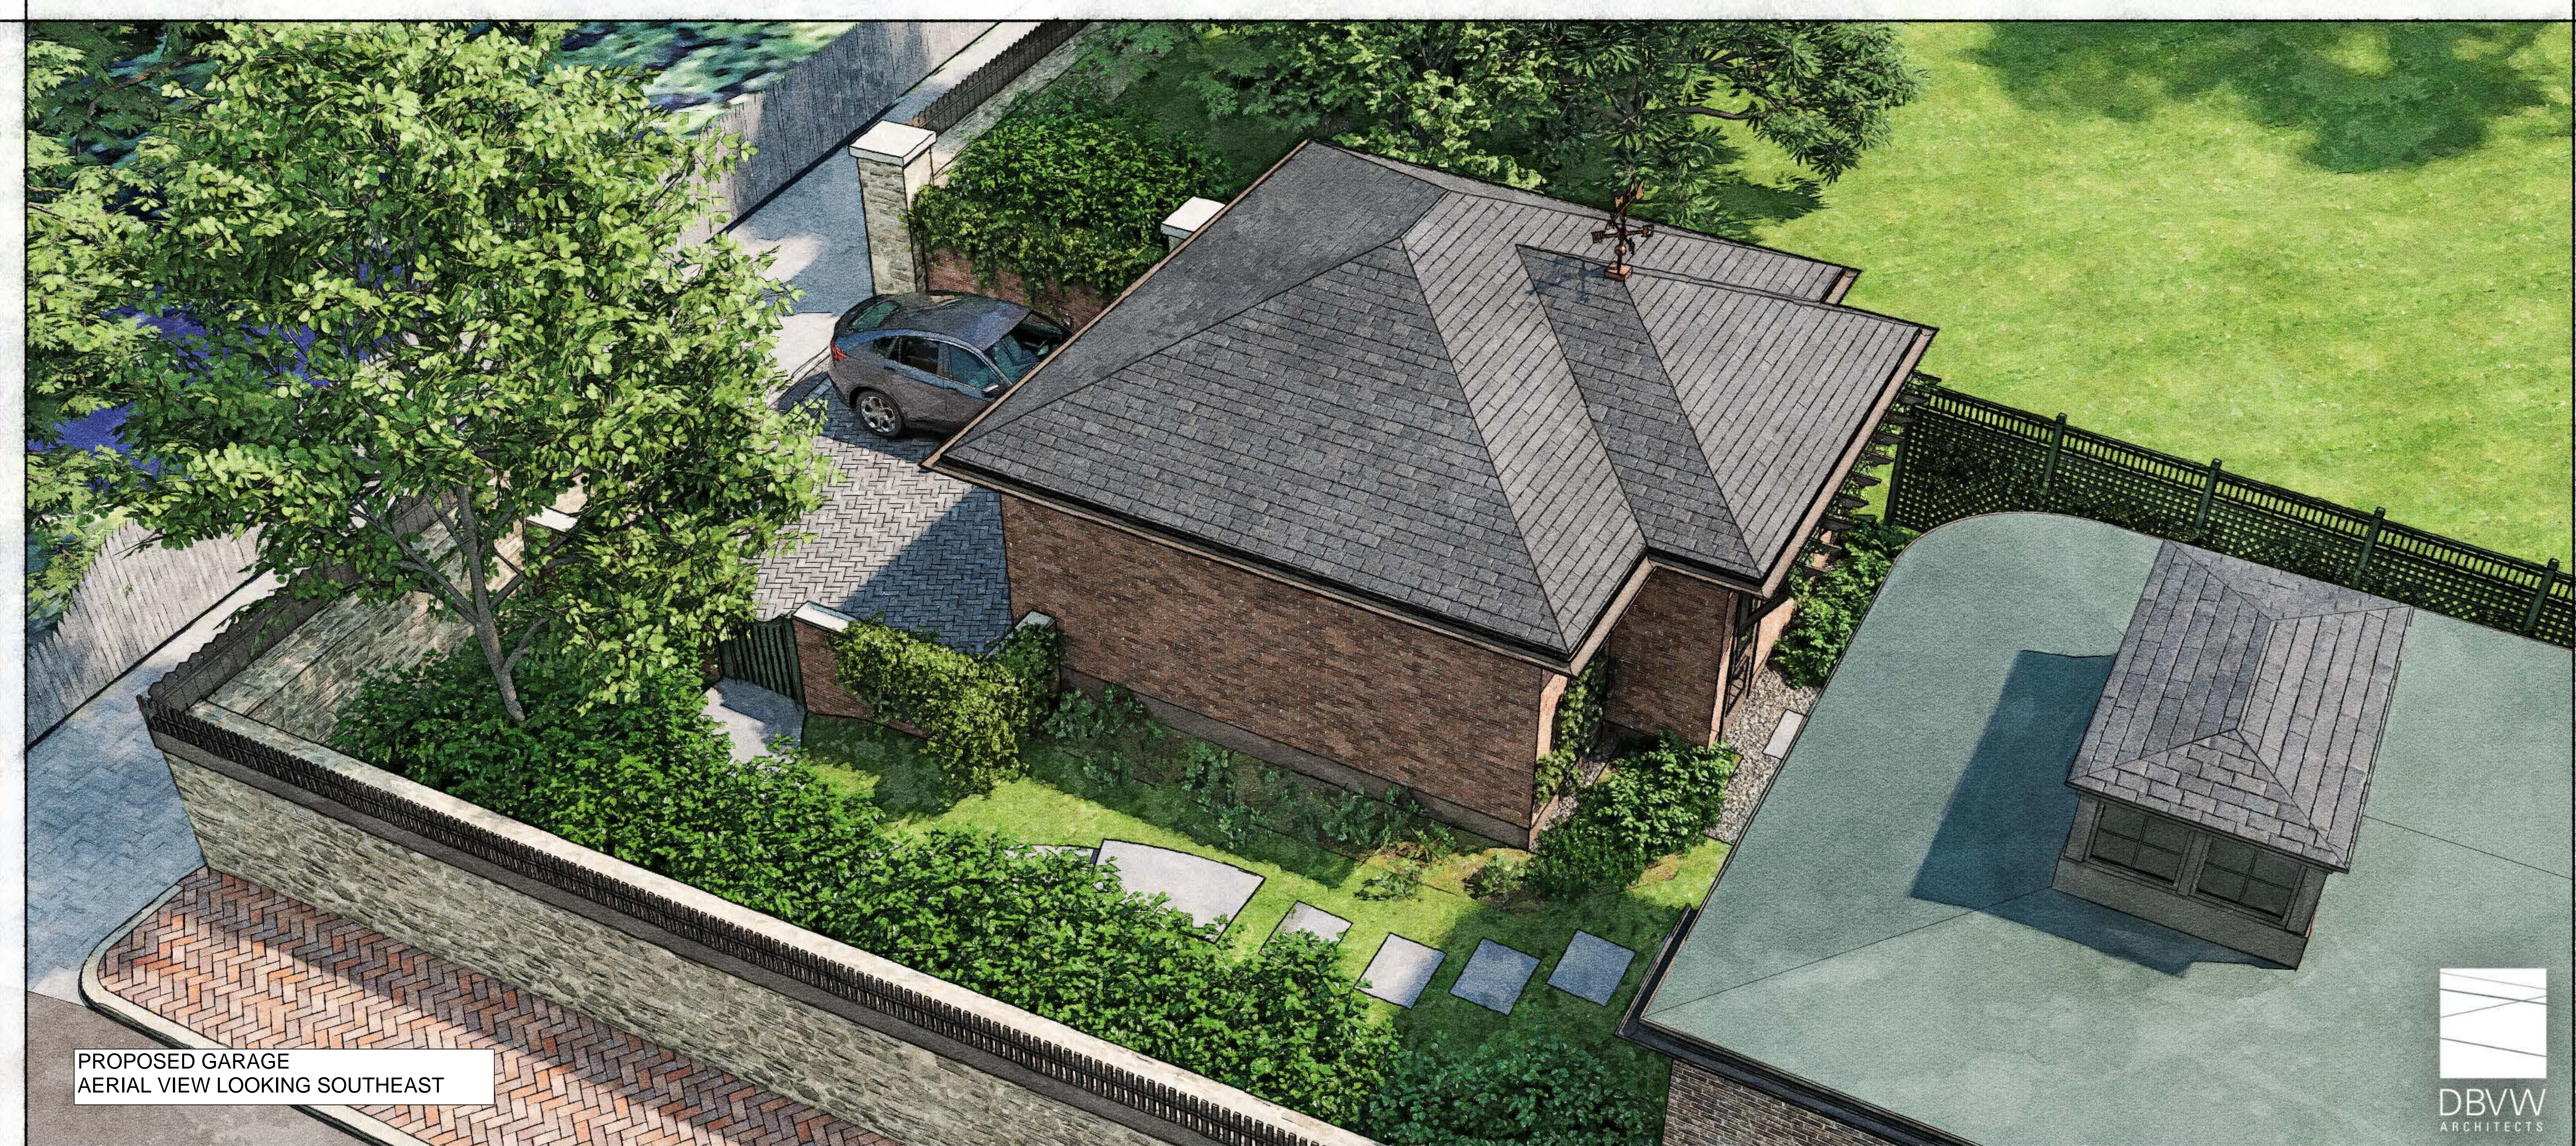
PROPOSED GARAGE
AERIAL VIEW LOOKING SOUTHEAST
