5. **CASE 25.060, 66 WILLIAMS STREET, [Corliss-Carrington House](#), 1810-12 (COLLEGE HILL)**

CARRINGTON HOUSE

66 Williams Street, Providence

ATTACHMENT A: HDC Scope of Work

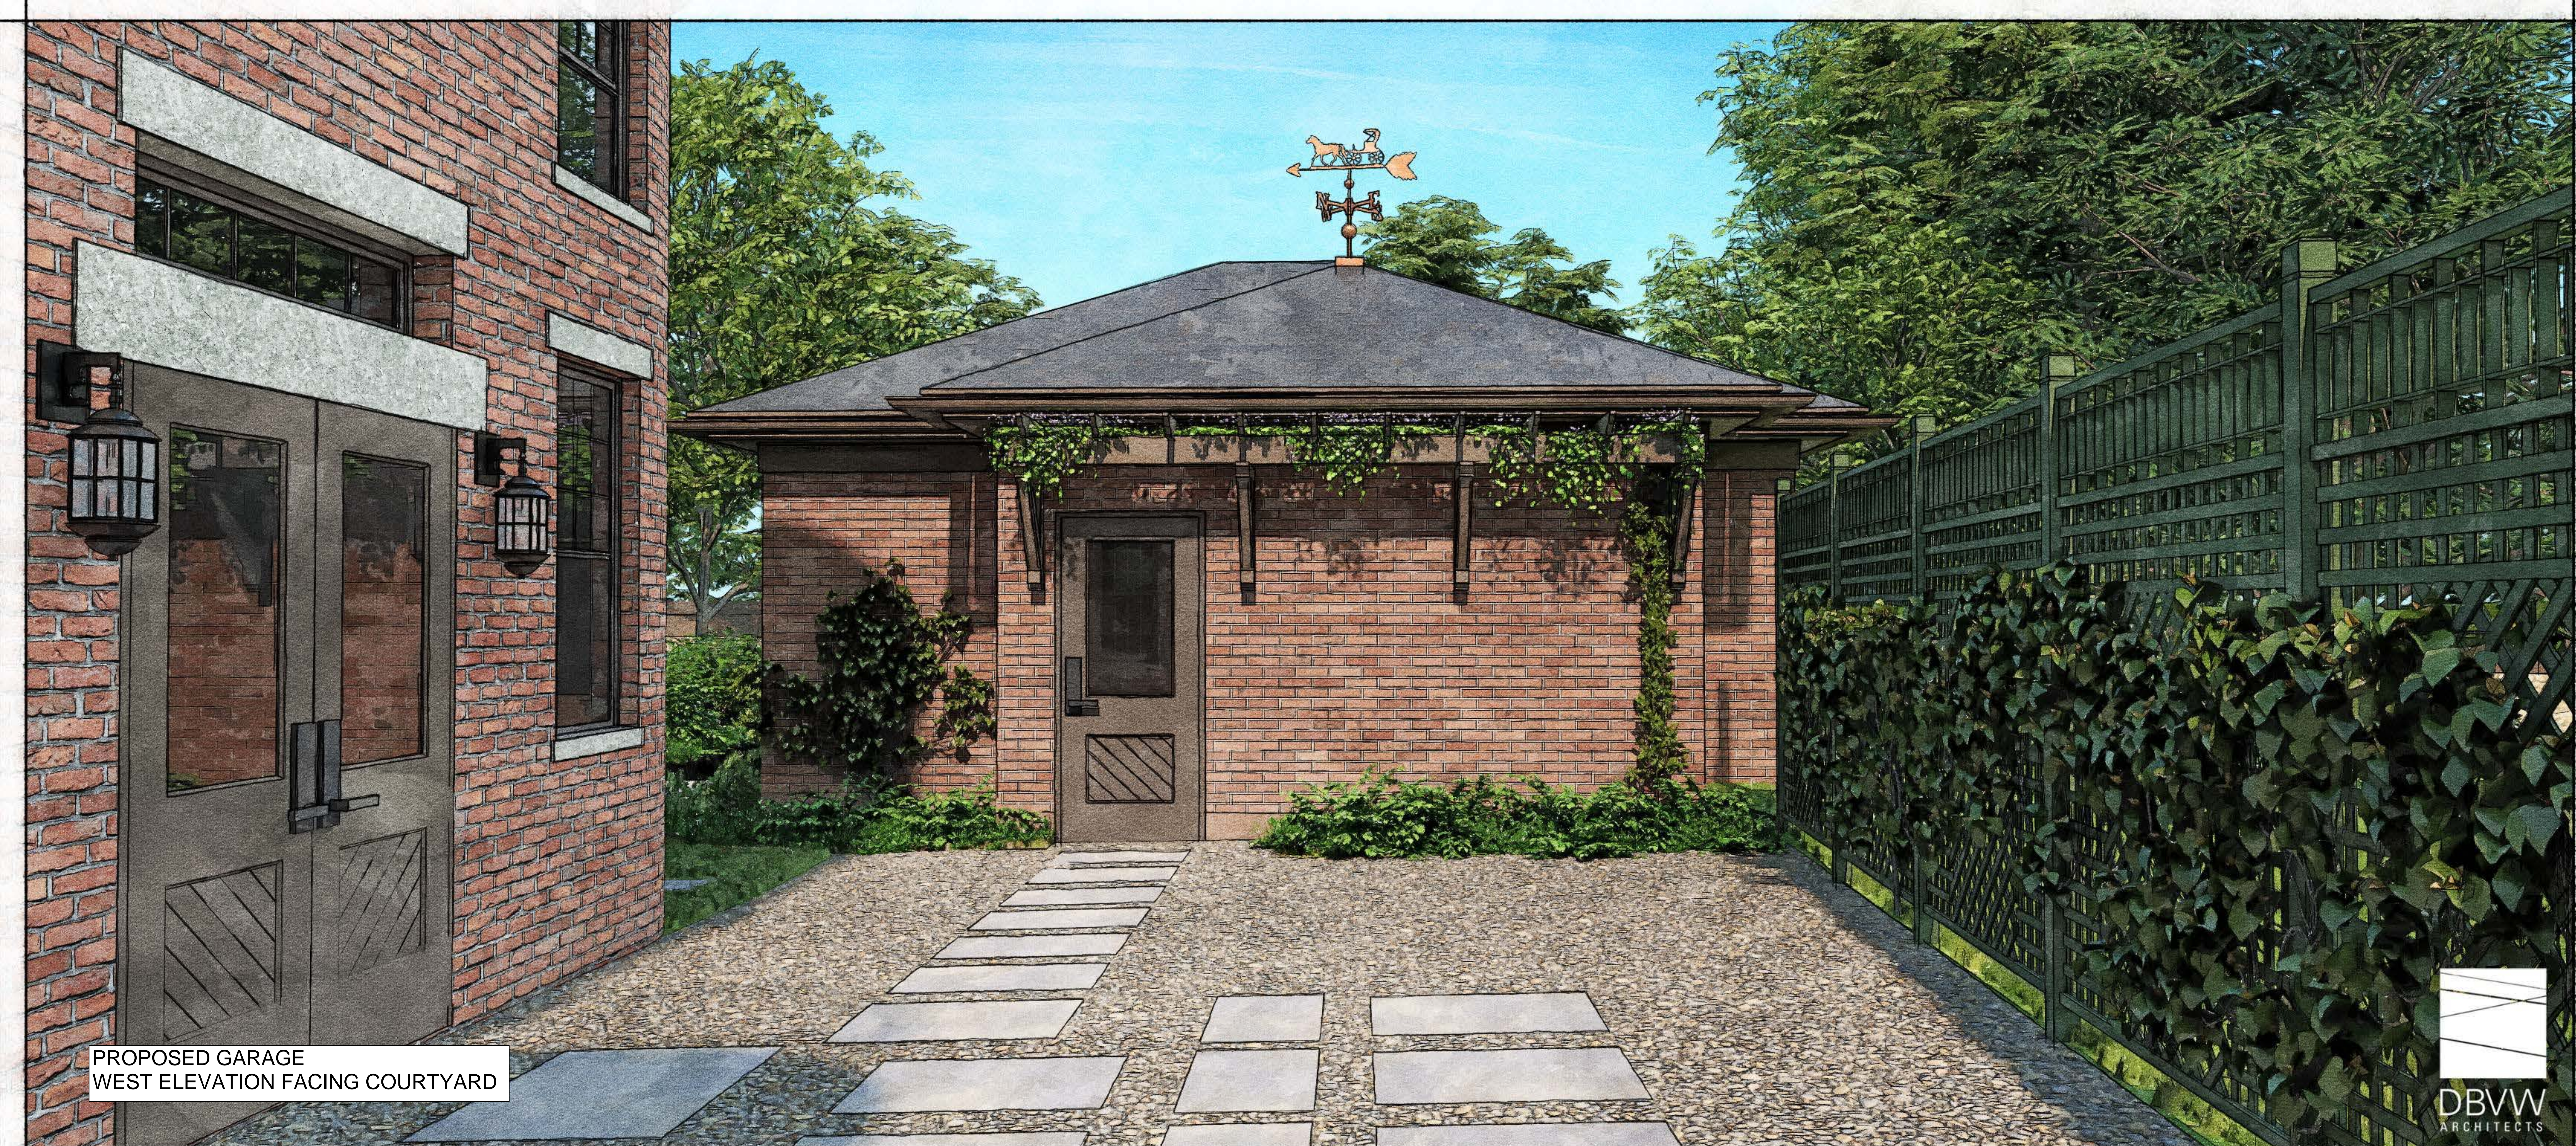
PROPOSED GARAGE
WEST ELEVATION FACING COURTYARD

courtyard. Because vehicular access to the garage will be from Copley Lane (as required by zoning), which is approximately 30" below the grade of the courtyard, the garage will be very understated from the courtyard side. It is designed to be compatible with the historic buildings on site, but is clearly a product of its own time. The walls will be brick and the roof will be slate to match the existing carriage house. On Copley Lane, a new opening will be created in the stone wall to provide vehicular access to the garage (photo 10). Brick walls (no more than six feet in height) will extend from the edges of the new opening in the stone wall to the new garage, so the new garage access will not be perceived from within the historic confines of the property.

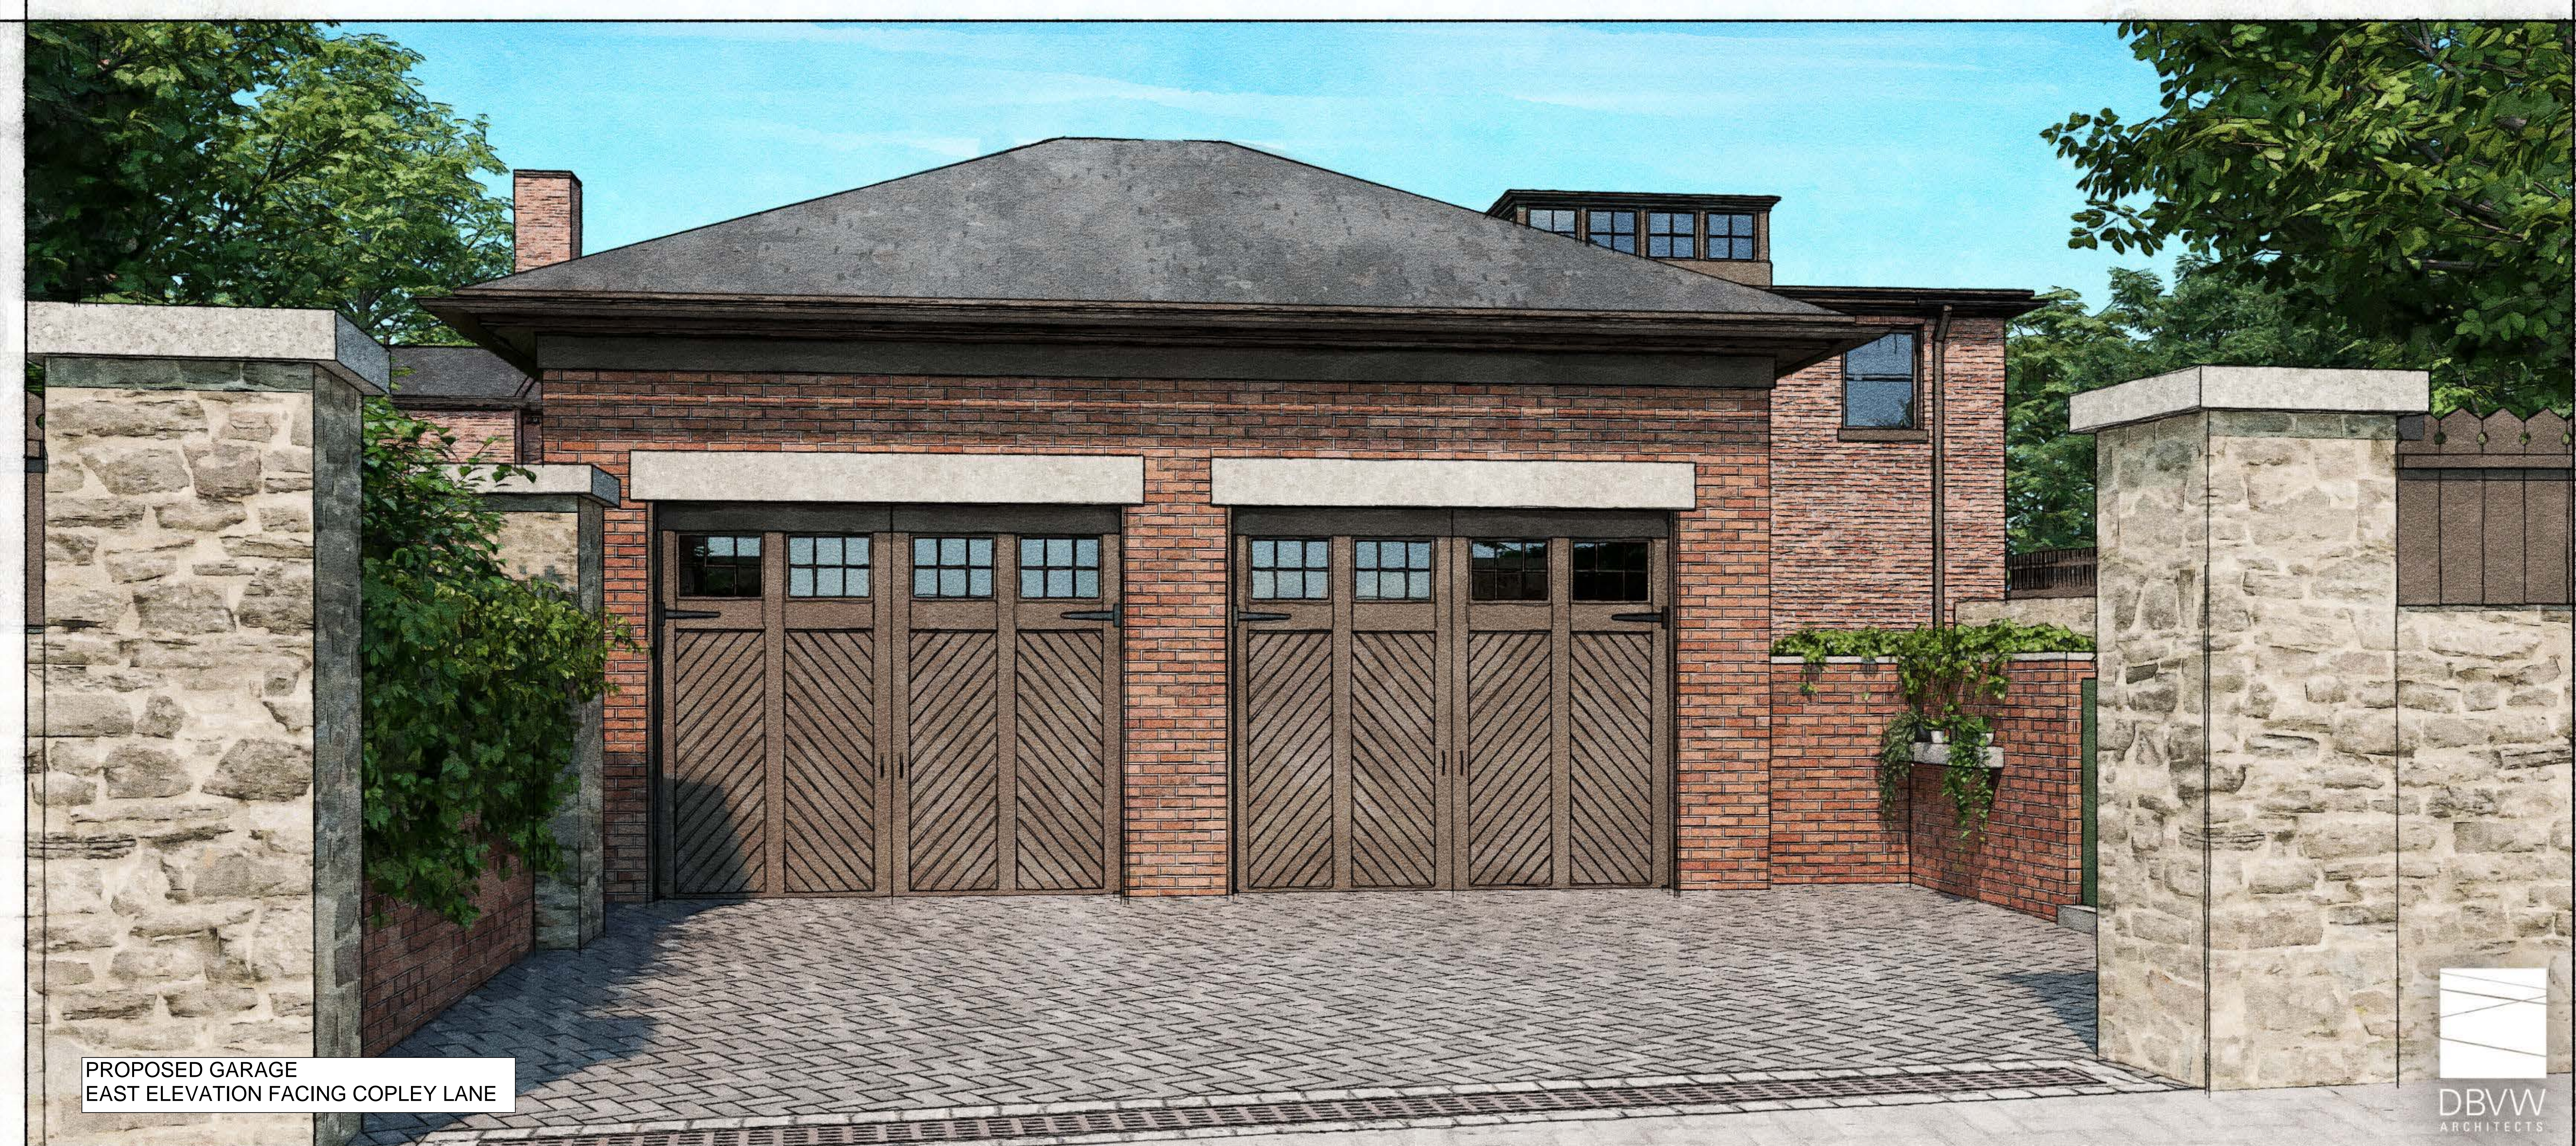
PROPOSED GARAGE
EAST ELEVATION FACING COPLEY LANE

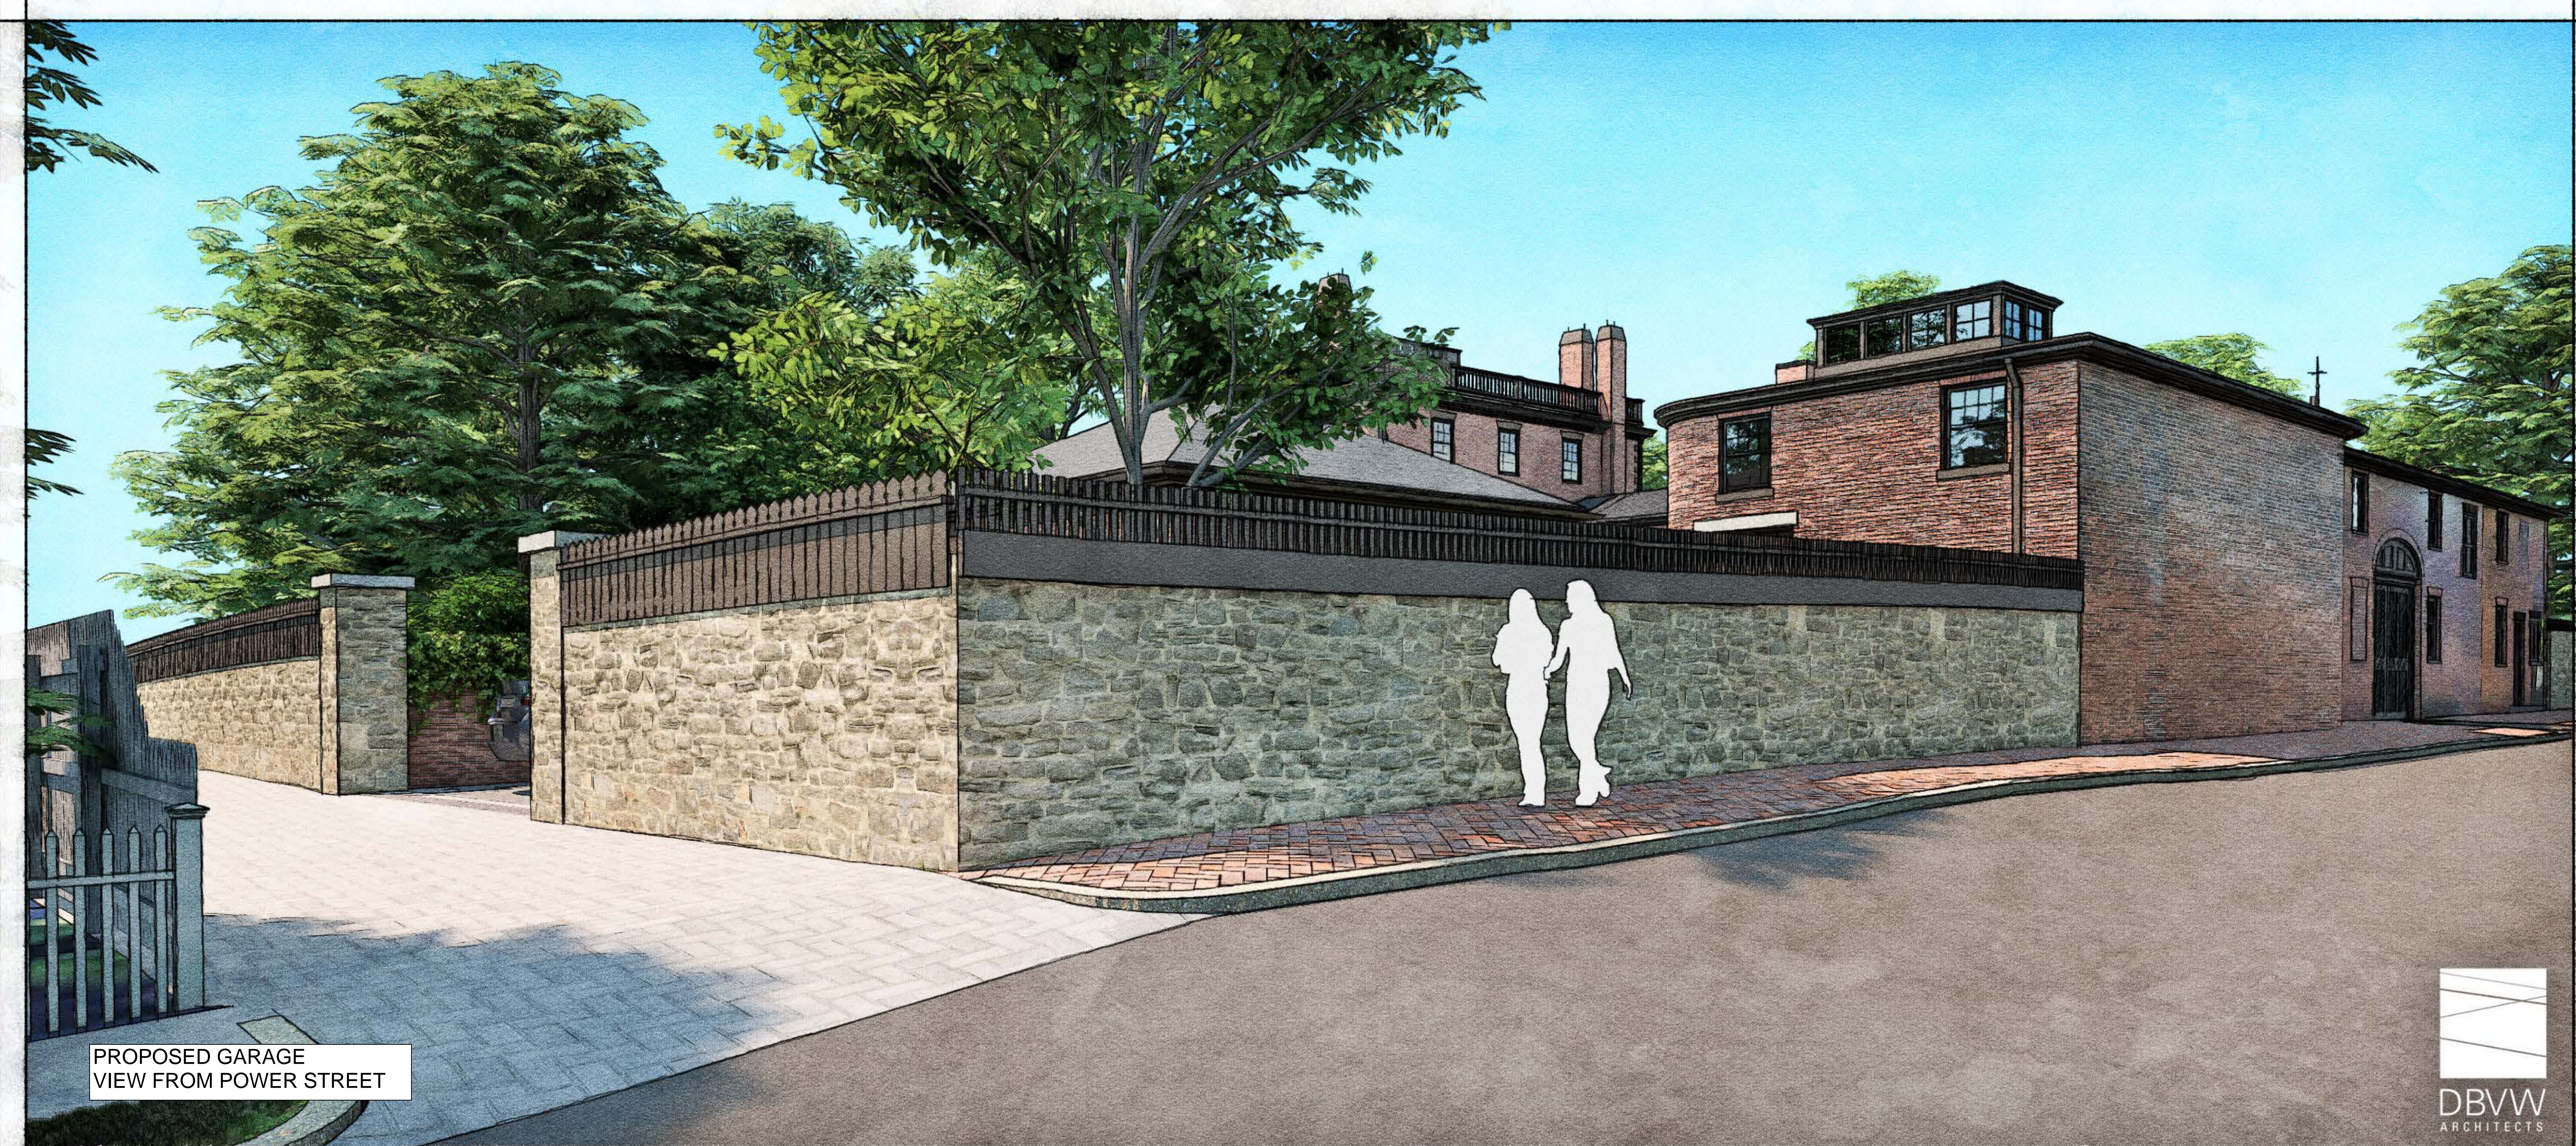
PROPOSED GARAGE
VIEW FROM POWER STREET

The main focus of the project is to preserve the single-family use, and carefully restore this important historic resource. It is important to note that none of the proposed alterations is visible from any public right of way, with the exception of the new garage. The garage roof will be minimally visible from Power Street (the rear of the property), and the east elevation will be visible from Copley Lane. The proposed opening in the stone wall along Copley Lane will be slightly visible from Power Street. Please refer to the attached renderings.

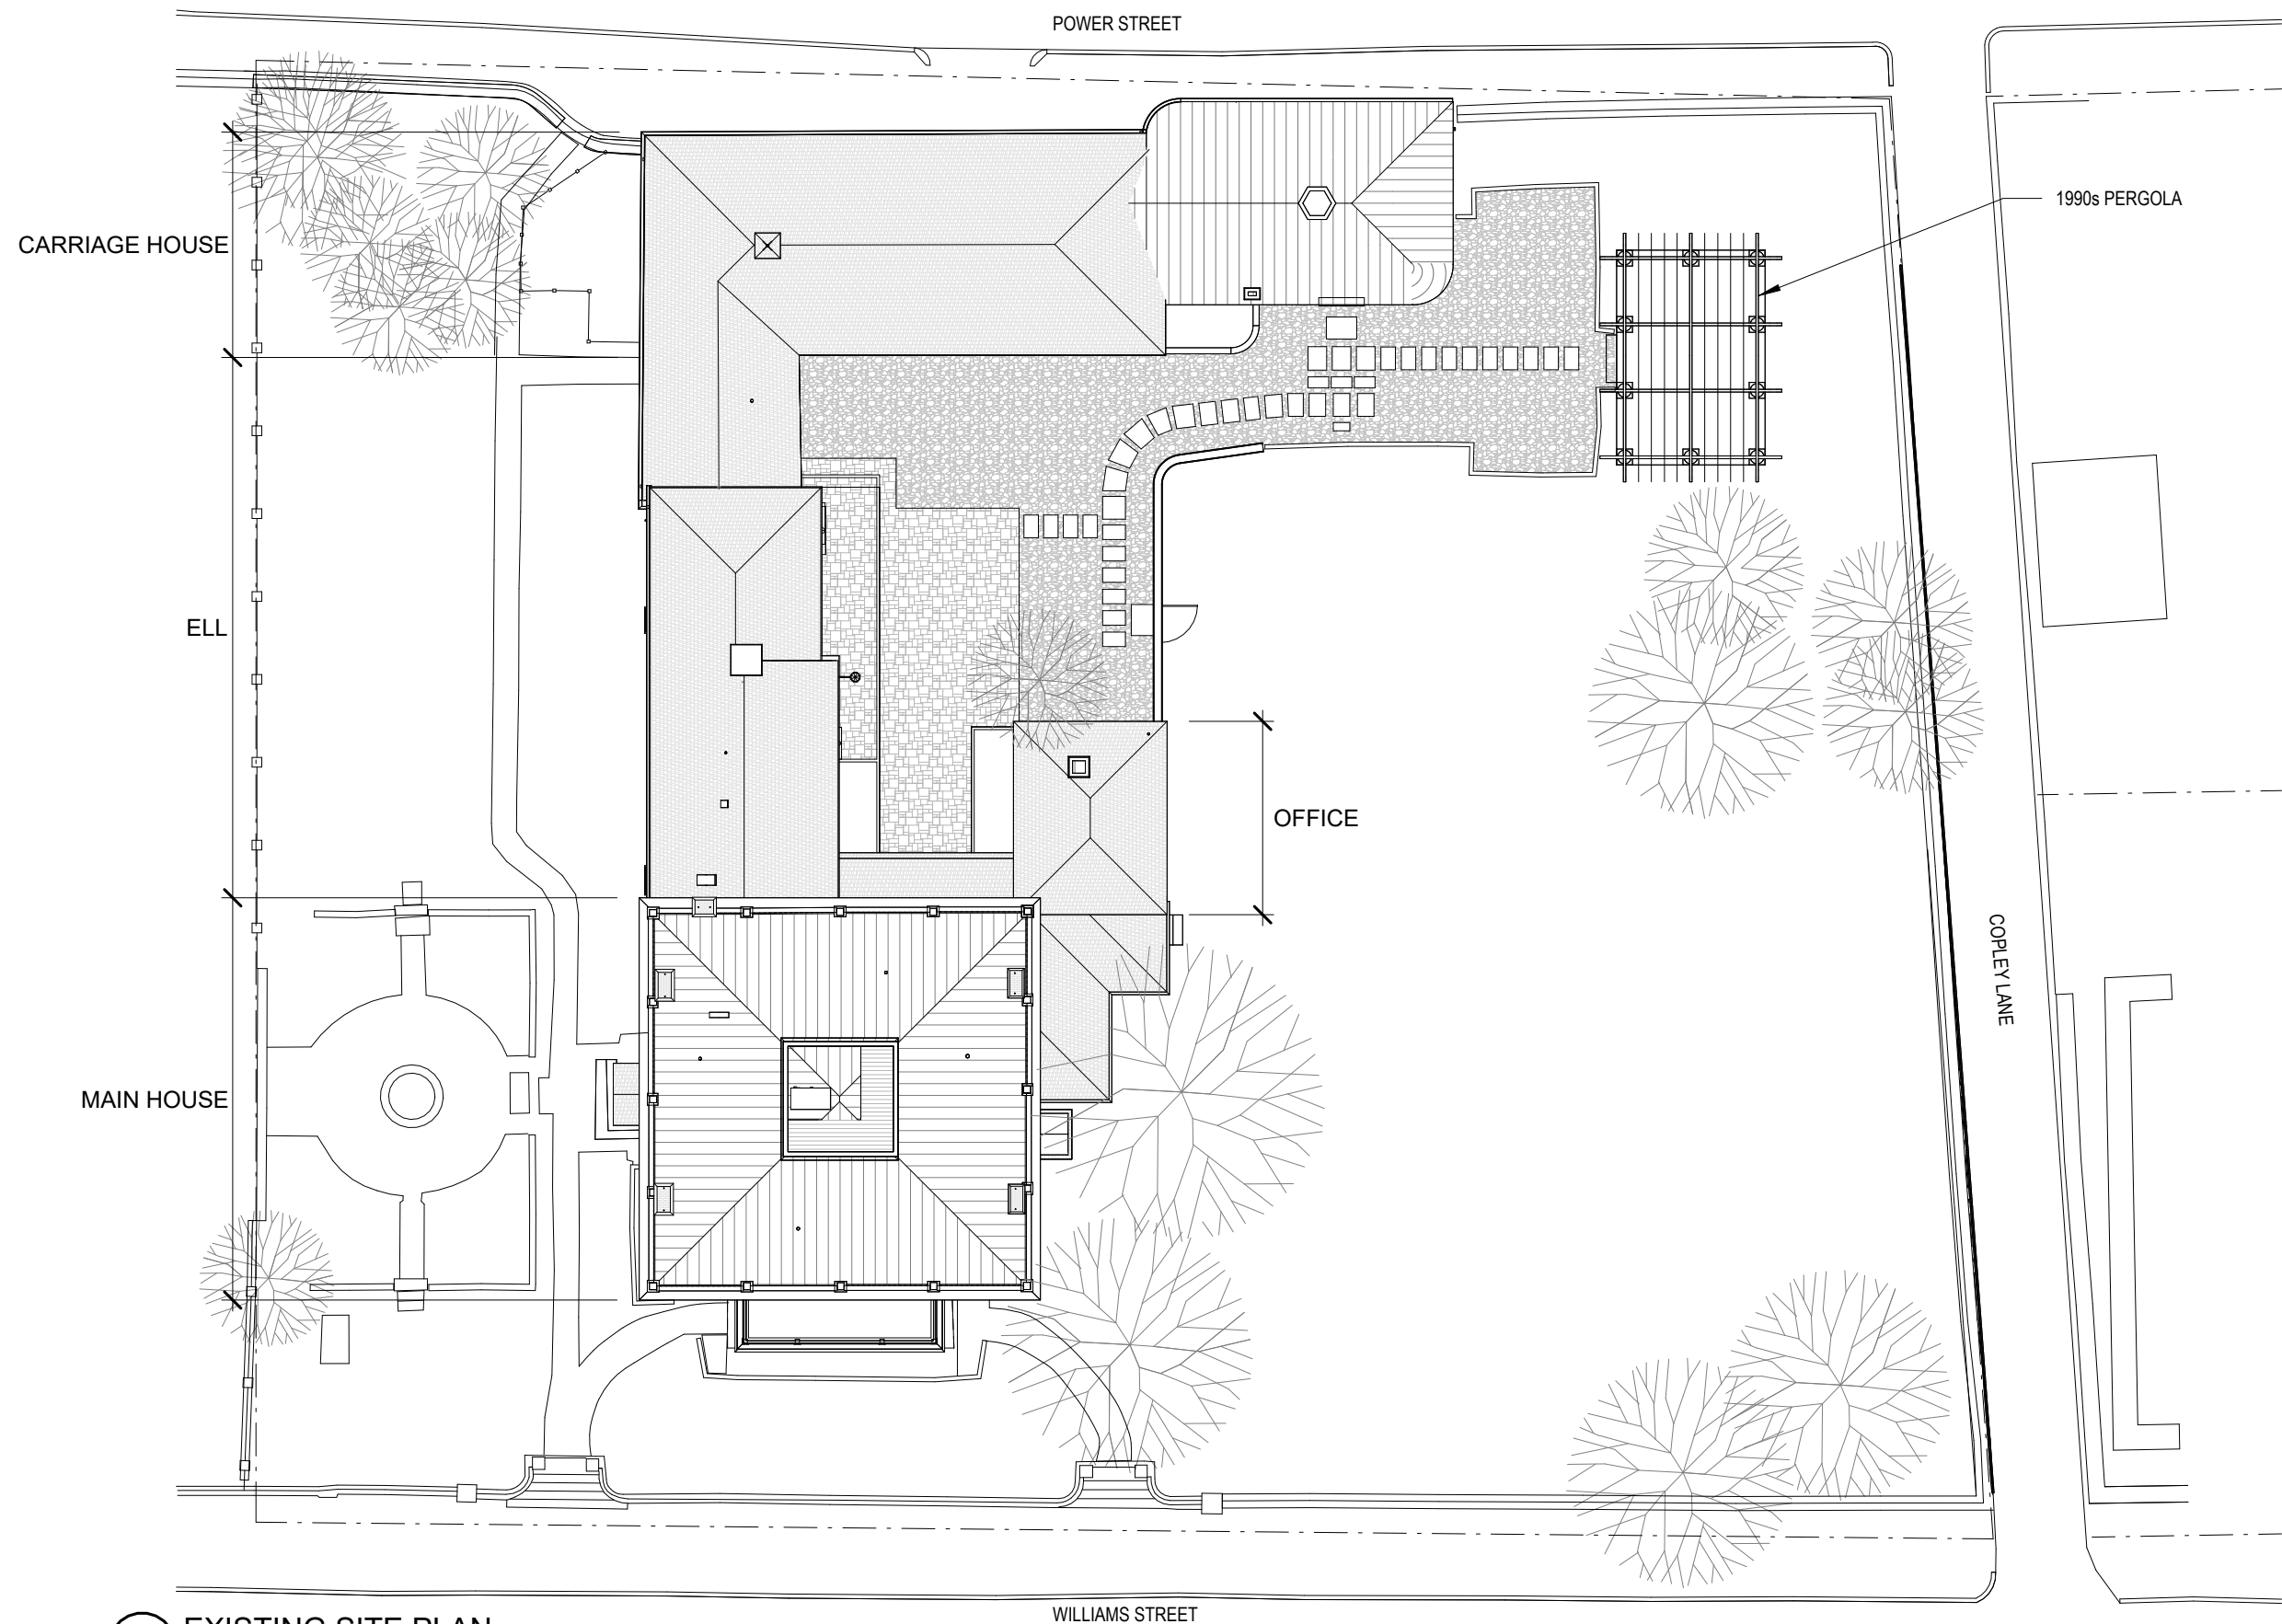
1 EXISTING SITE PLAN
 3/64" = 1'-0"

Site: The site is enclosed by a stone wall that is capped with a short wood fence. The stone wall acts as a retaining wall because the interior of the property is elevated approximately 30" above the sidewalk and street elevations that surround the property. The property is bordered on the south by Williams Street, on the north by Power Street, and on the east by Copley Lane. The west side of the property borders other residential lots. Within the property, the main house and carriage house surround a cobblestone courtyard.
