66 POWER STREET - PROPOSED SCOPE OF WORK OVERVIEW

COW BARN + CARRIAGE HOUSE

HDC Meeting Date: 09/29/2025

**Narrative in Support of Application for Certificate of Appropriateness:
Cow Barn and Carriage House**

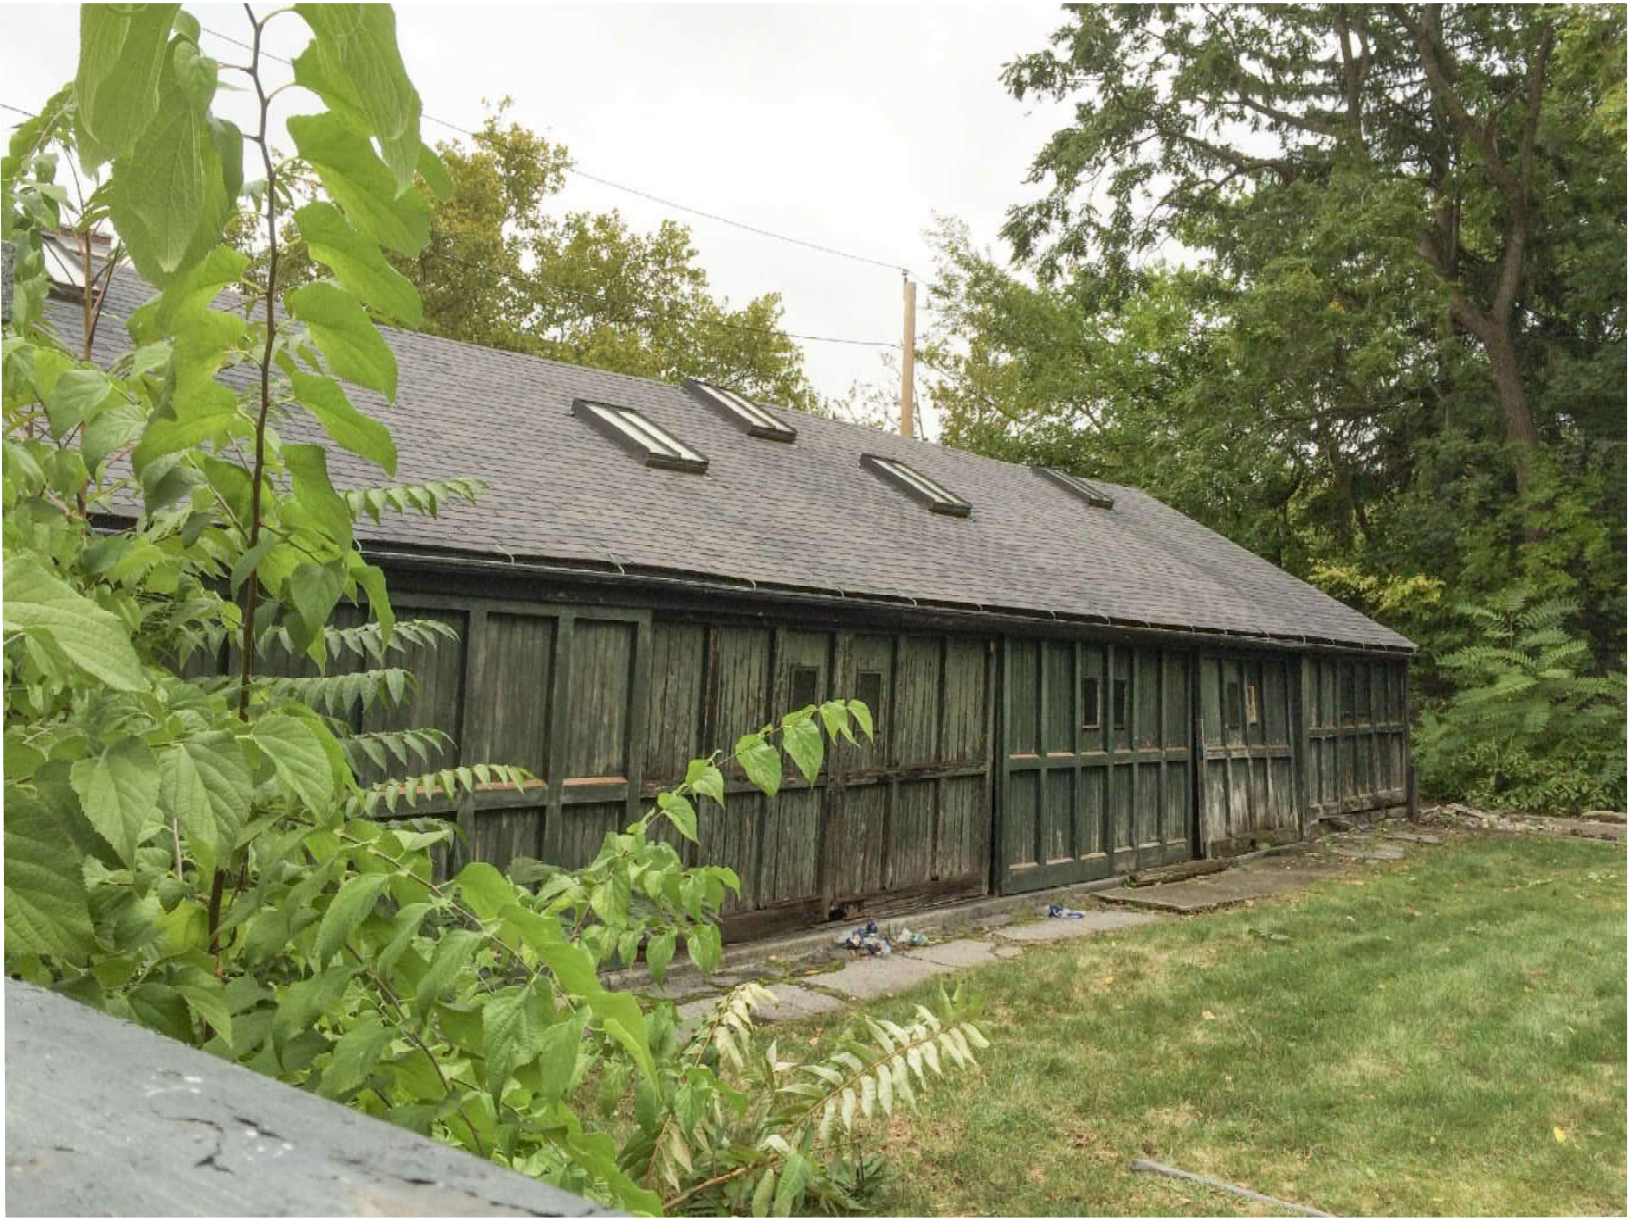
① Cow Barn - Site Plan + Floor Plan
3/16" = 1'-0"

- The floor slab is existing to remain, no footprint changes
- New wood structure at all inward facing facades
- Salvage and re-use of existing skylights
- Three (3) new overhead operating carriage style garage doors
- New textured exterior wall panels with rail and stile detailing
- Existing to remain brick façade at Brown Street with new and salvaged rake board trim detail at the roof rake
- Repaired masonry cap and stone wall at Charlesfield Street
- New roof ridge
- New gutters and downspouts

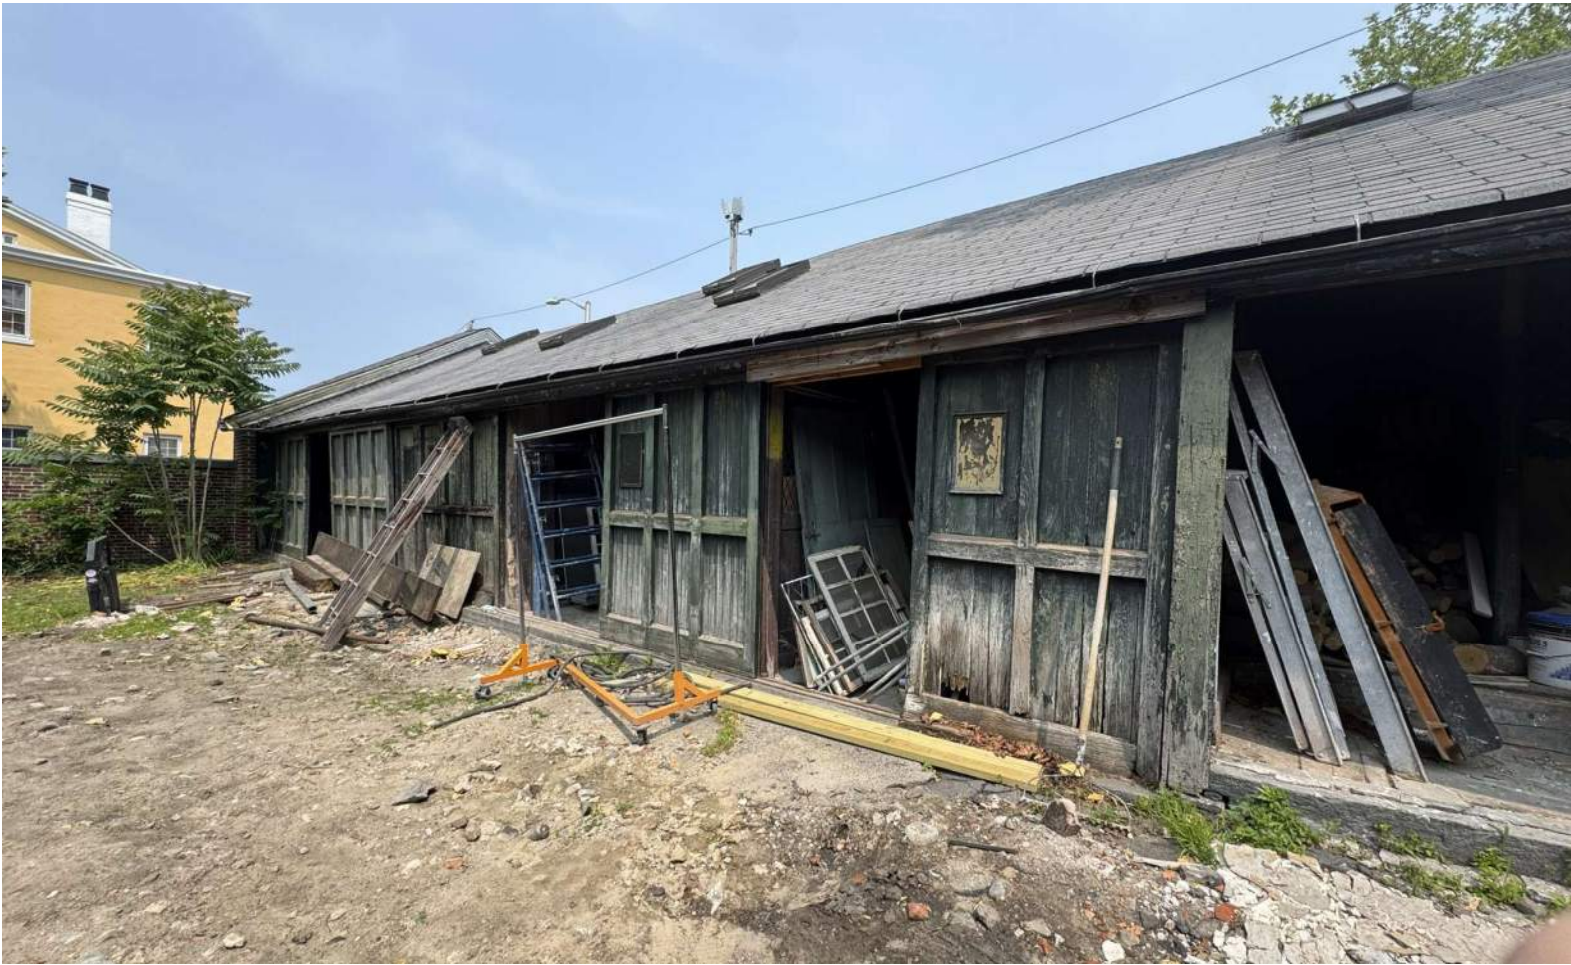
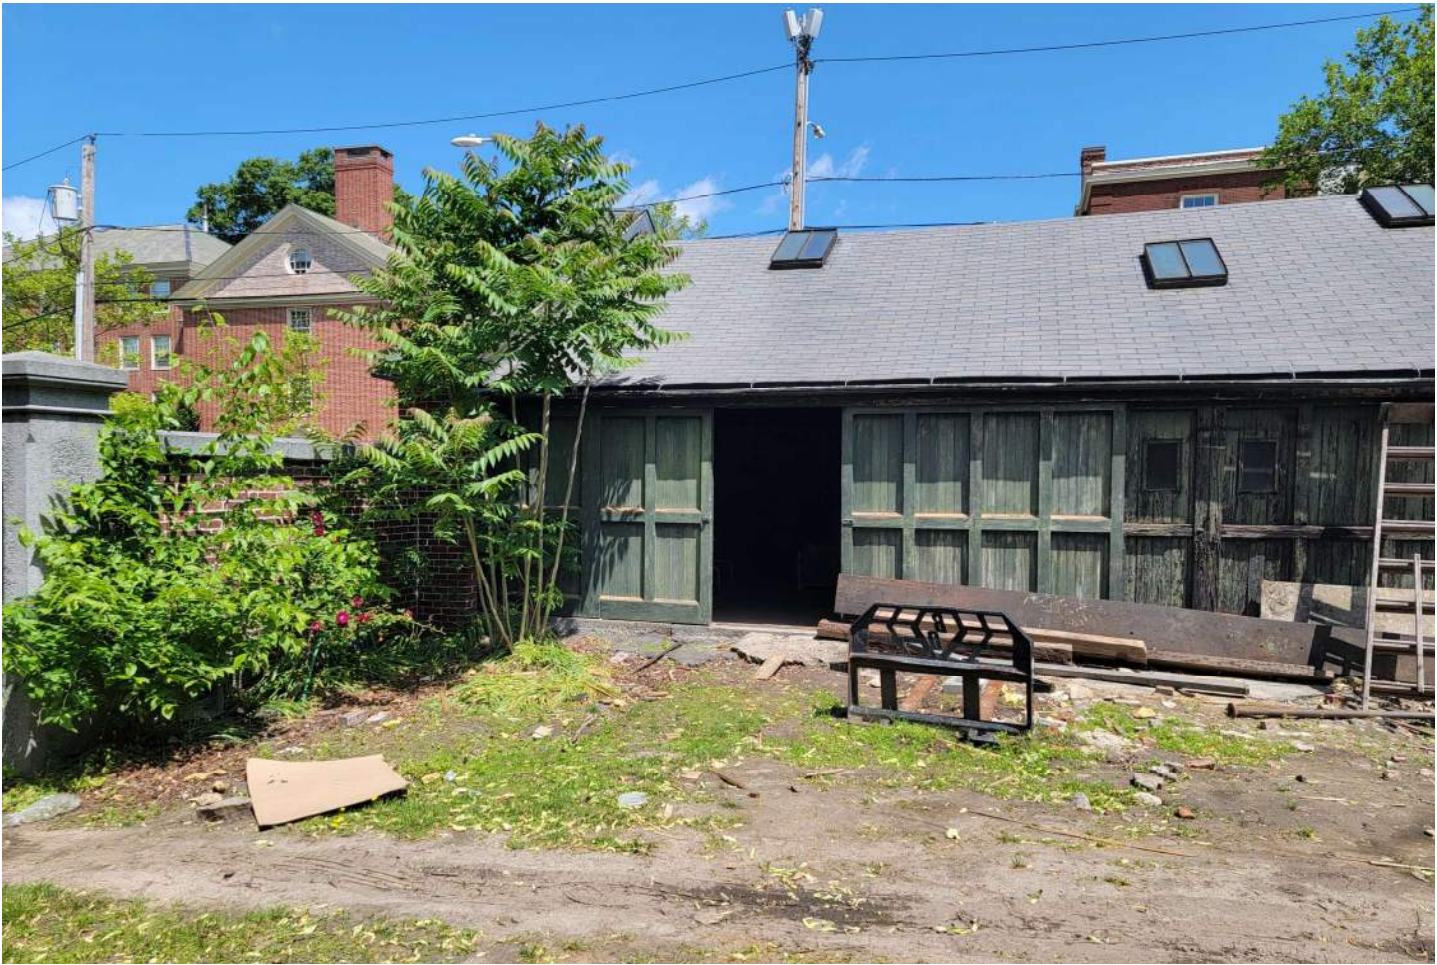
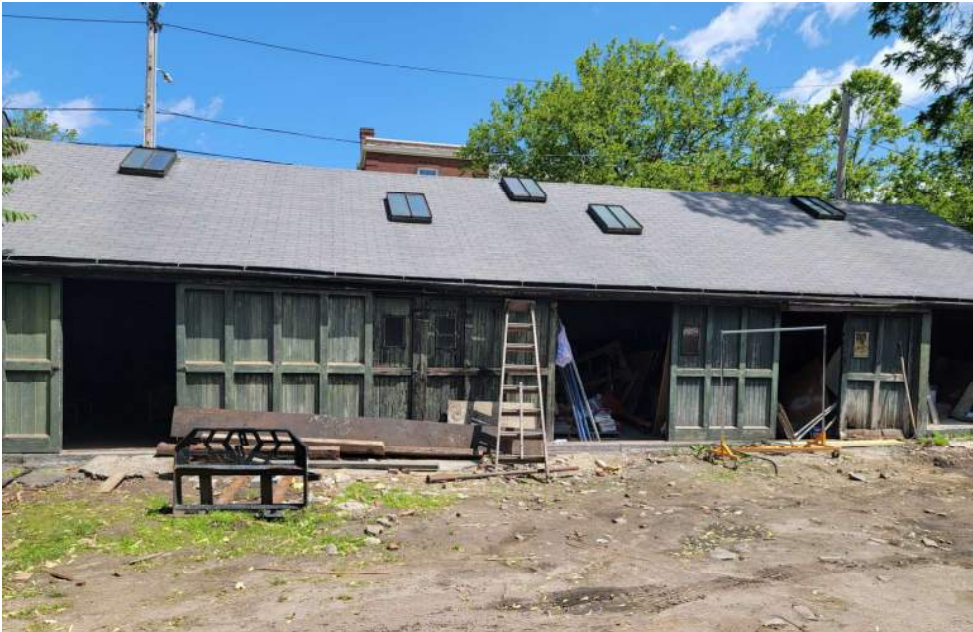
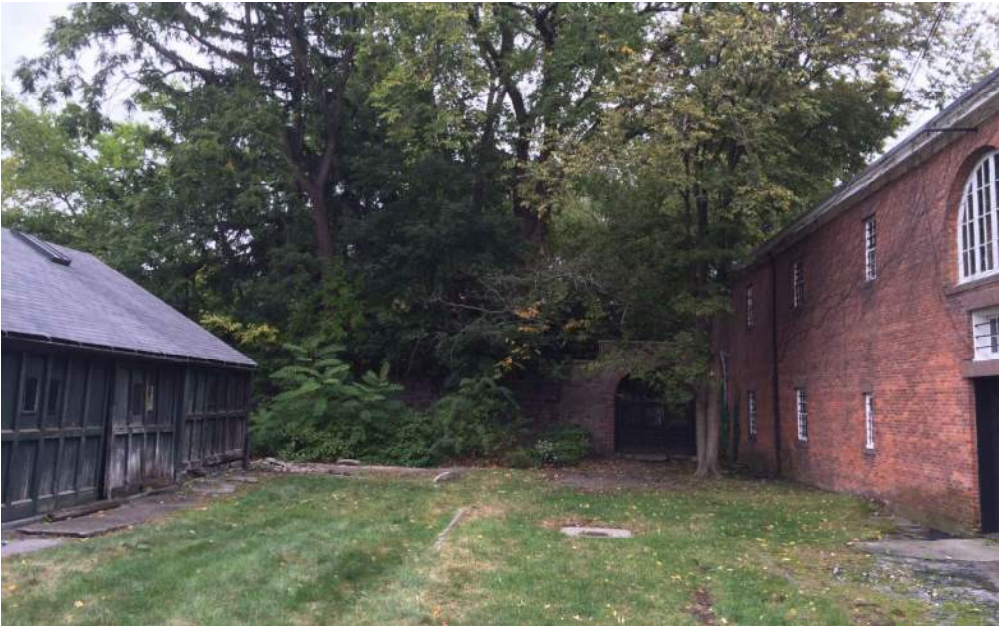
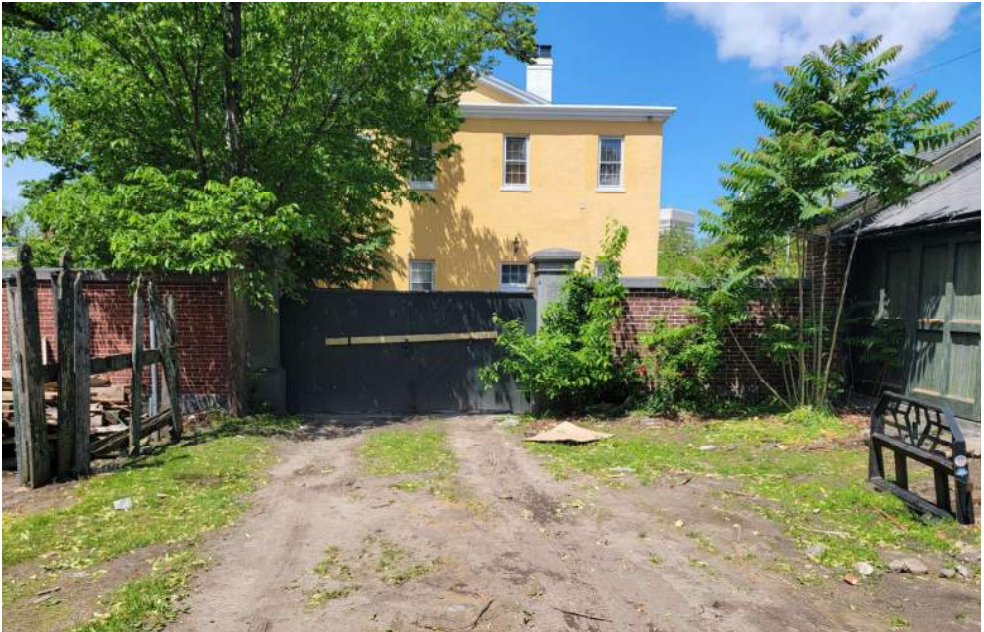
PRE-EXISTING CONDITIONS

The structure known as the ‘Cow Barn’ has much less historical significance than the main dwelling and the Carriage House. It is a small out-building in a vernacular style. The Cow Barn has been deteriorating for many years. A building permit application from 2017 (applied for by the current Owner’s predecessor in title) indicates that the structure needed to be shored up to prevent it from falling down. Eight years later, in 2025, the current Owner engaged a contractor to inspect the Cow Barn and evaluate its structural integrity. When the contractor entered the Cow Barn in late July, he captured its existing condition in a videorecording, which has been submitted to the Commission (referred to hereinafter as the “Cow Barn Video”). As the Cow Barn Video demonstrates, the rafters had rotted away and the roof was resting on the exterior perimeter wall. The contractor was concerned that the building was in imminent danger of collapse. Under the mistaken impression that alterations to the Cow Barn would not require review and approval by the Commission, both because the structure was not historically significant and because it was located behind a wall, with almost no features visible from the street, the contractor undertook an immediate demolition and reconstruction of the structure.

We are seeking retroactive approval for the demolition of the Cow Barn and replacement, in kind, of a similar wood structure to be used as a three-car garage, including the following.

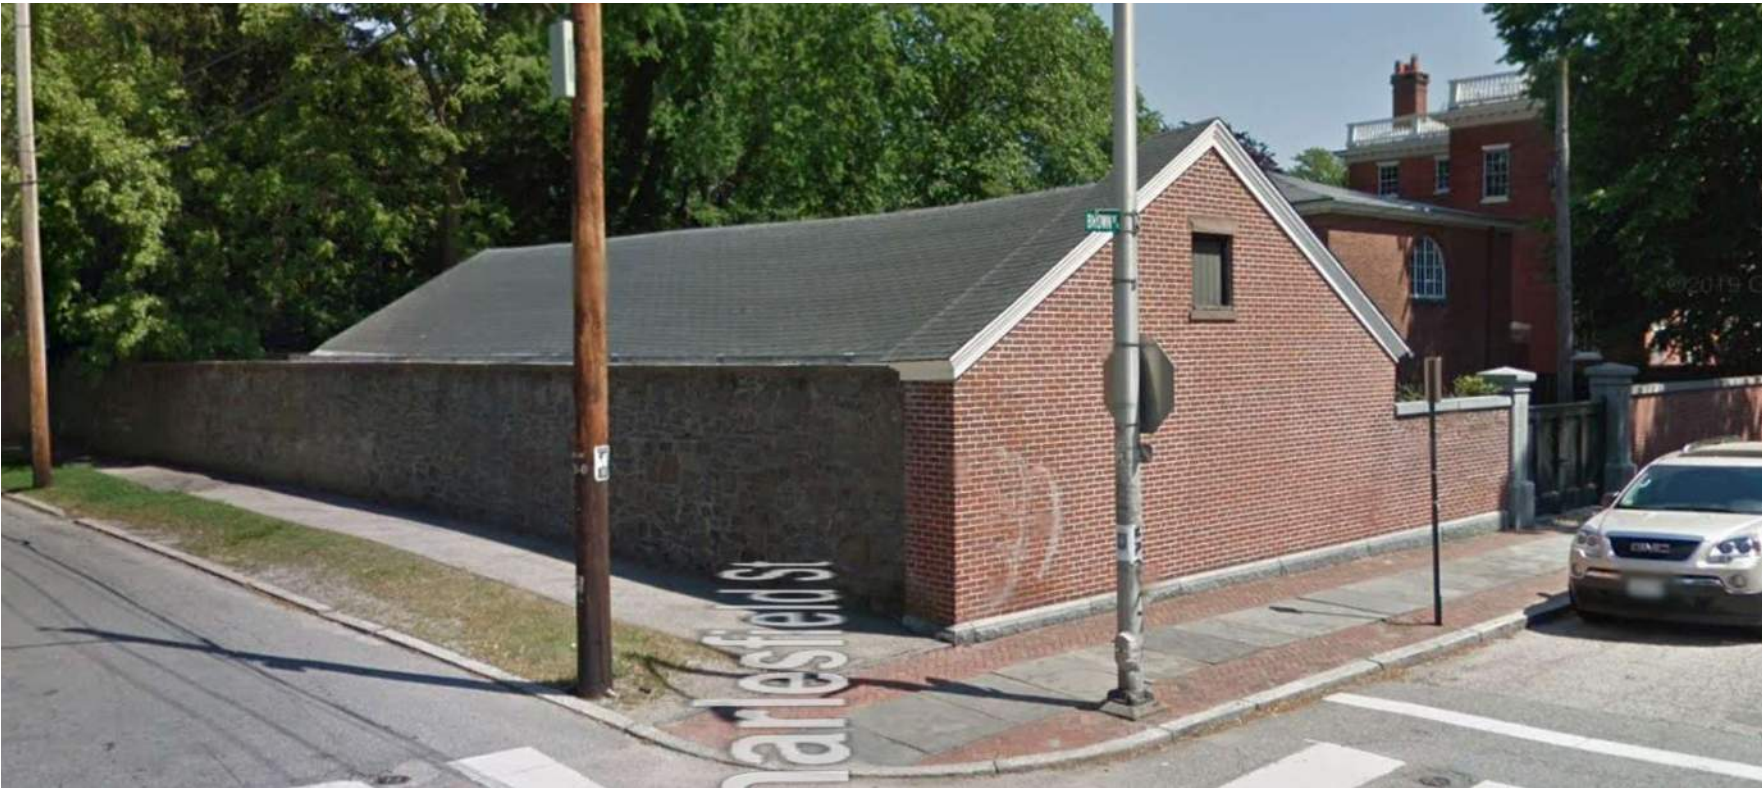
BEFORE + AFTER

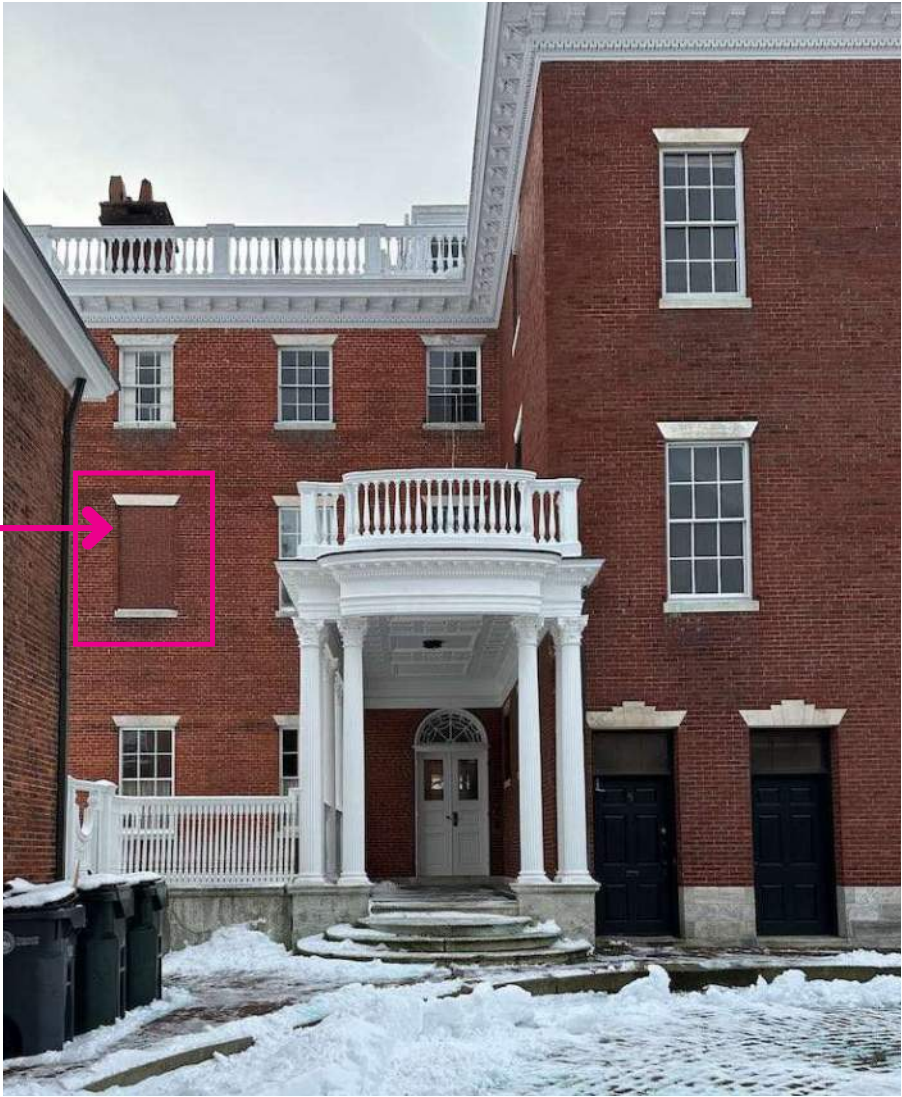
SECTION DETAIL THROUGH GHOSTED BRICK WINDOW OPENING

INSTALL NEW STONE
LINTEL, MATCH EXISTING,
ALIGN FACE OF LINTEL WITH
FACE OF BRICK AT PRIMARY
FACADE

GHOSTED WINDOW OPENING

INSTALL 21 COURSES OF
BRICK, RECESSED 1 3/4" FROM
FACE OF PRIMARY FACADE.
RECESSED BRICK TO MATCH
HEIGHT AND WIDTH OF
ADJACENT OPENINGS

NEW STONE SILL, MATCH EXISTING,
ALIGN FACE OF SILL TO ALIGN WITH
FACE OF BRICK AT PRIMARY FACADE

- Remove the newly installed brick at a previous second floor window location and install a “ghosted window detail”.
- Reinstall the removed second floor window on the first floor (below the previous opening). The previous first floor window opening was smaller, so the new opening was adjusted to account for the larger size.
- Repointing and repairing of brick at the replaced first floor window.
- At these two locations we propose installing new custom lintels and sills to match the existing adjacent lintels and sills.
