PROJECT REVIEW

1. CASE 25.175, 66 POWER STREET, Thomas Poynton Ives House, 1806 (COLLEGE HILL)

66 POWER STREET - PROPOSED SCOPE OF WORK OVERVIEW
COW BARN + CARRIAGE HOUSE
HDC Meeting Date: 09/29/2025

HISTORIC DISTRICT COMMISSION
COWBARN + CARRIAGE HOUSE EXTERIOR

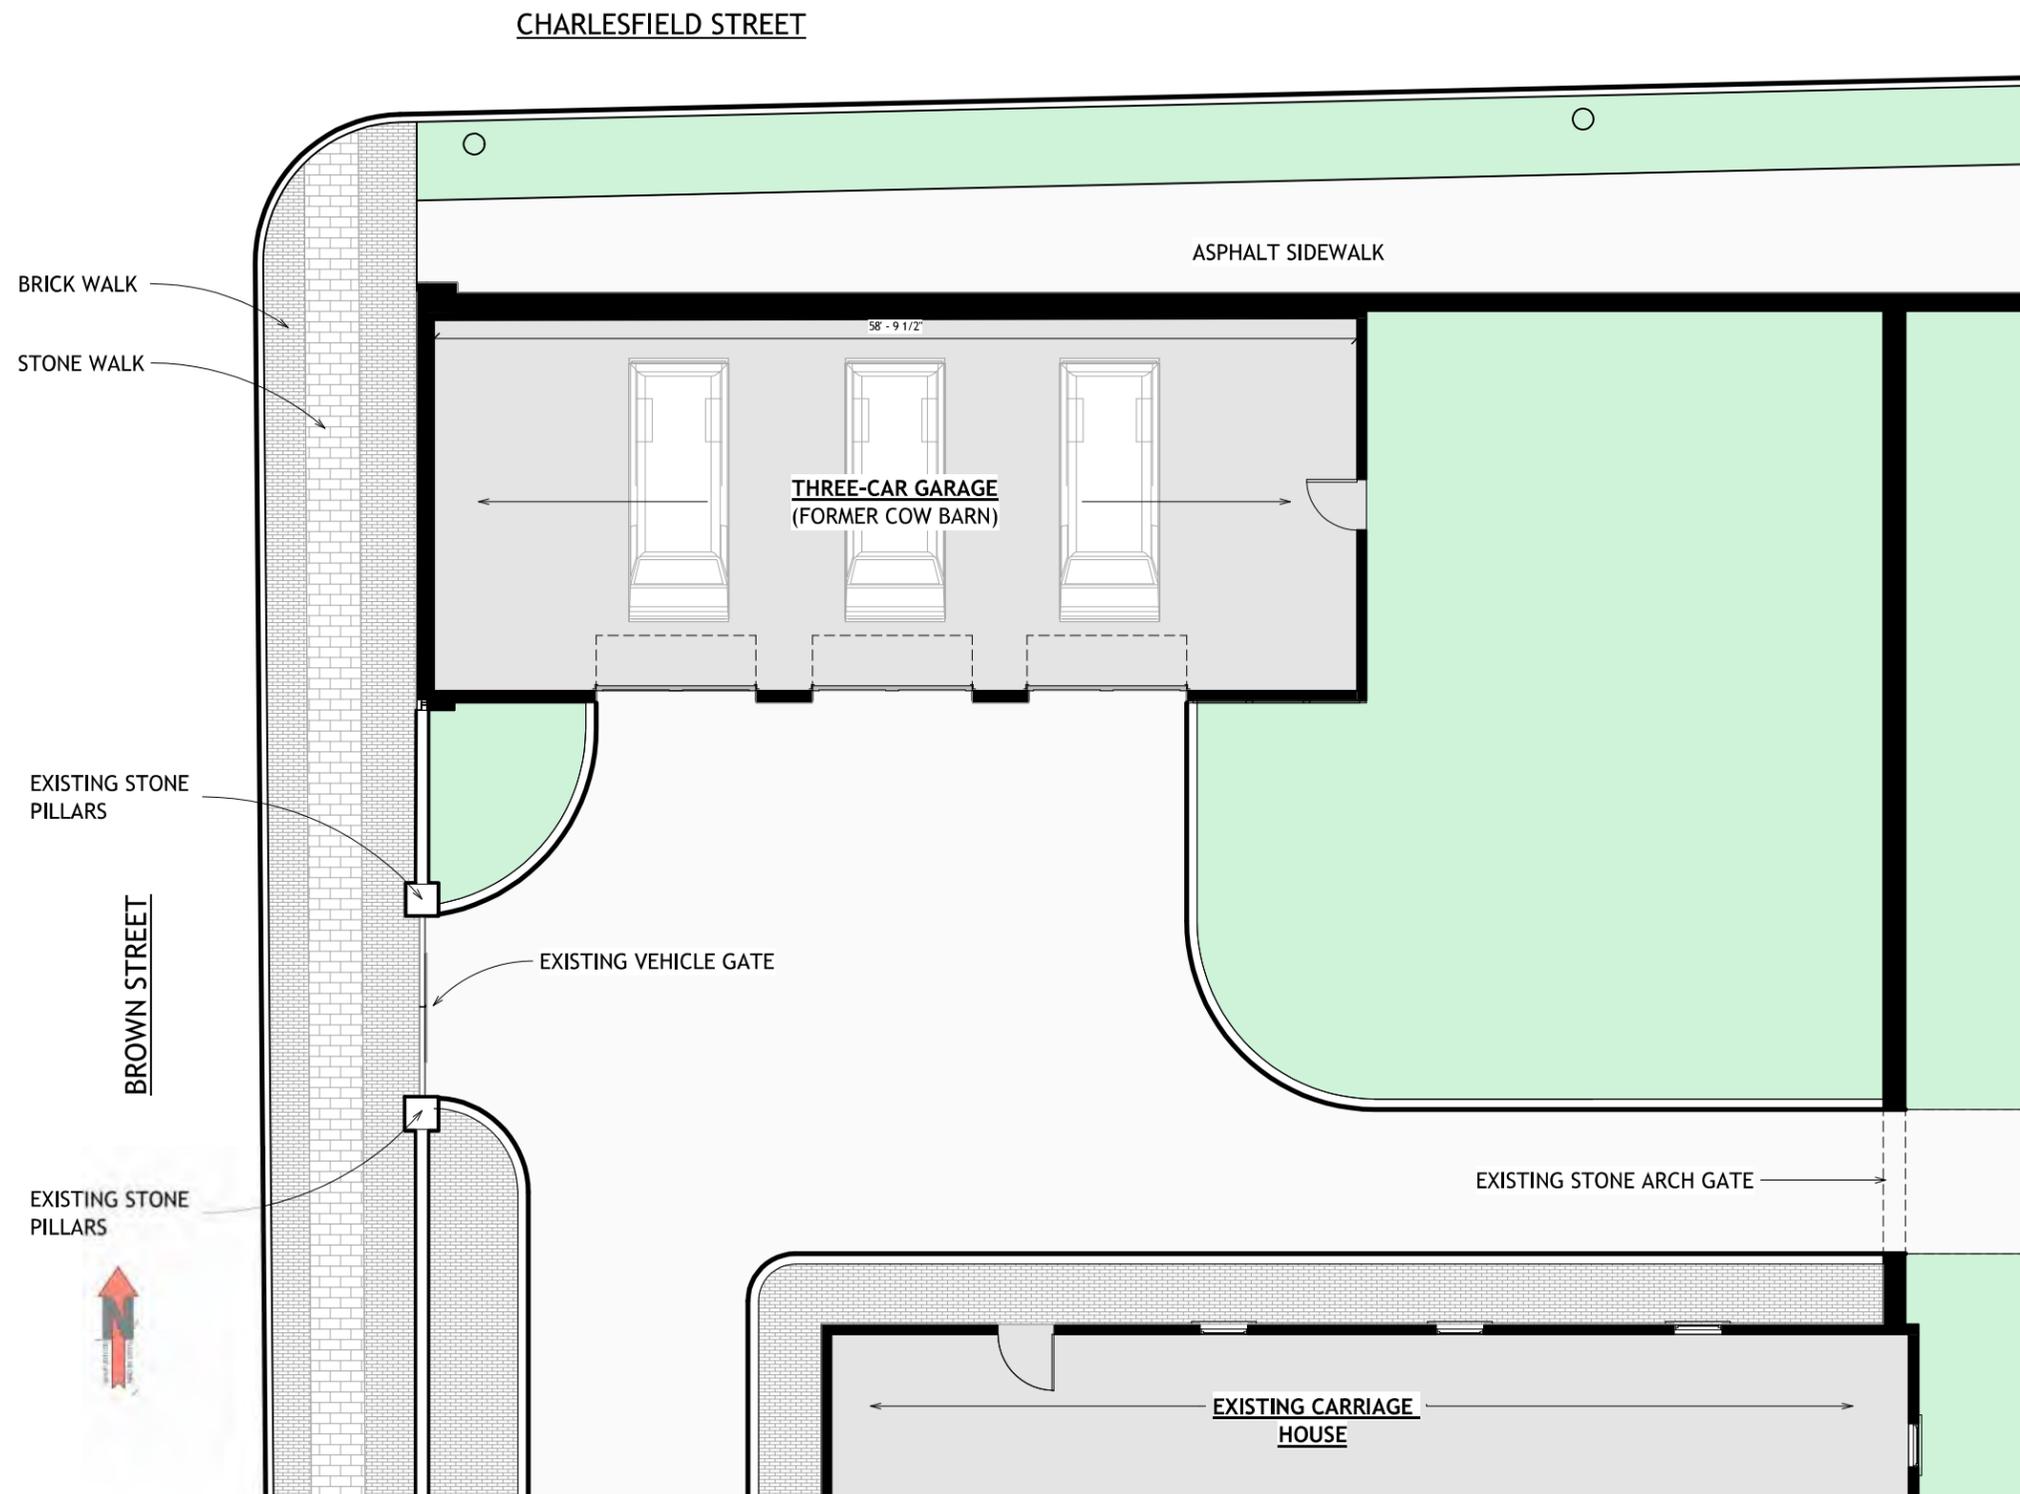
① Cow Barn - Site Plan + Floor Plan
3/16" = 1'-0"

- The floor slab is existing to remain, no footprint changes
- New wood structure at all inward facing facades
- Salvage and re-use of existing skylights
- Three (3) new overhead operating carriage style garage doors
- New textured exterior wall panels with rail and stile detailing
- Existing to remain brick façade at Brown Street with new and salvaged rake board trim detail at the roof rake
- Repaired masonry cap and stone wall at Charlesfield Street
- New roof ridge
- New gutters and downspouts

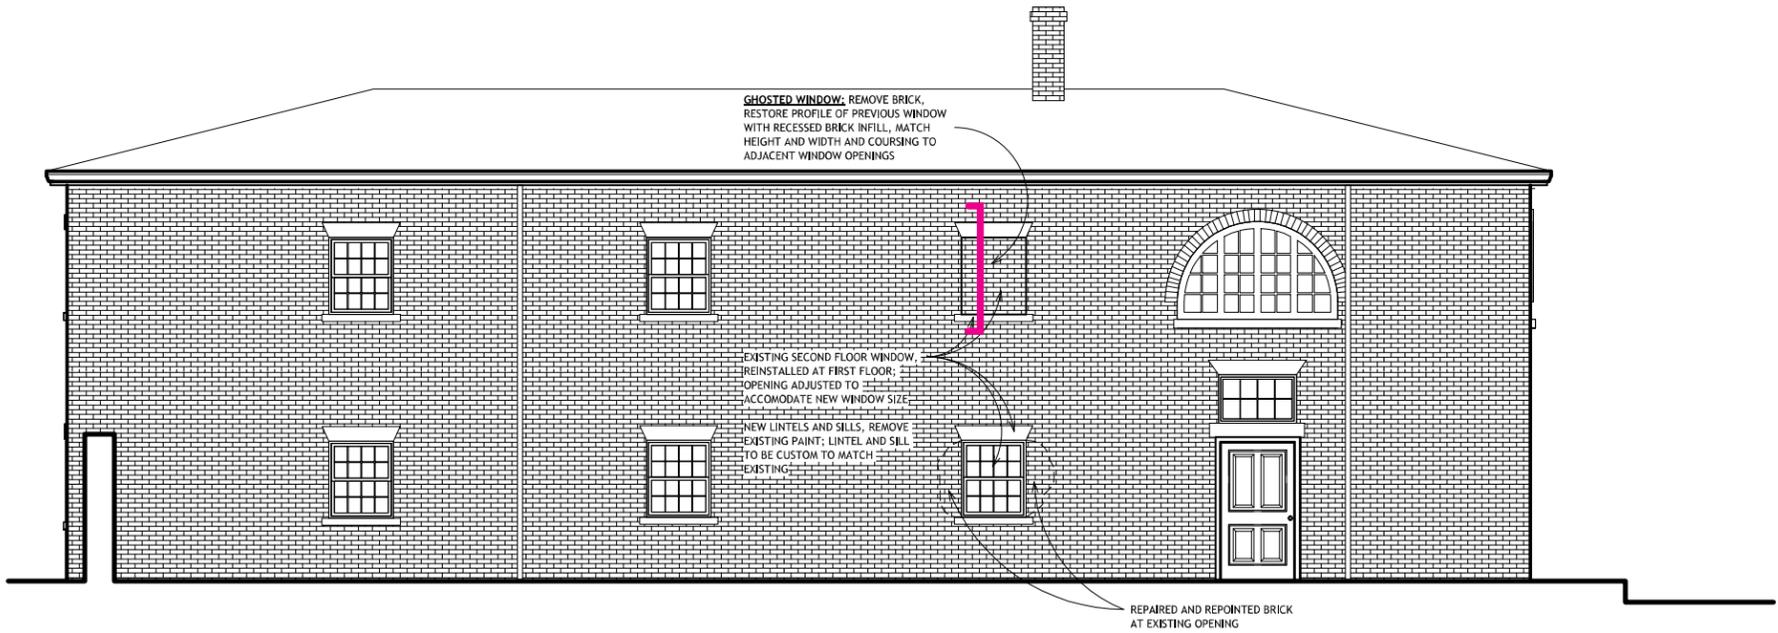
2 Proposed - Carriage House North Facade
1/4" = 1'-0"

- Remove the newly installed brick at a previous second floor window location and install a “ghosted window detail”.
- Reinstall the removed second floor window on the first floor (below the previous opening). The previous first floor window opening was smaller, so the new opening was adjusted to account for the larger size.
- Repointing and repairing of brick at the replaced first floor window.
- At these two locations we propose installing new custom lintels and sills to match the existing adjacent lintels and sills.

Work Overview. On the Carriage House, one window was removed and bricked in. The Applicant proposes to install a 'ghosted window detail' for this feature. The removed window was reinstalled on the first floor, below the previous opening. This window location was adjusted to accommodate a larger window size, and the brick in this location was repointed and repaired. For both of these locations, the Applicant proposes to install new custom lintels and sills to match the existing adjacent features.

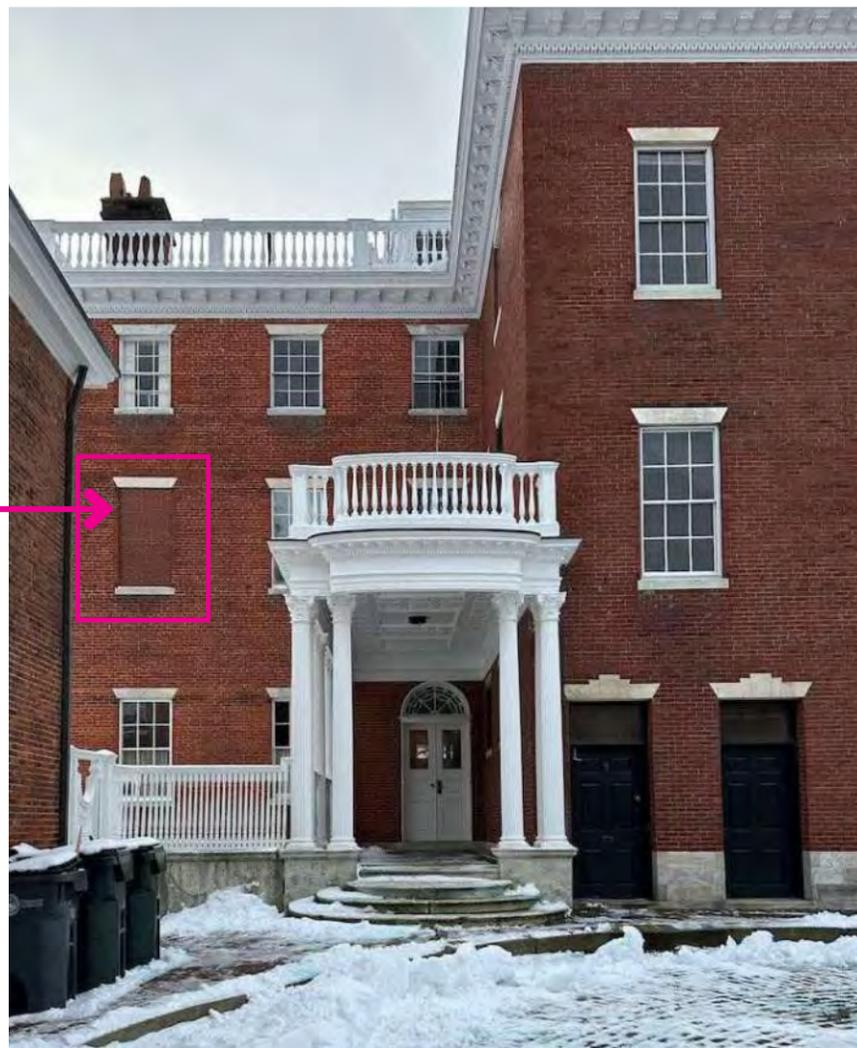
SECTION DETAIL THROUGH GHOSTED BRICK WINDOW OPENING

INSTALL NEW STONE LINTEL, MATCH EXISTING, ALIGN FACE OF LINTEL WITH FACE OF BRICK AT PRIMARY FACADE

GHOSTED WINDOW OPENING
 INSTALL 21 COURSES OF BRICK, RECESSED 1 3/4" FROM FACE OF PRIMARY FACADE. RECESSED BRICK TO MATCH HEIGHT AND WIDTH OF ADJACENT OPENINGS

NEW STONE SILL, MATCH EXISTING, ALIGN FACE OF SILL TO ALIGN WITH FACE OF BRICK AT PRIMARY FACADE
