**BOARD OF CONTRACT AND SUPPLY  
CITY OF PROVIDENCE, RHODE ISLAND**

# REQUEST FOR QUALIFICATIONS

**Item Description:** Engineering And Design Services for Manton Ave Tar Bridge

# **Appendix A: Bridge Inspection Report**

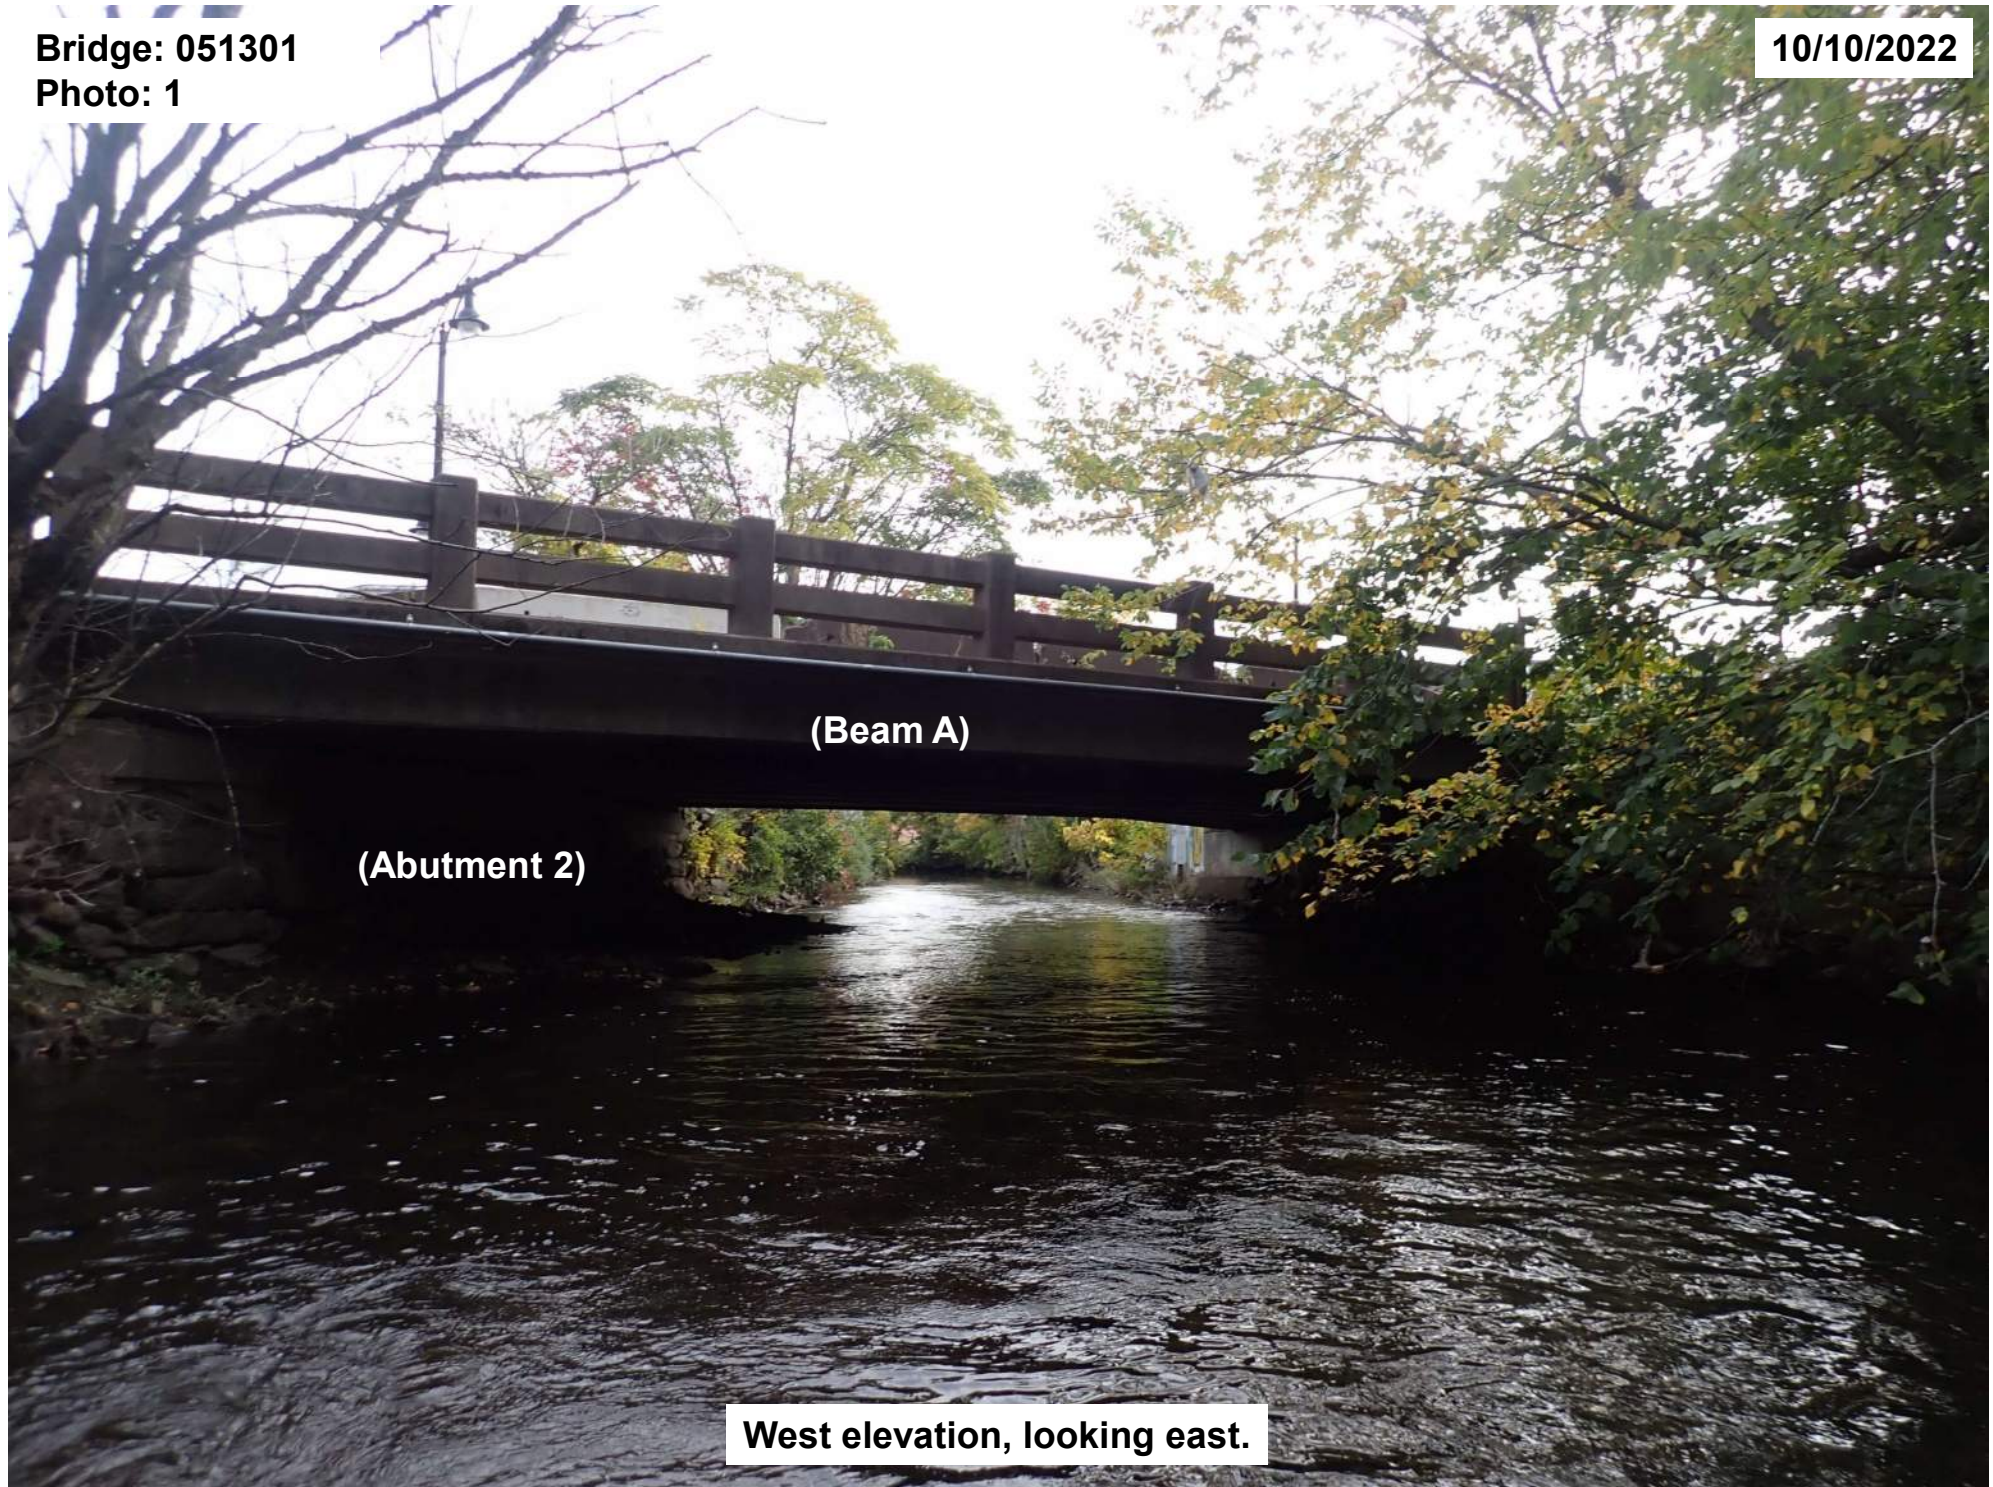
Bridge: 051301  
Photo: 1

East elevation, looking west.

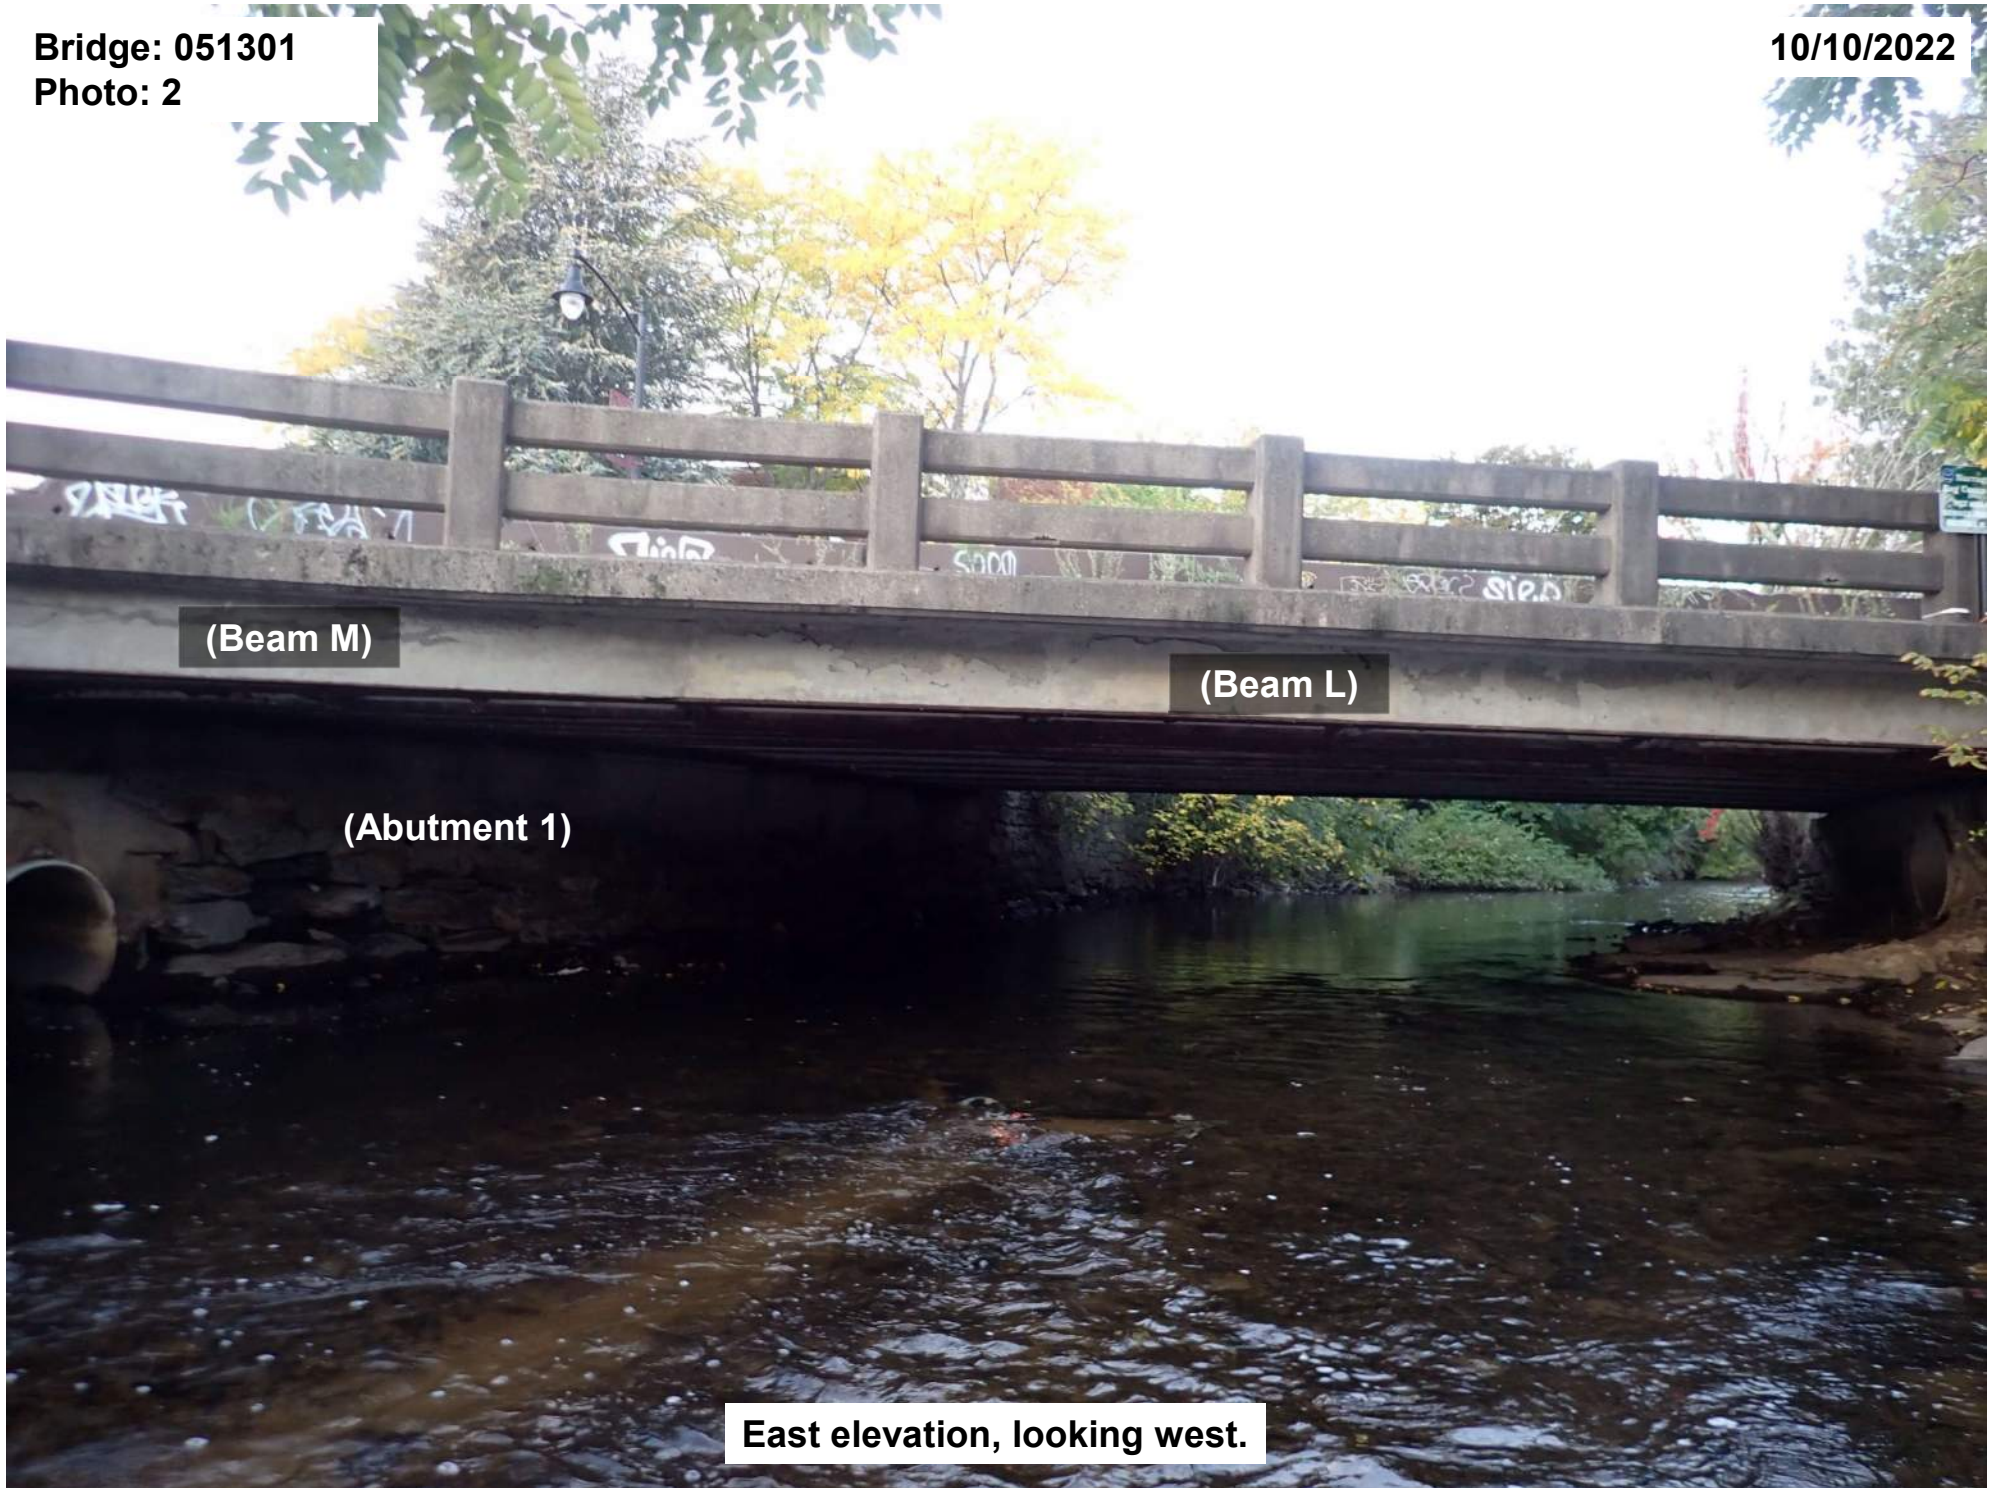
Bridge: 051301  
Photo: 3

The wearing surface has scattered hairline cracks measuring up to 3.0' long throughout (Photo 3).

Abutment 1 joint, looking west.

The wearing surface has scattered cracks, patches, and moderate wheel line rutting throughout (Photos 3 to 5 & 8).

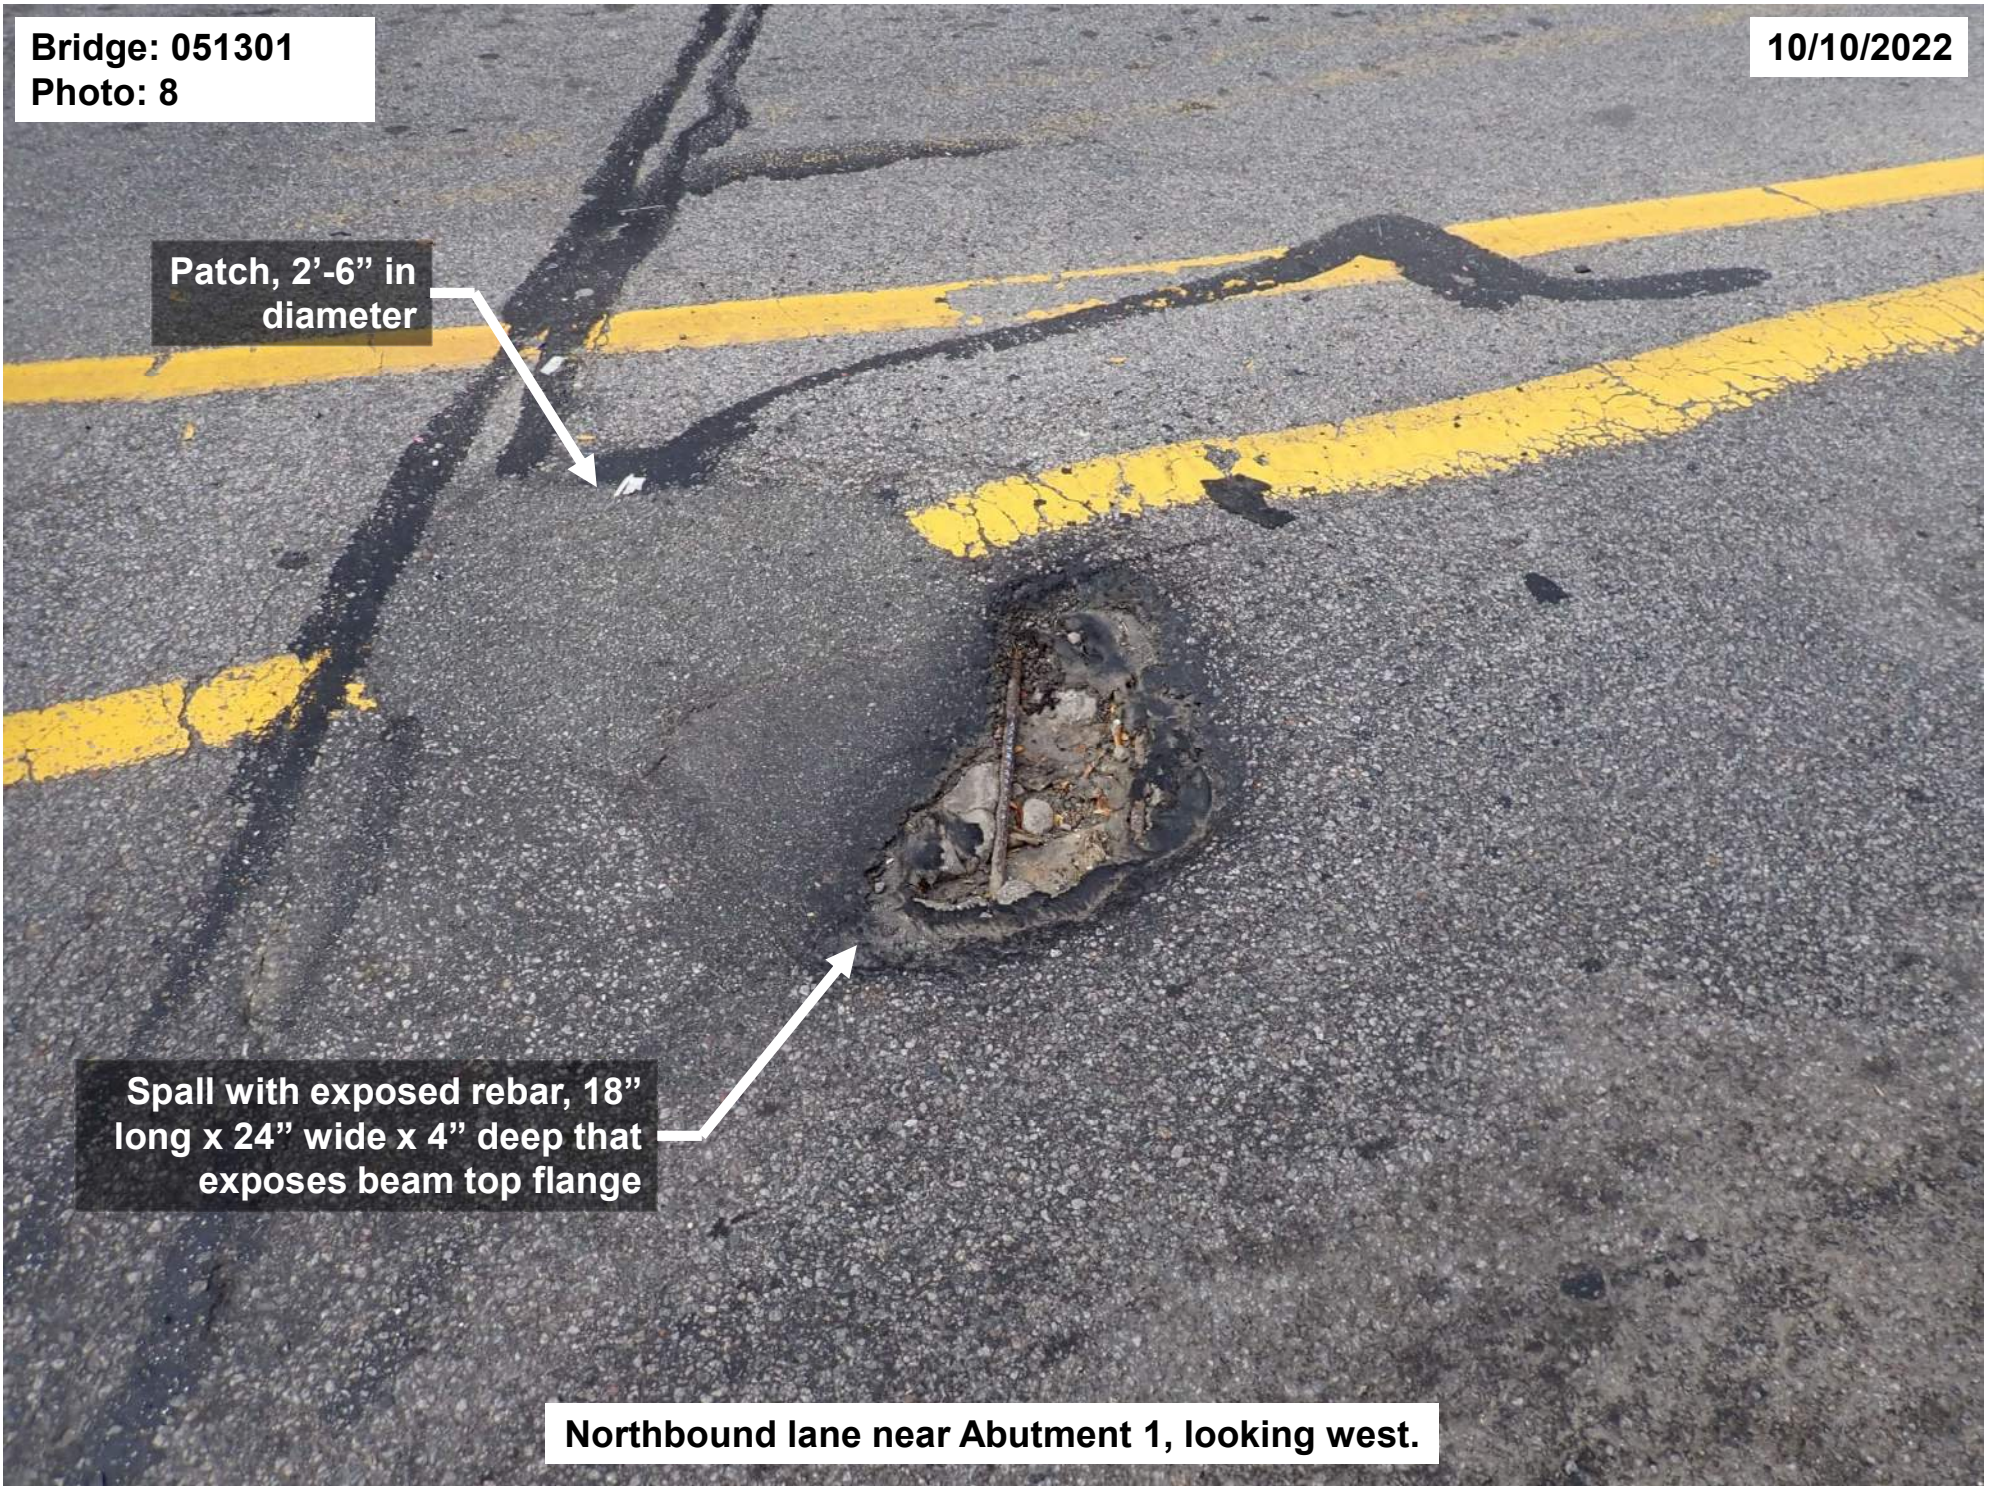
**Bridge: 051301**  
**Photo: 9**

**(Areas of graffiti and scattered vertical and horizontal hairline cracks with and without edge chipping)**

**West bridge railing, looking southwest.**

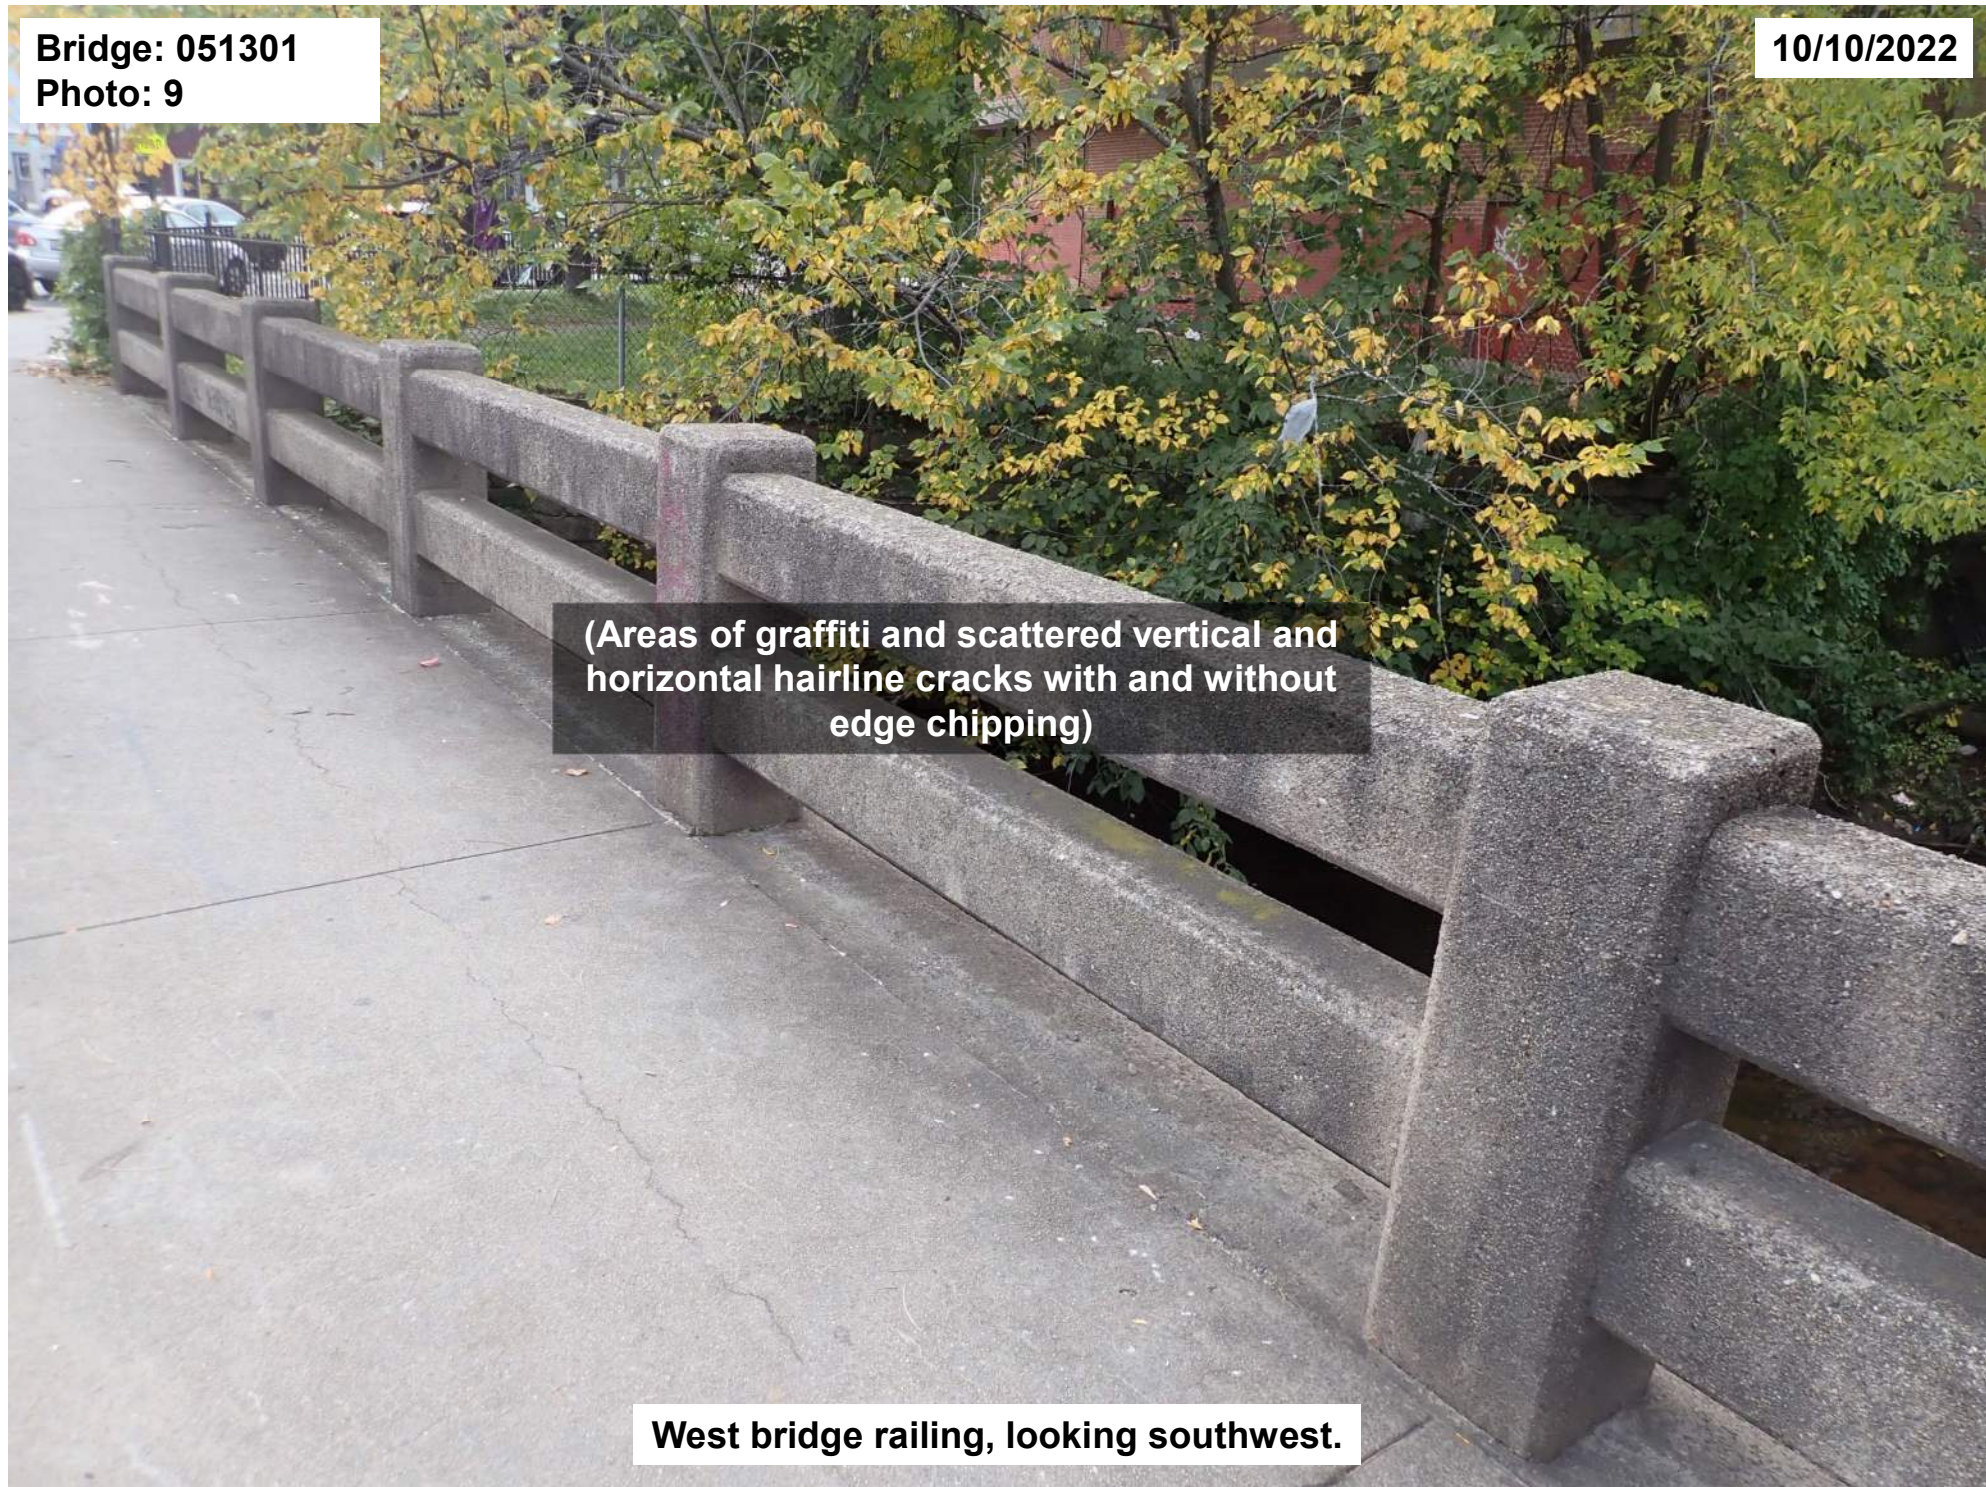
Bridge: 051301  
Photo: 10

Spall with exposed rebar, 6" long  
x 2-1/2" high x 1" deep

West bridge railing at the south end, looking south.

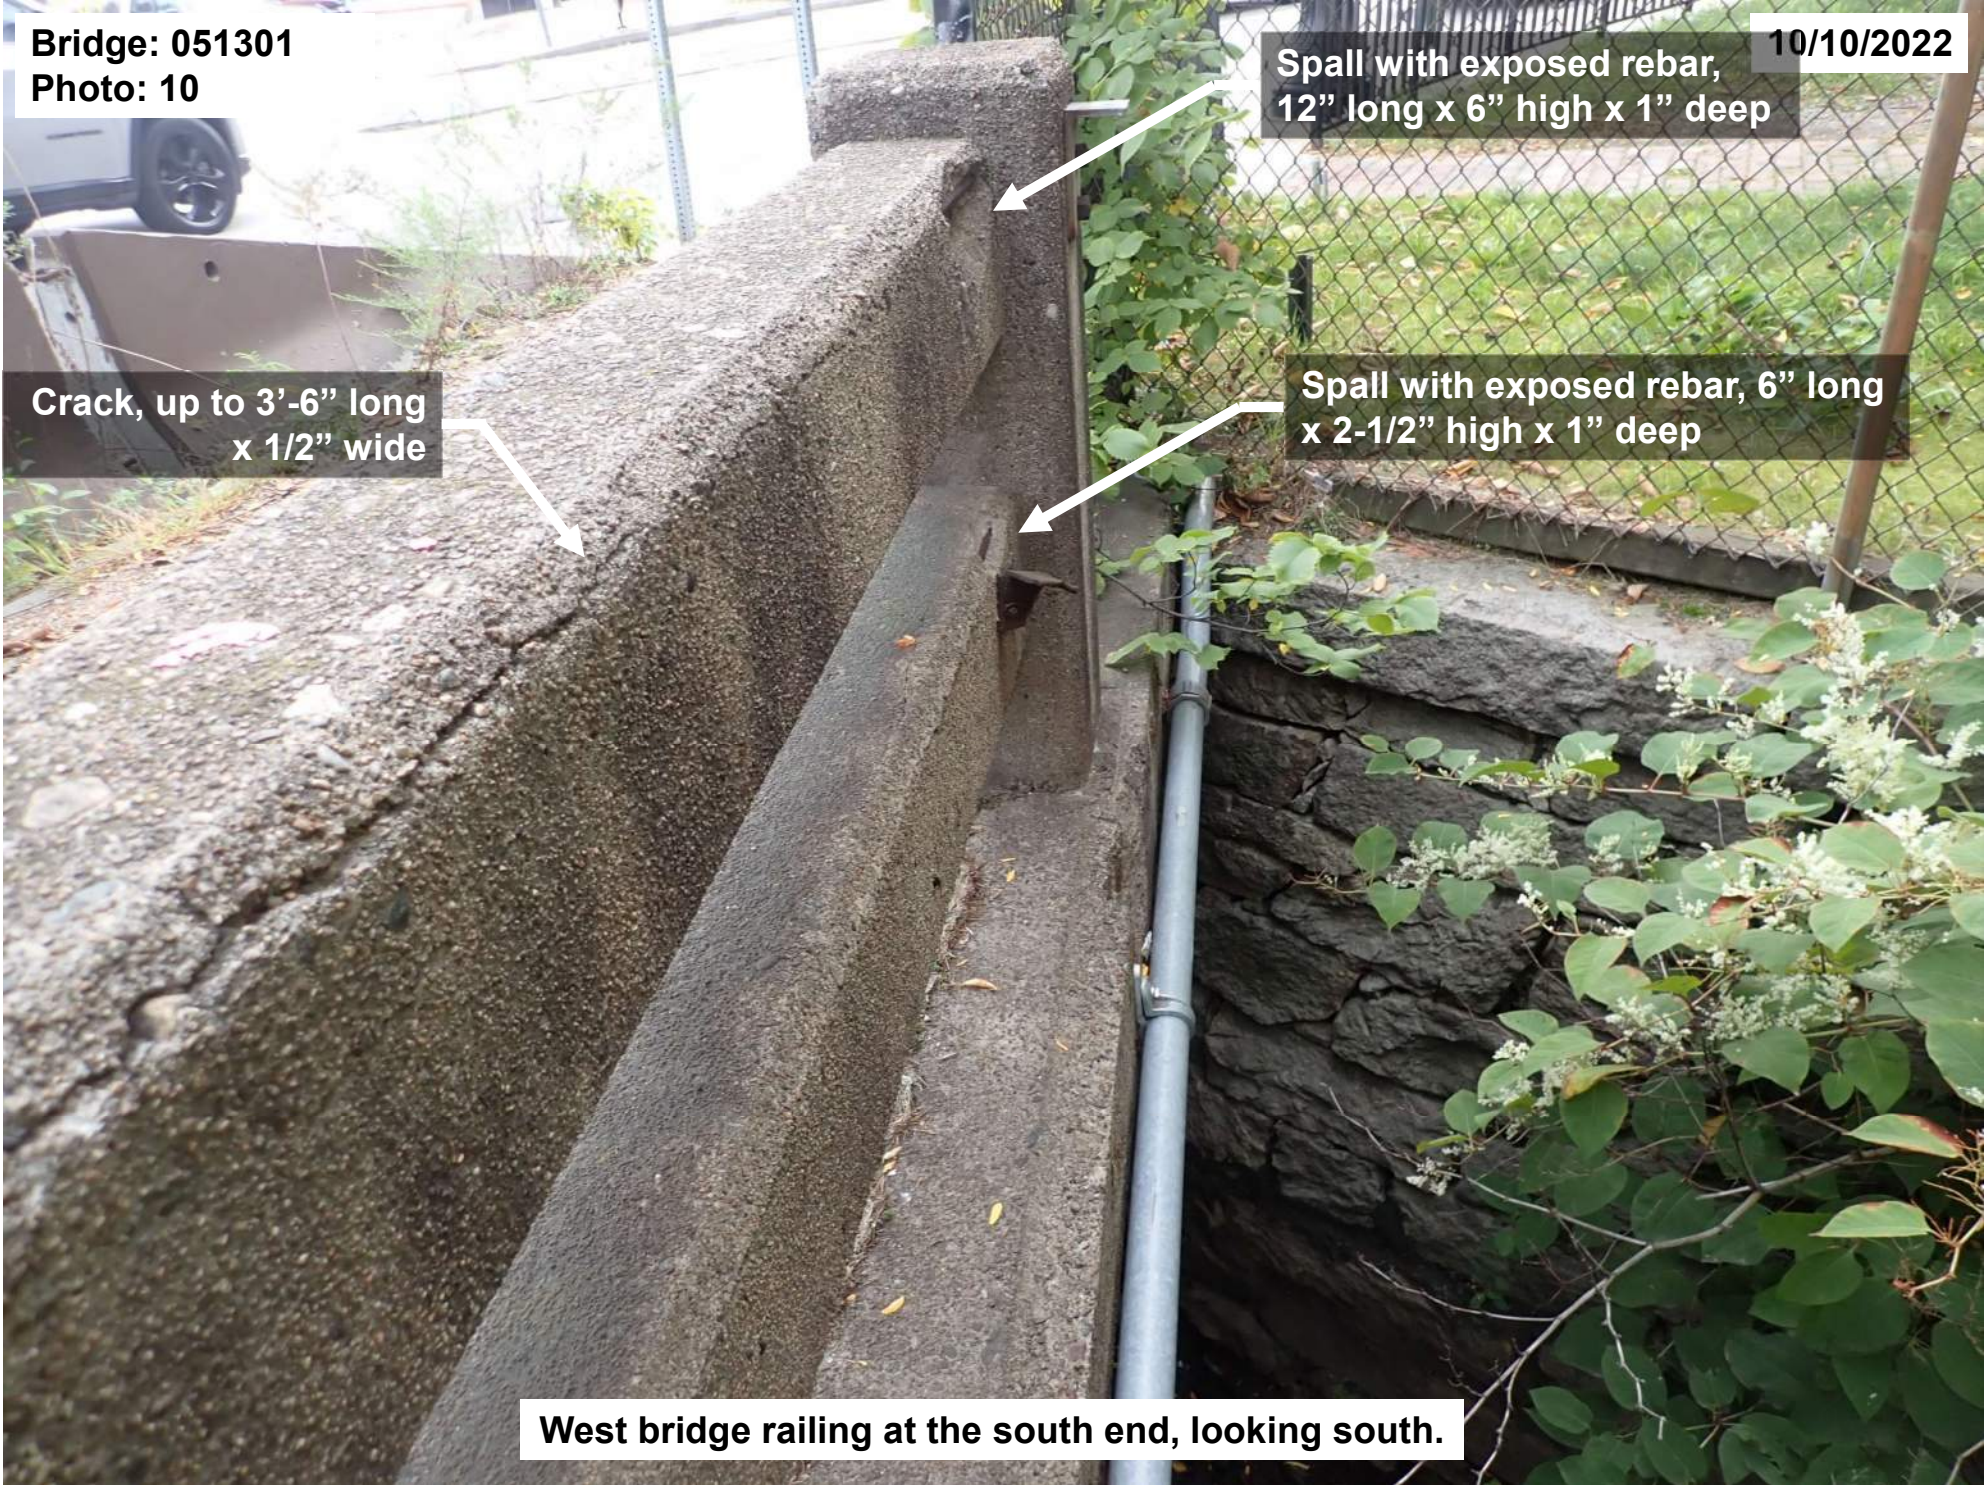
Bridge: 051301  
Photo: 11

Spall with exposed rebar,  
7" long x 3" high x 1" deep

East bridge railing at the north end, looking north.

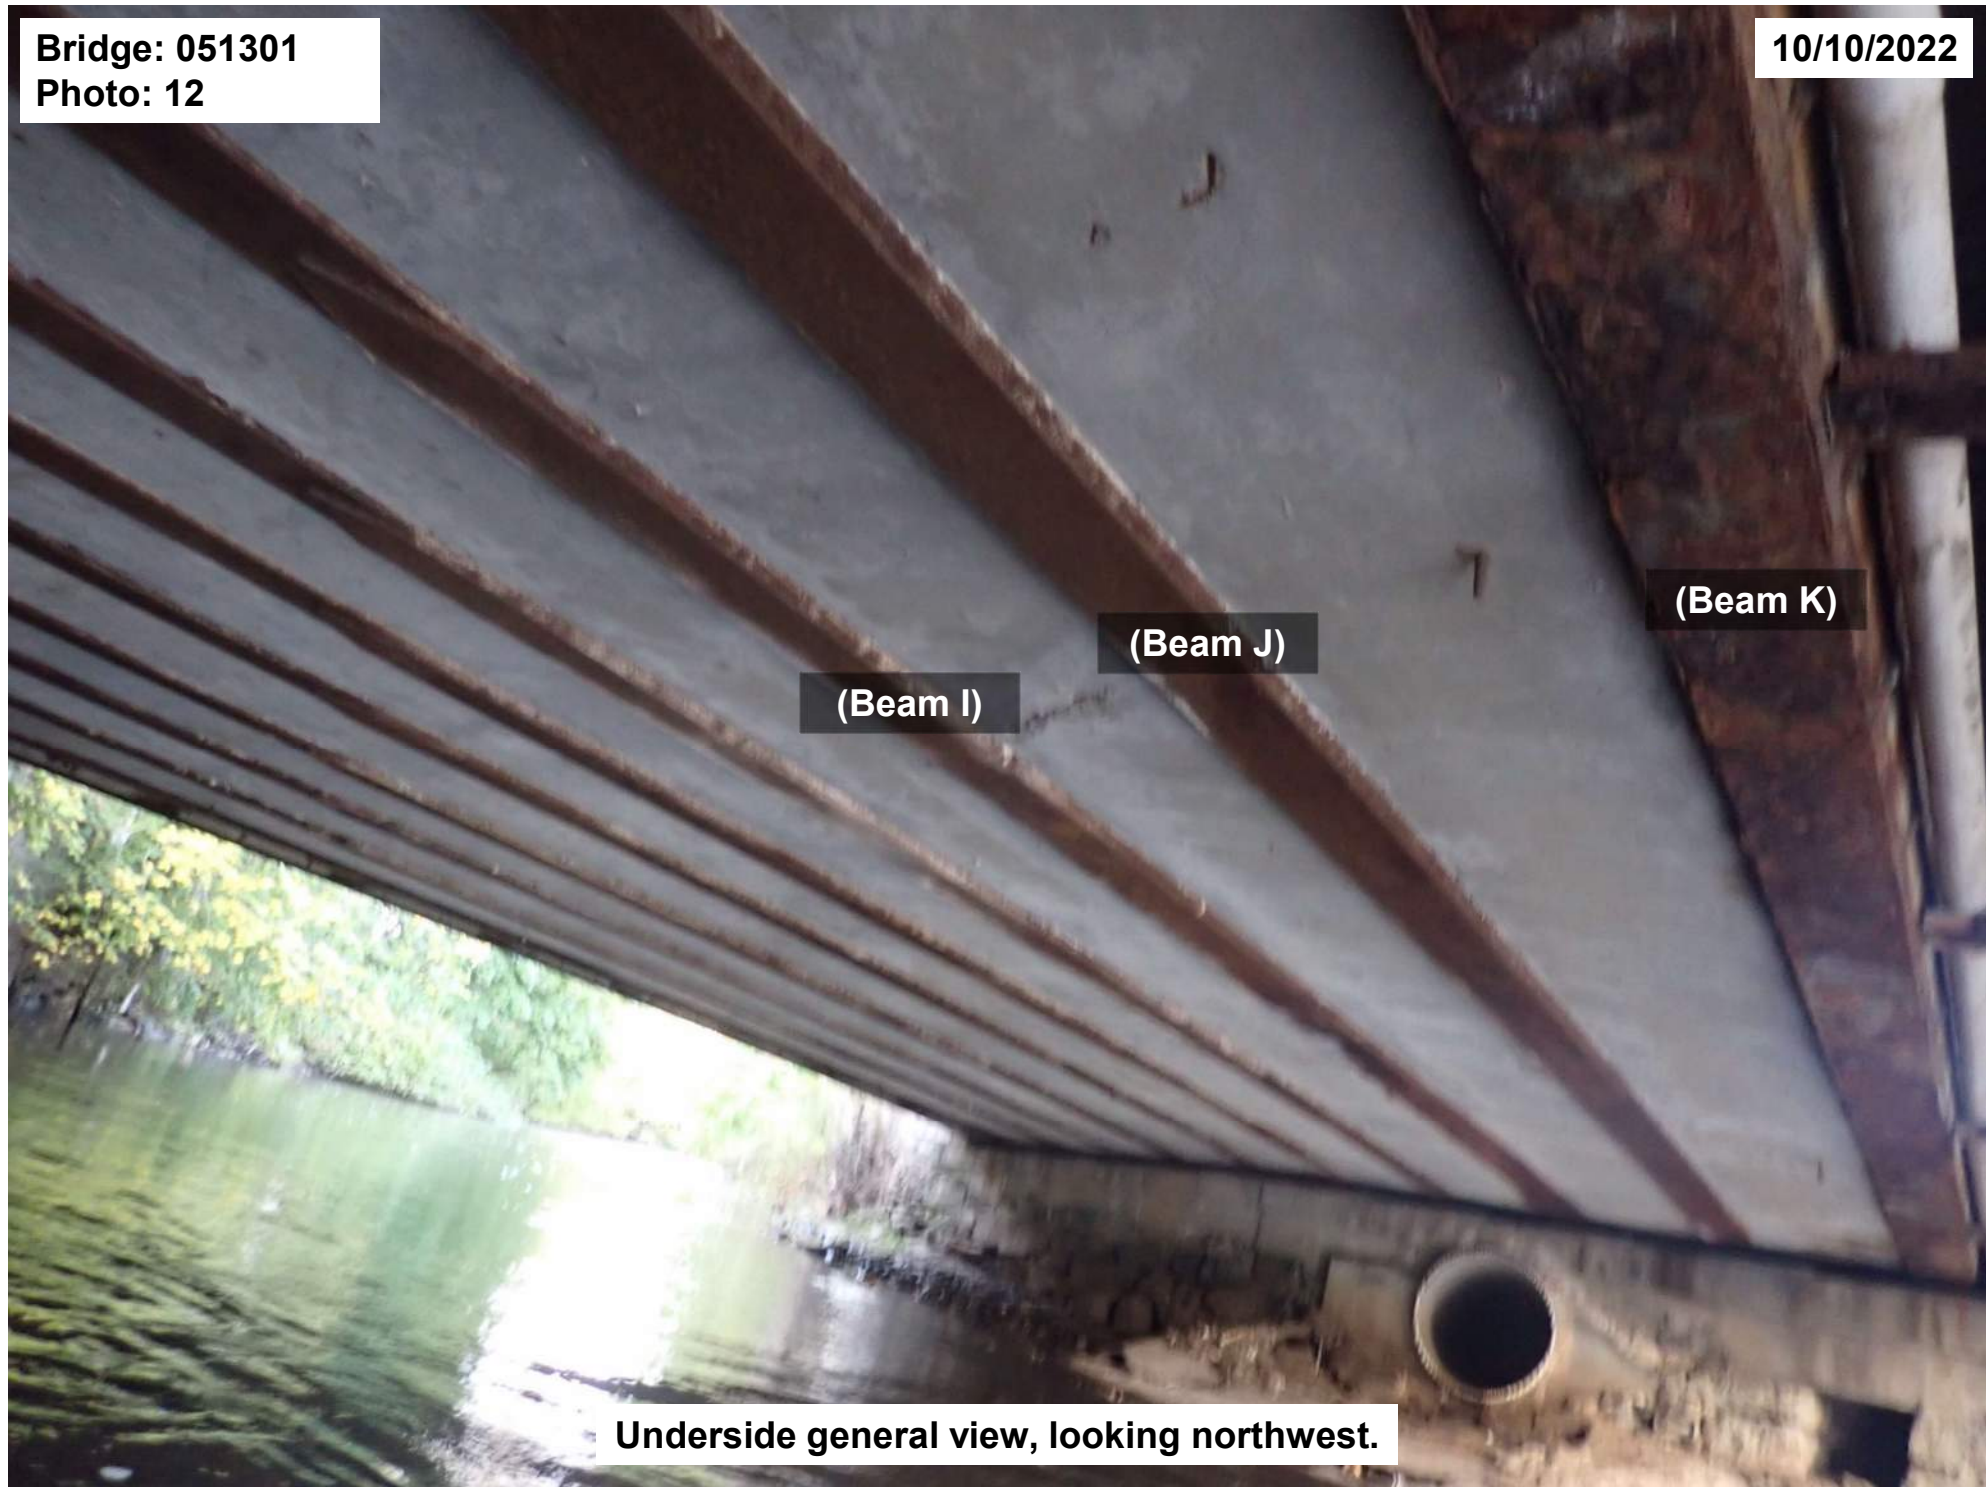
Bridge: 051301  
Photo: 13

(Beam K)

Underside general view, looking northwest.

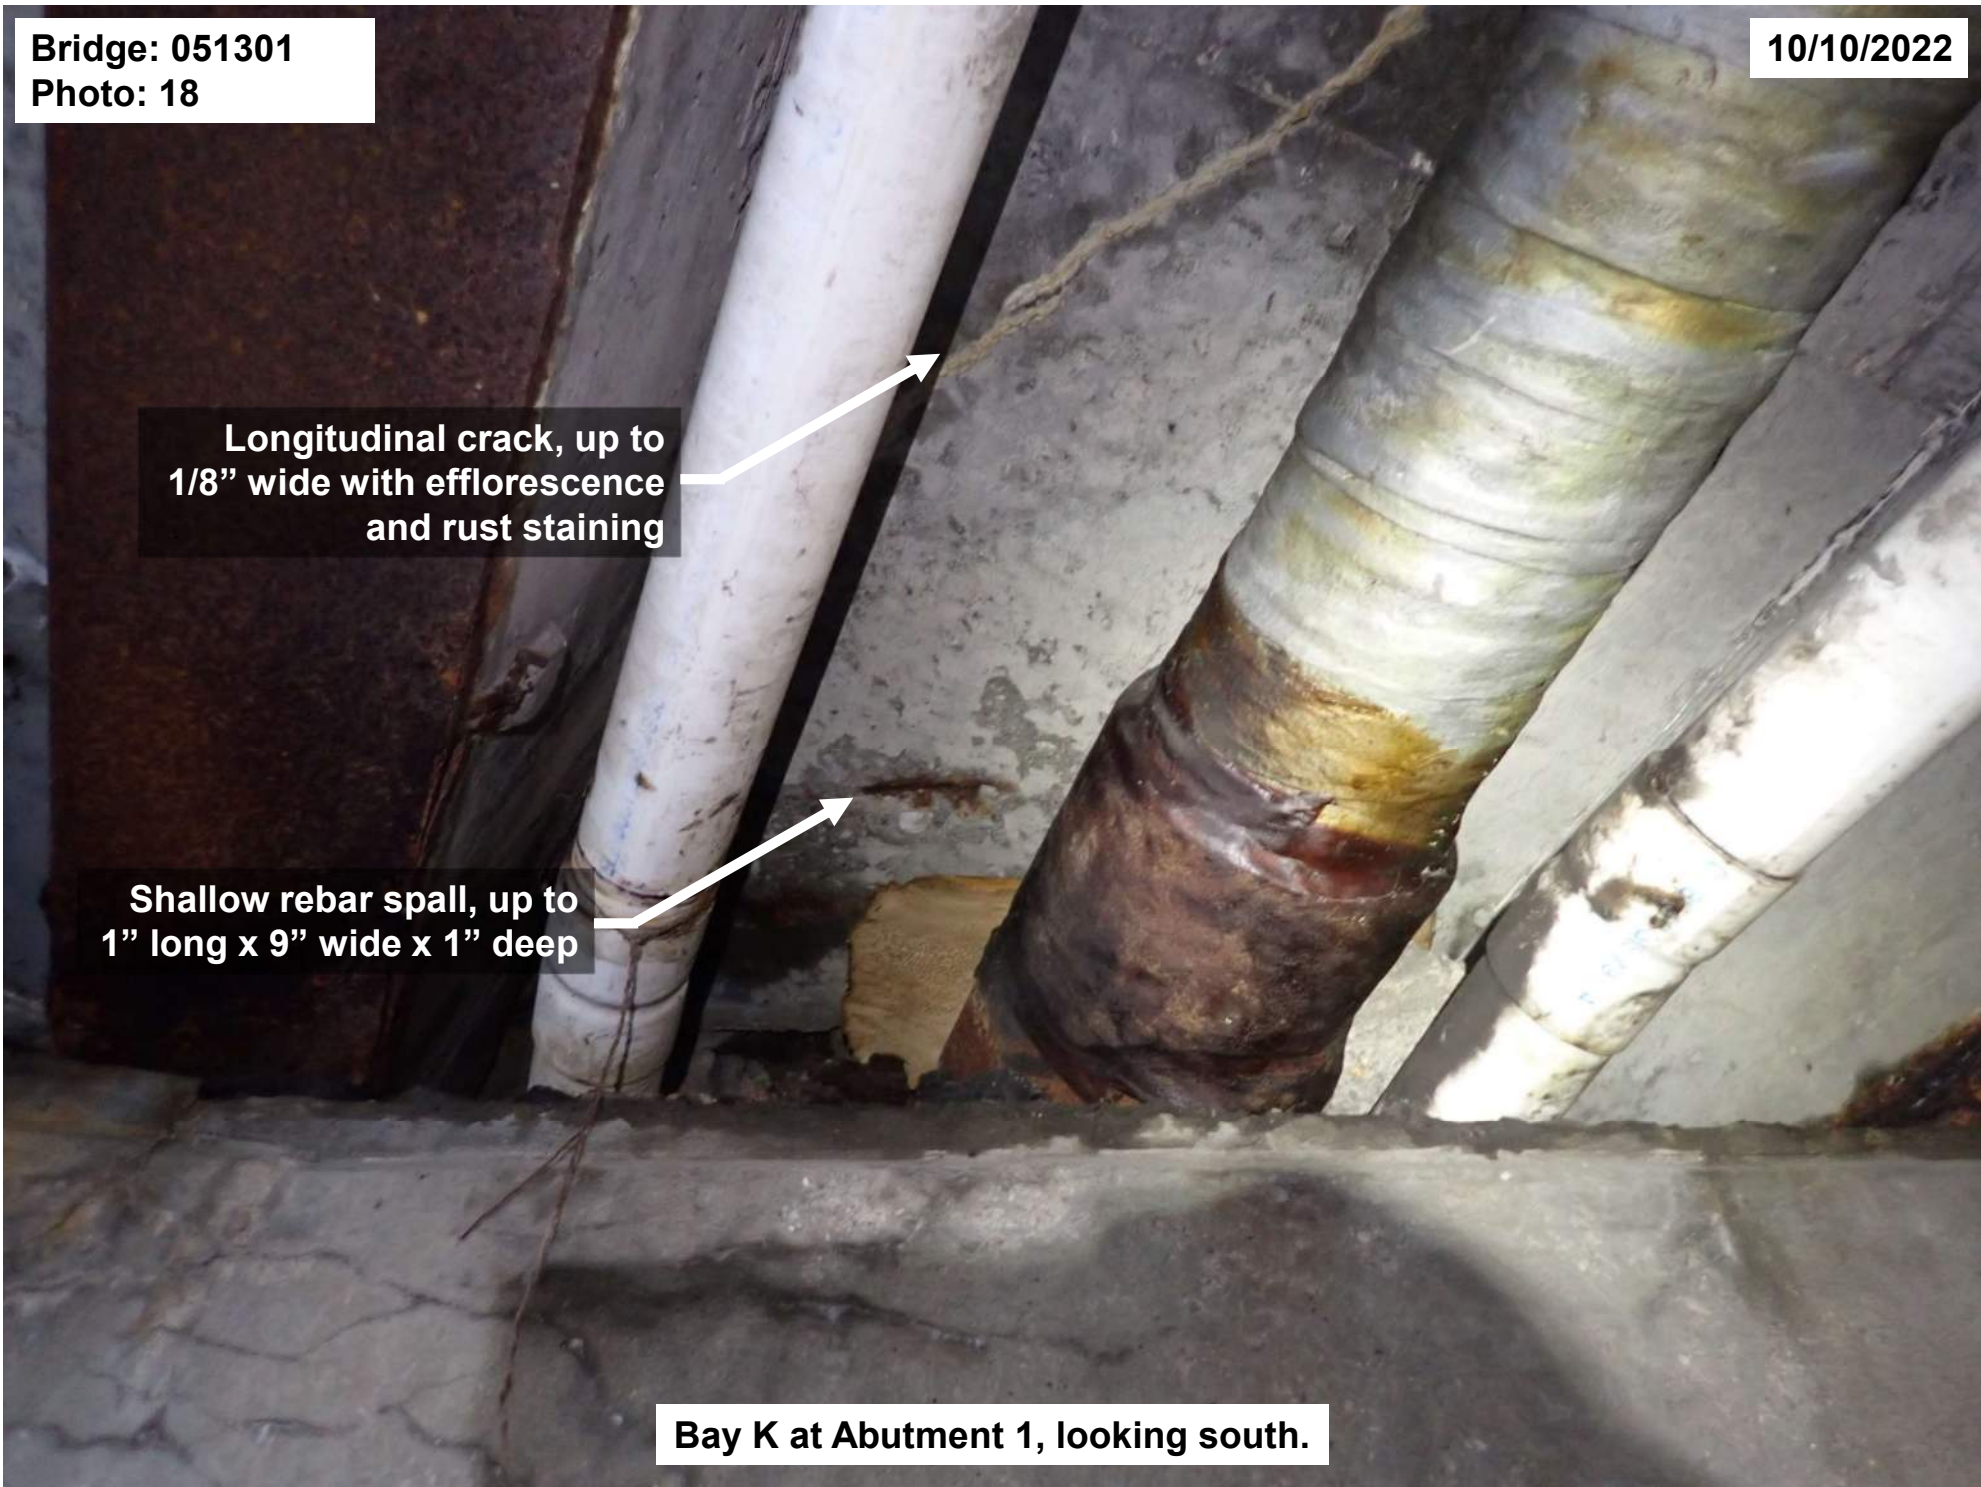
Bridge: 051301  
Photo: 19

Shallow rebar spall, up to  
1" long x 9" wide x 1" deep

Bay K at Abutment 1, looking south.
