**BOARD OF CONTRACT AND SUPPLY  
CITY OF PROVIDENCE, RHODE ISLAND**

# REQUEST FOR QUALIFICATIONS

**Item Description:** Engineering And Design Services for Manton Ave Tar Bridge

# **Appendix A: Bridge Inspection Report**

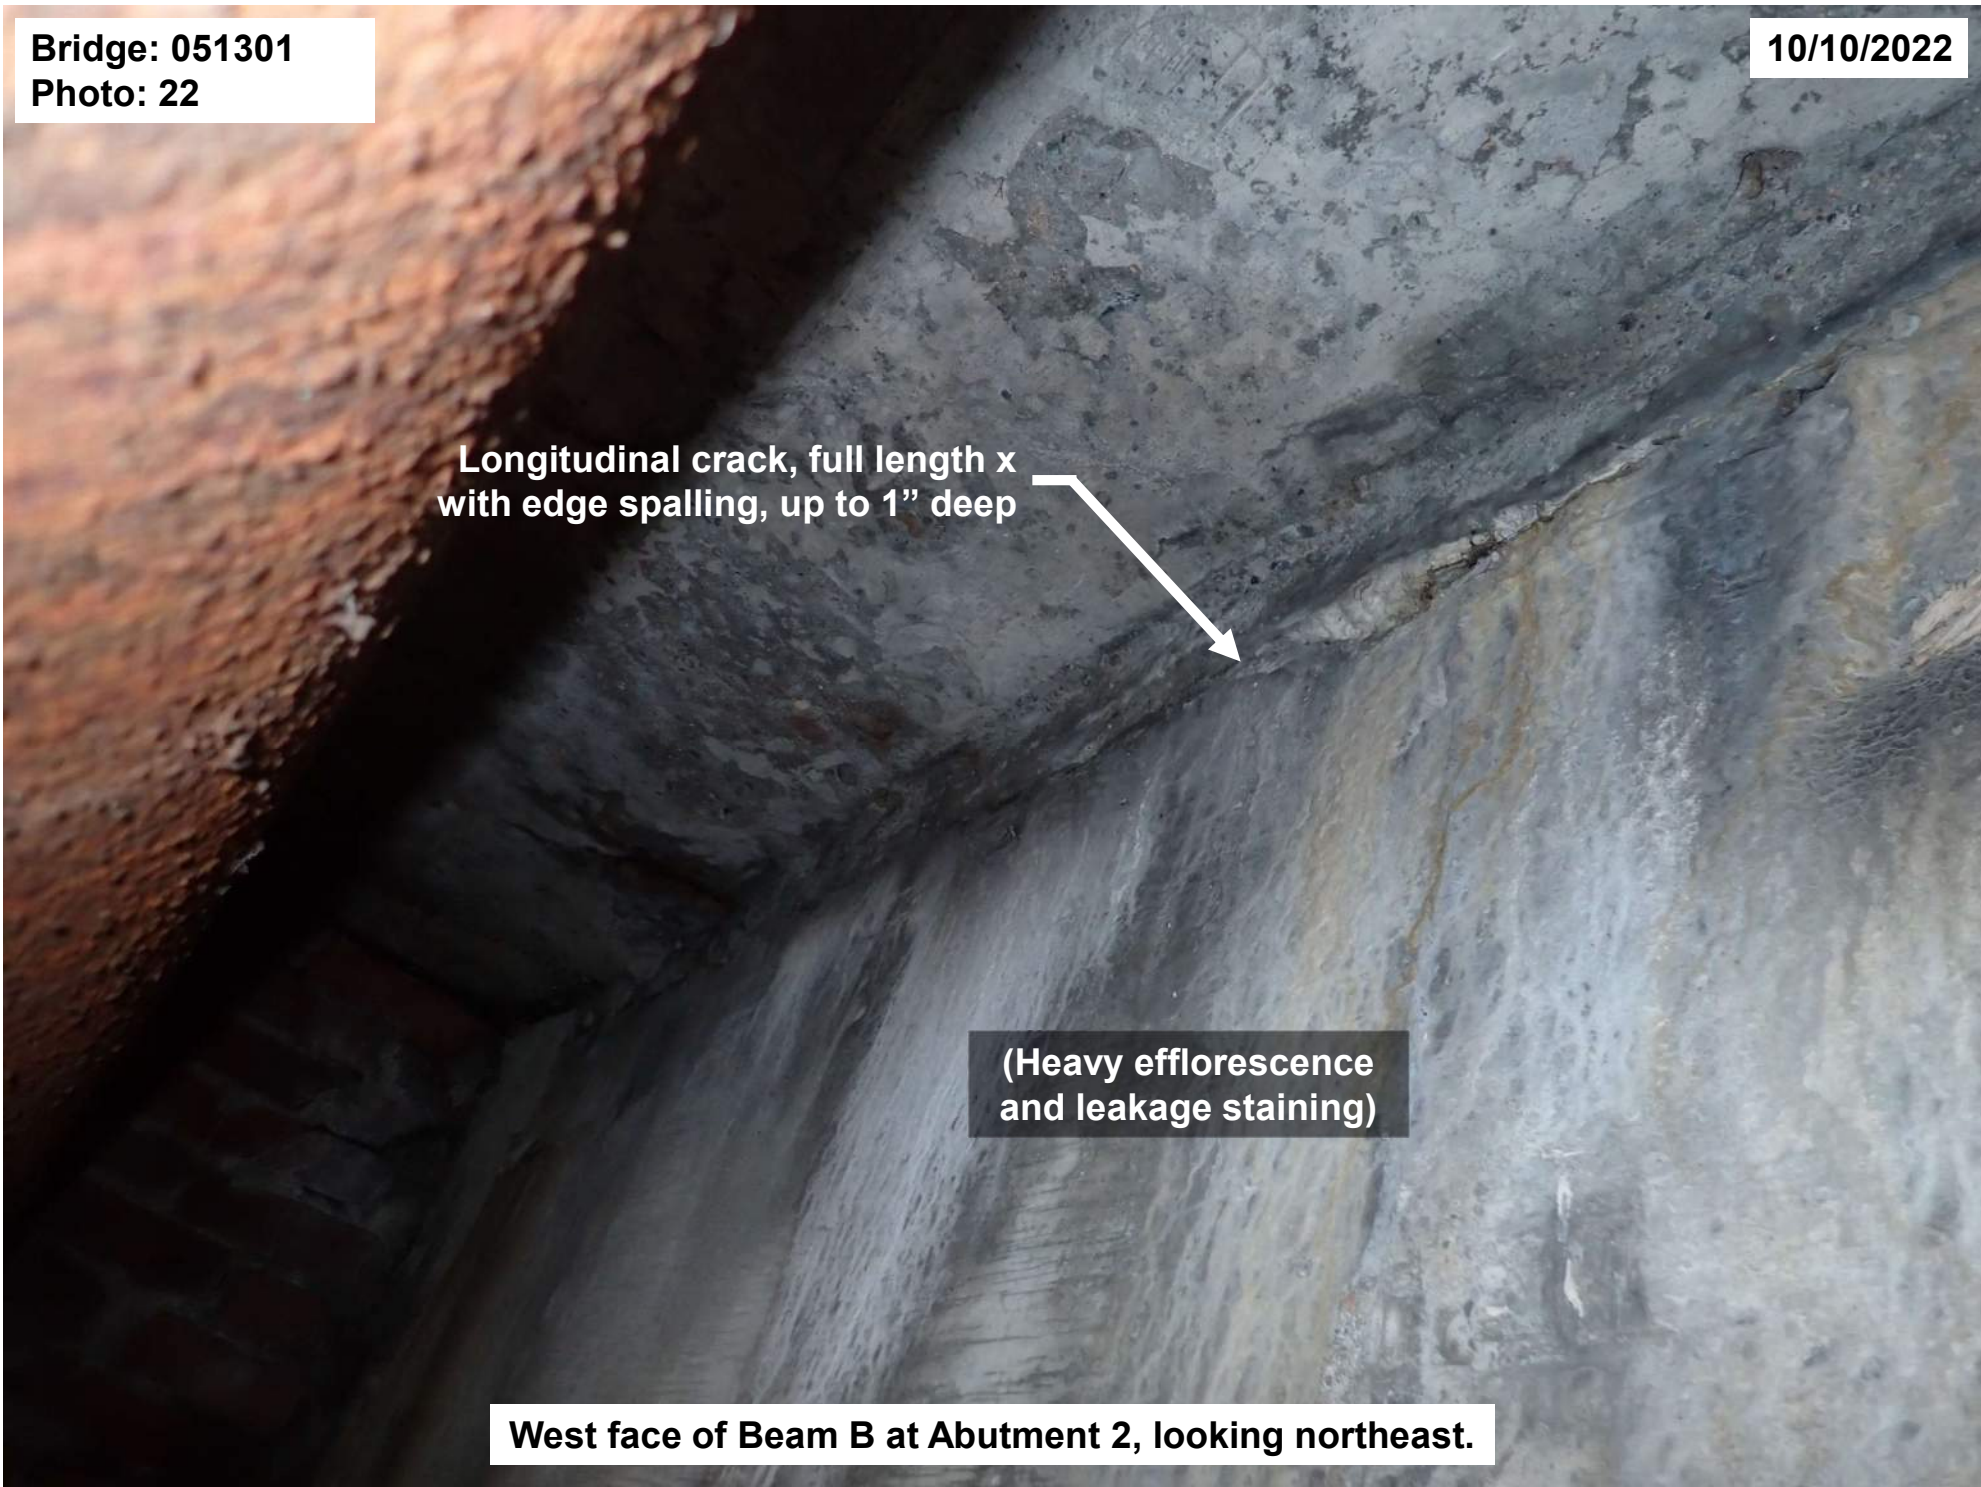
Bridge: 051301  
Photo: 23

The exposed portions of the steel beams have moderate to heavy laminated rust with section loss on the bottom flanges and cover plates measuring up to 3/16" deep (1/16" deep average) throughout (Photos 23 & 25).

The bottom flange of Beam B has heavy laminated rust with section loss measuring full-length x full-width x up to 1/8" deep (Photo 23).

(Heavy efflorescence  
and leakage staining)

West face of Beam B at Abutment 2, looking northeast.

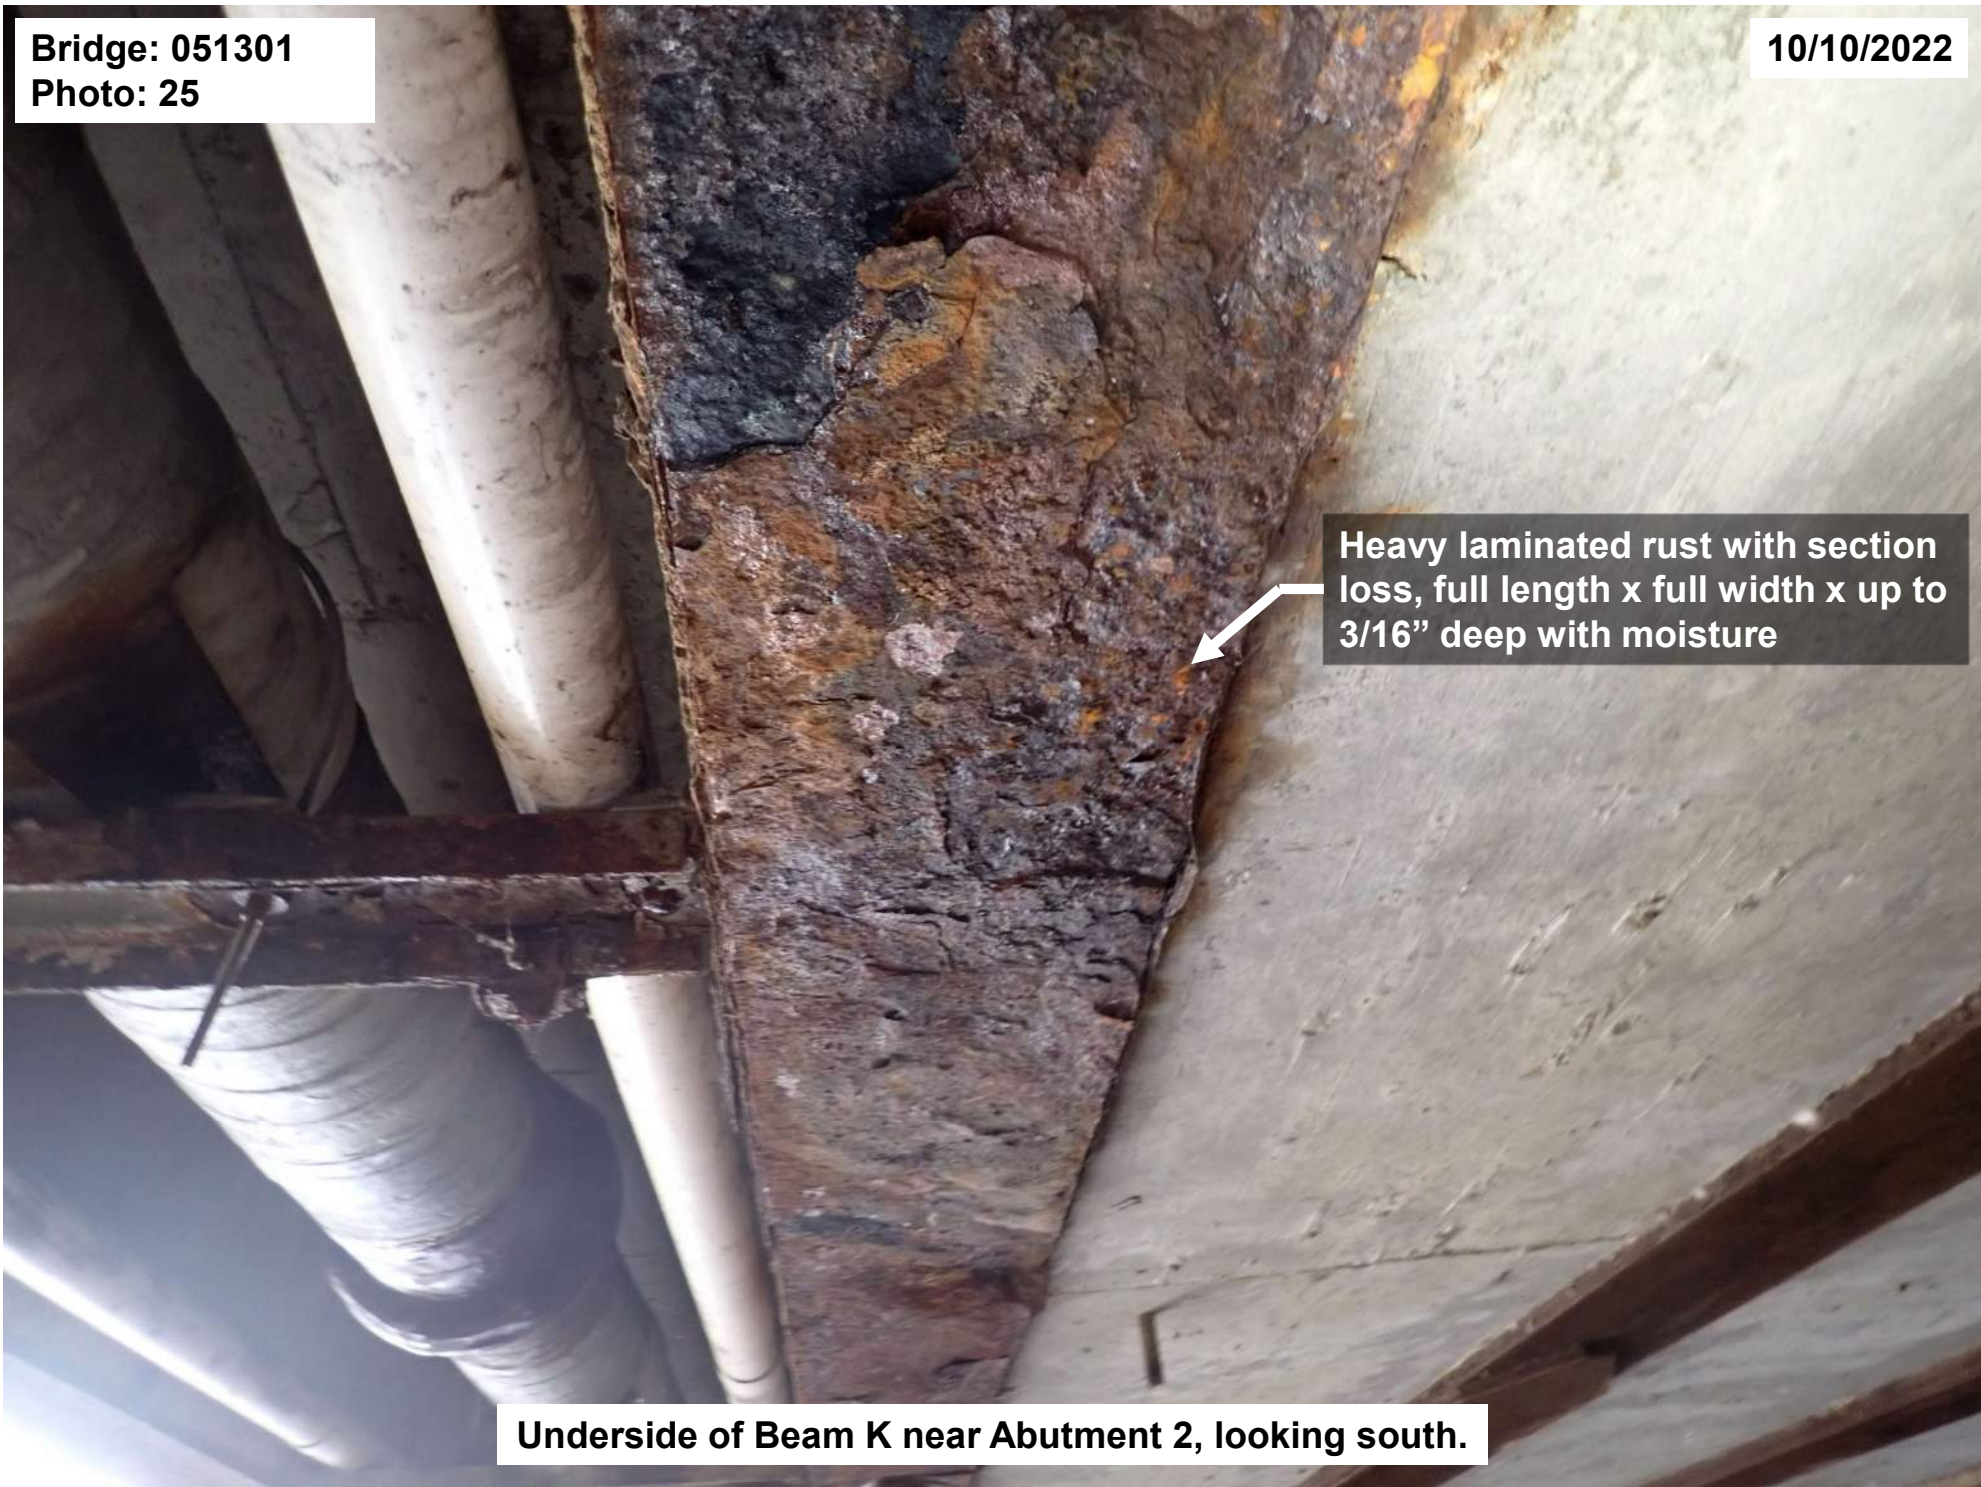
Bridge: 051301  
Photo: 26

(Scaling and  
efflorescence)

East face of Beam L at Abutment 1, looking west.

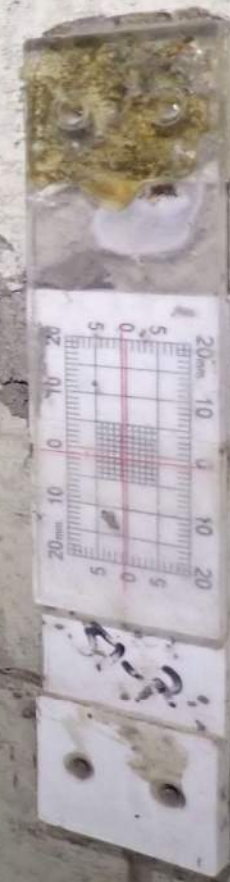
Bridge: 051301  
Photo: 28

The superstructure consists of twelve (12) concrete encased rolled steel beams labeled A through L from west to east with tapered partial length cover plates. The superstructure is flared at the southeast end with a kicker beam labeled as Beam M that is attached to Beam L near Abutment 1. Beams A, K, and L are encased in concrete with exposed bottom flanges and cover plates. The remaining beams are concealed from view by concrete closure slabs with only the bottom flanges and cover plates exposed. The exposed beam bottom flanges and cover plates have laminated rust with section loss (Photos 23 & 25). The steel beam concrete encasements have the following defects: The west face of Beam M at Abutment 1 has a longitudinal crack measuring up to full-length x 1/8" wide (Photo 27). The east face of Beam M at Abutment 1 has a hollow area measuring 11" long x up to full-height, vertical cracks measuring up to full-height x 1/16" wide, and a longitudinal crack measuring full-length x up to 1/8" wide that has been partially covered by a thin concrete patch (Photo 28).

Longitudinal crack,  
full length x 1/8" wide

West face of Beam M at Abutment 1, looking northeast.

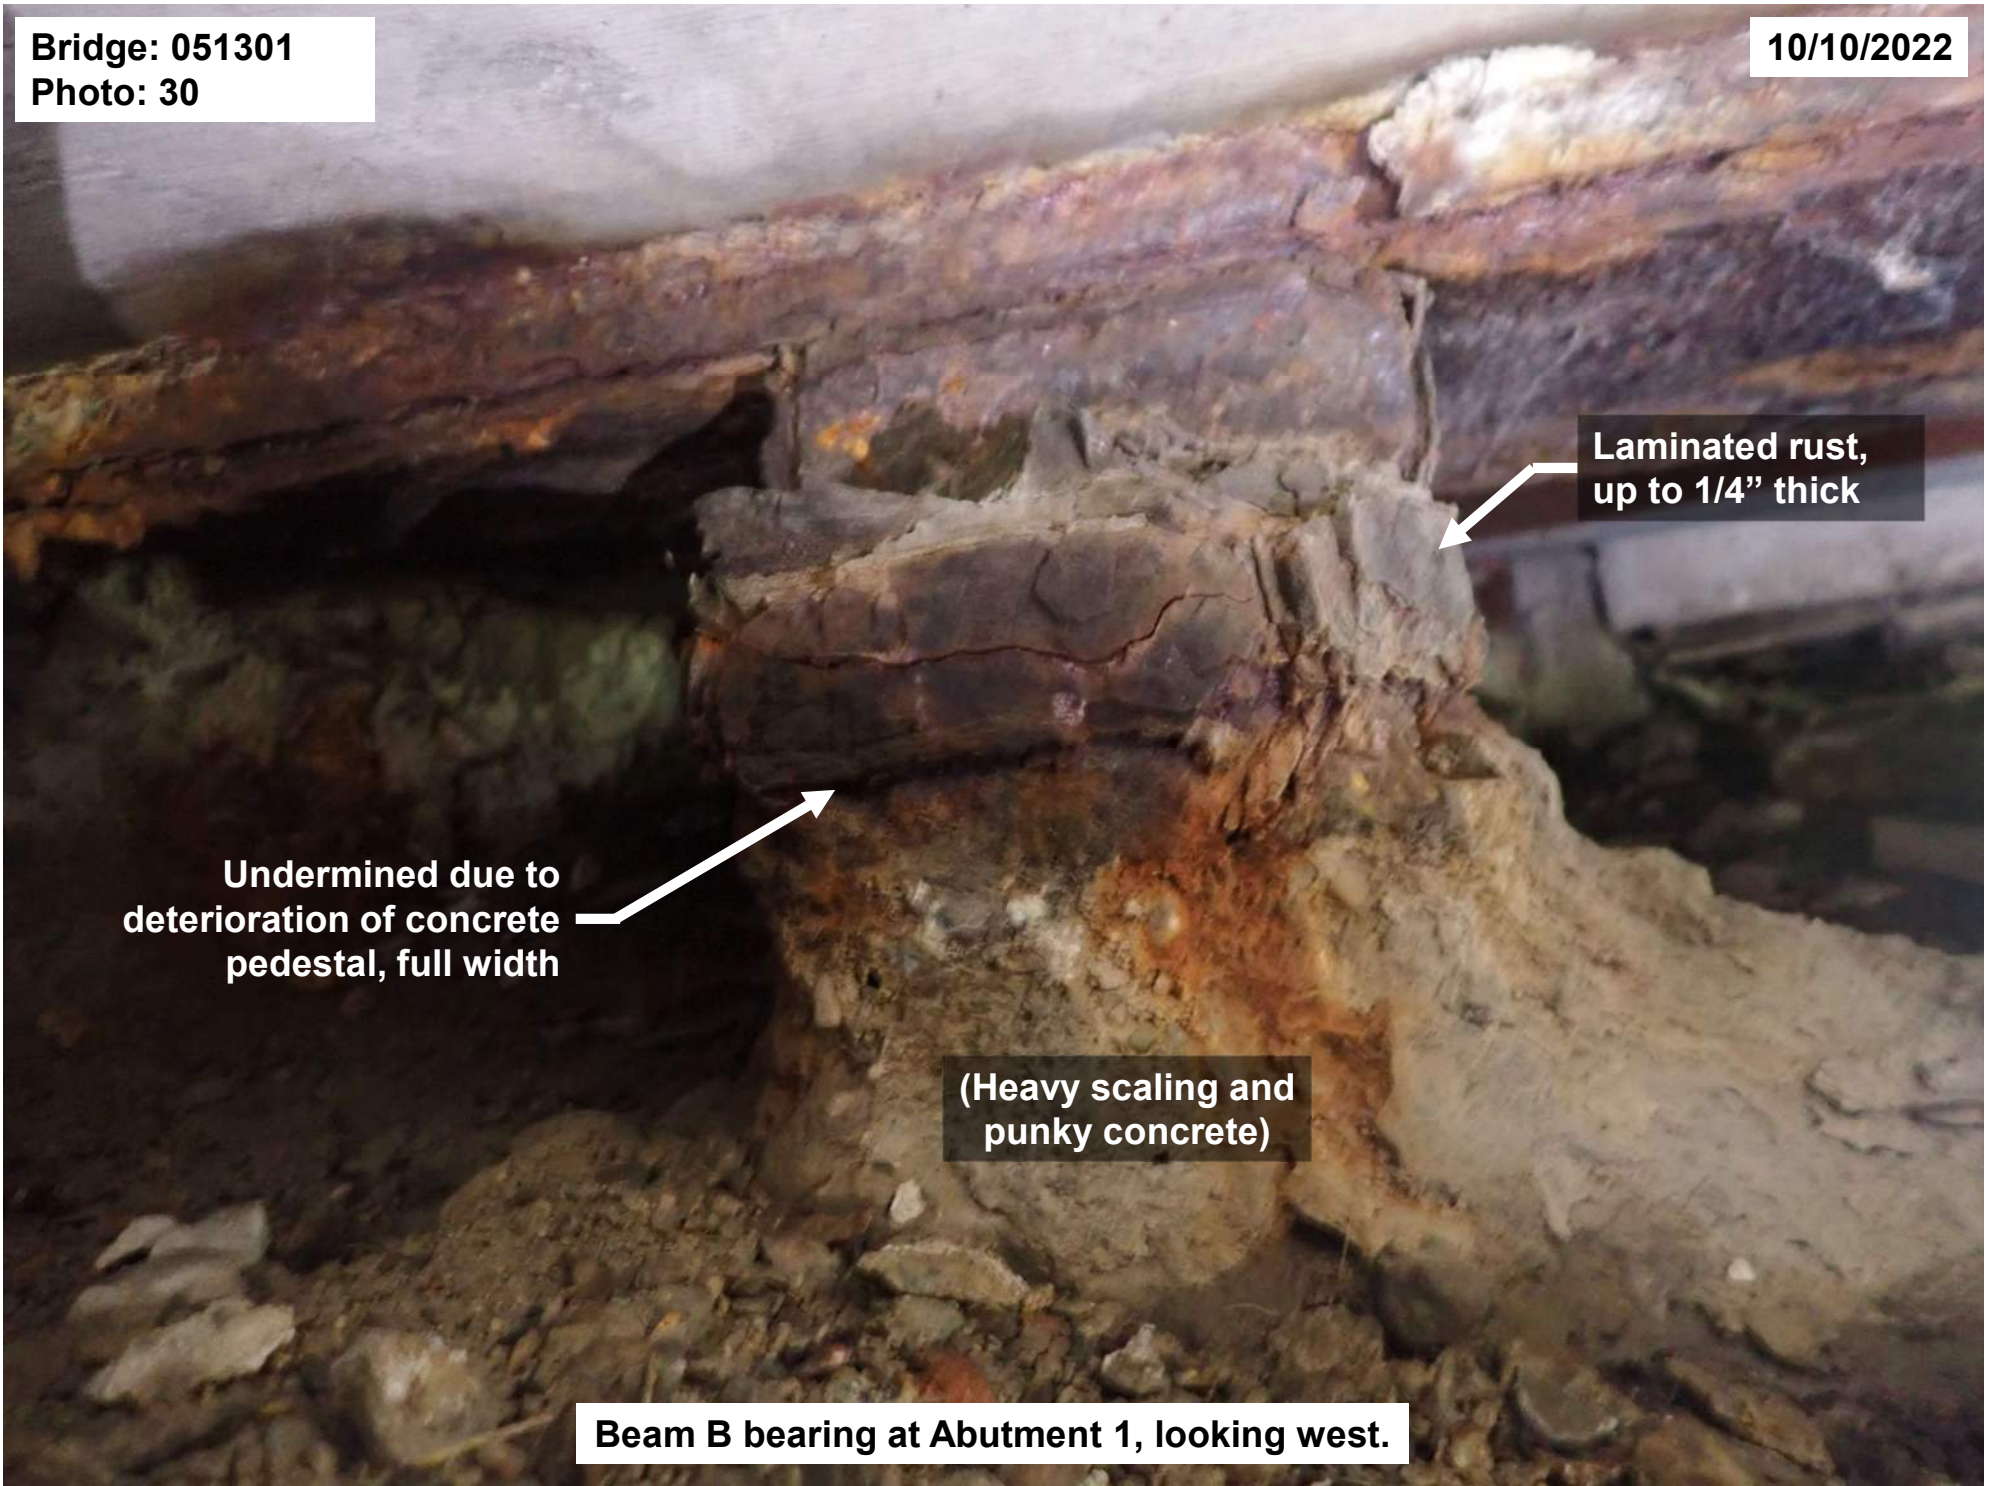
Bridge: 051301  
Photo: 31

Up to 100% anchor  
bolt section loss

Beam L bearing at Abutment 1, looking west.

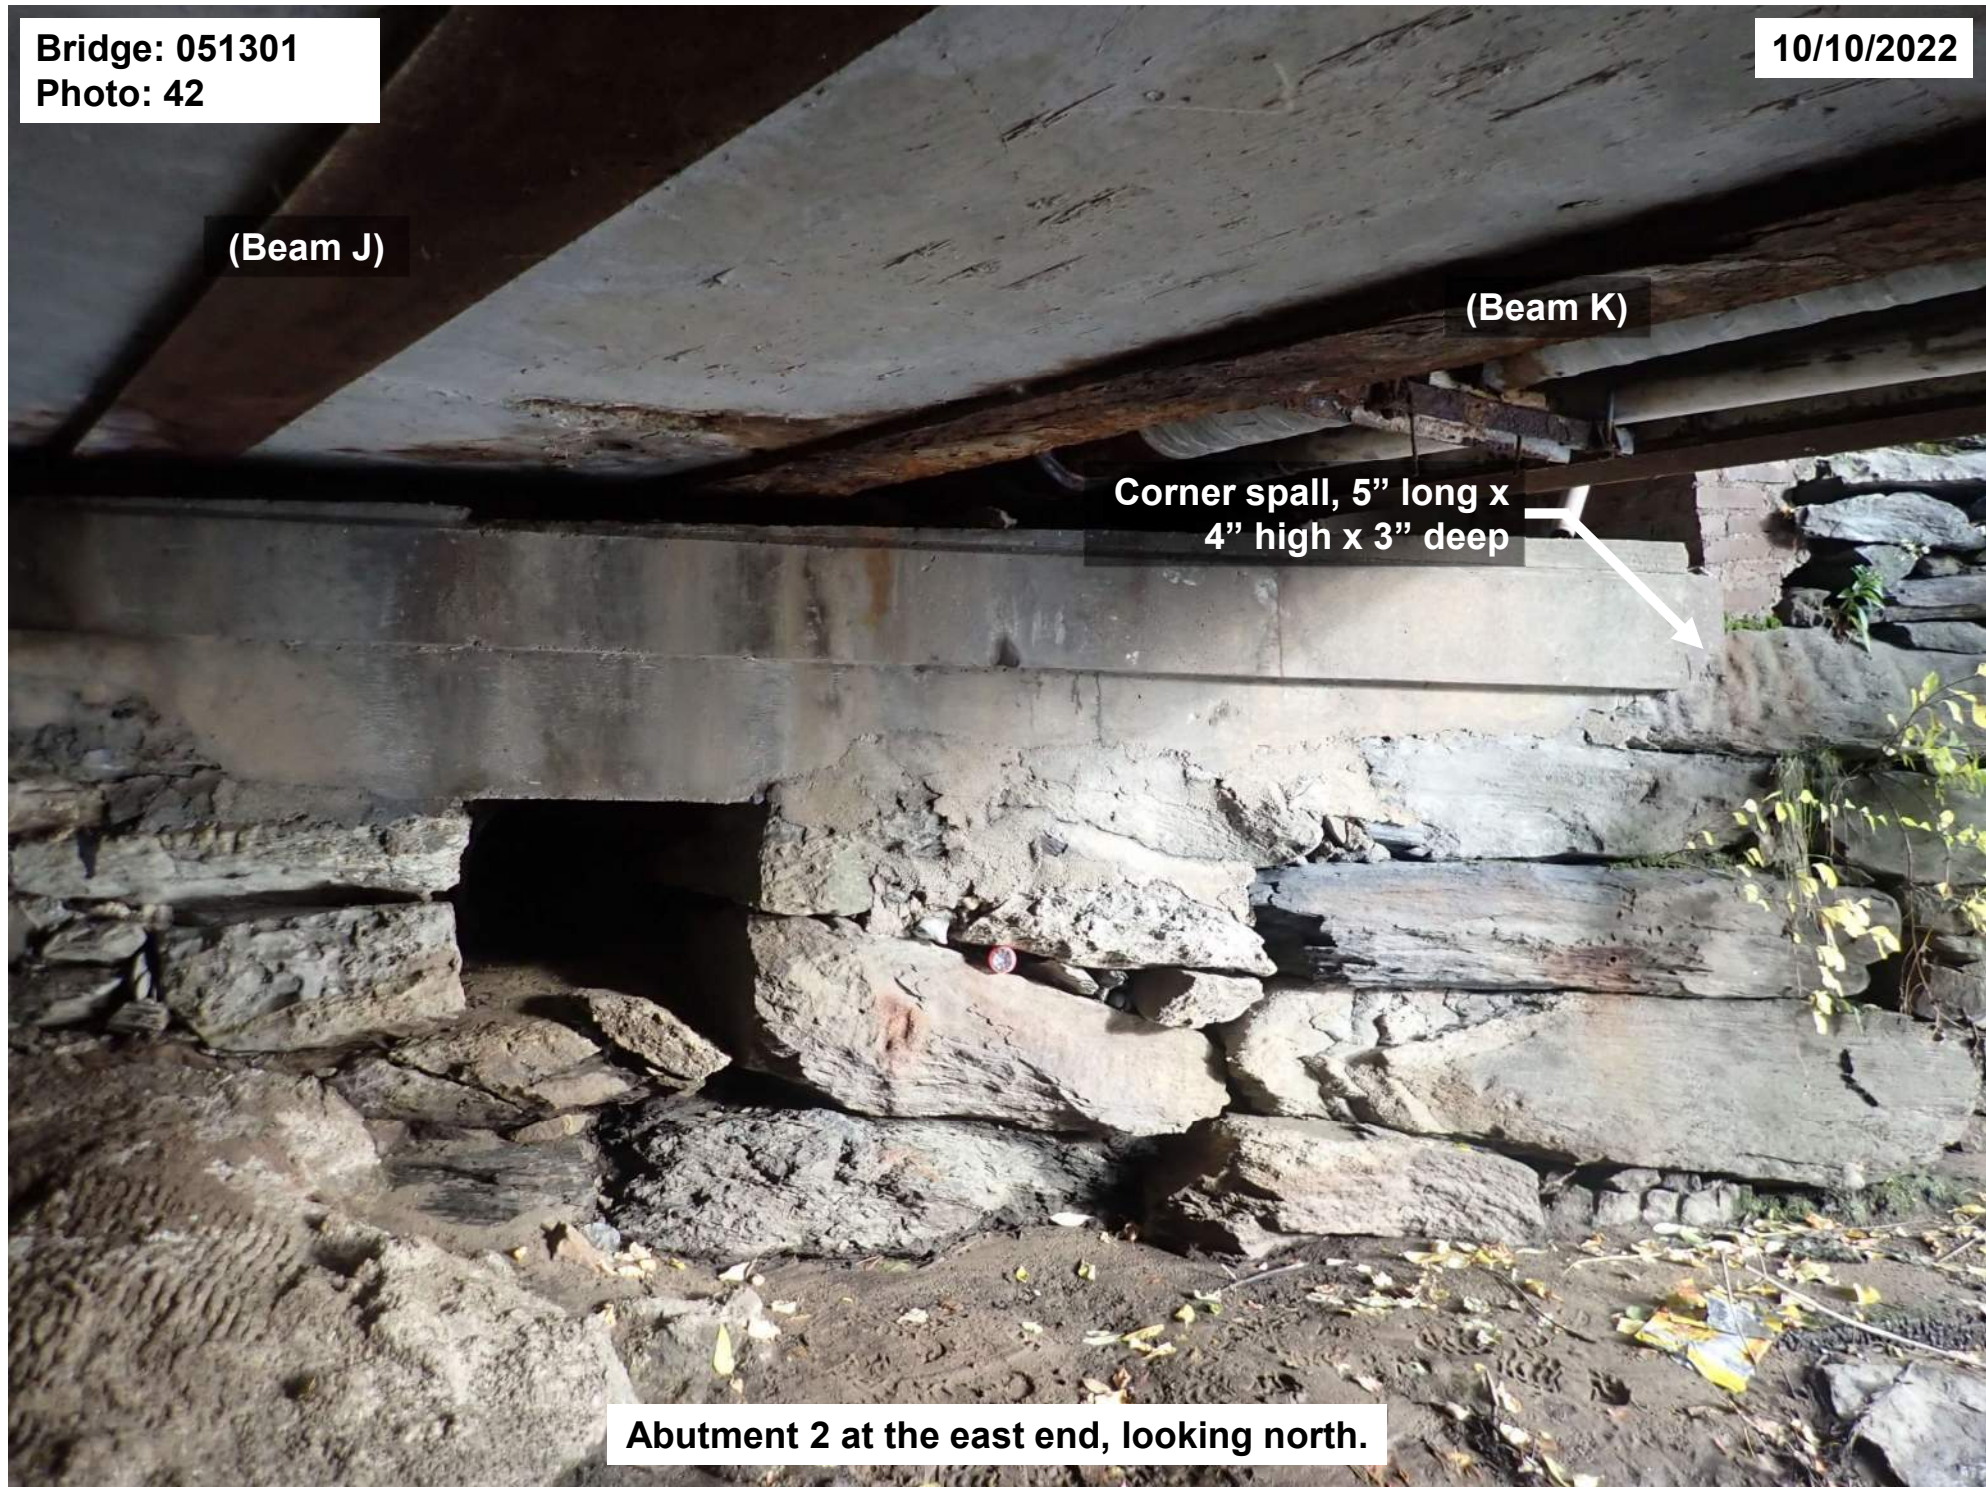
Bridge: 051301  
Photo: 43

(Hairline mapcracking  
with efflorescence  
and rust staining)

Abutment 1 backwall in Bay L, looking south.

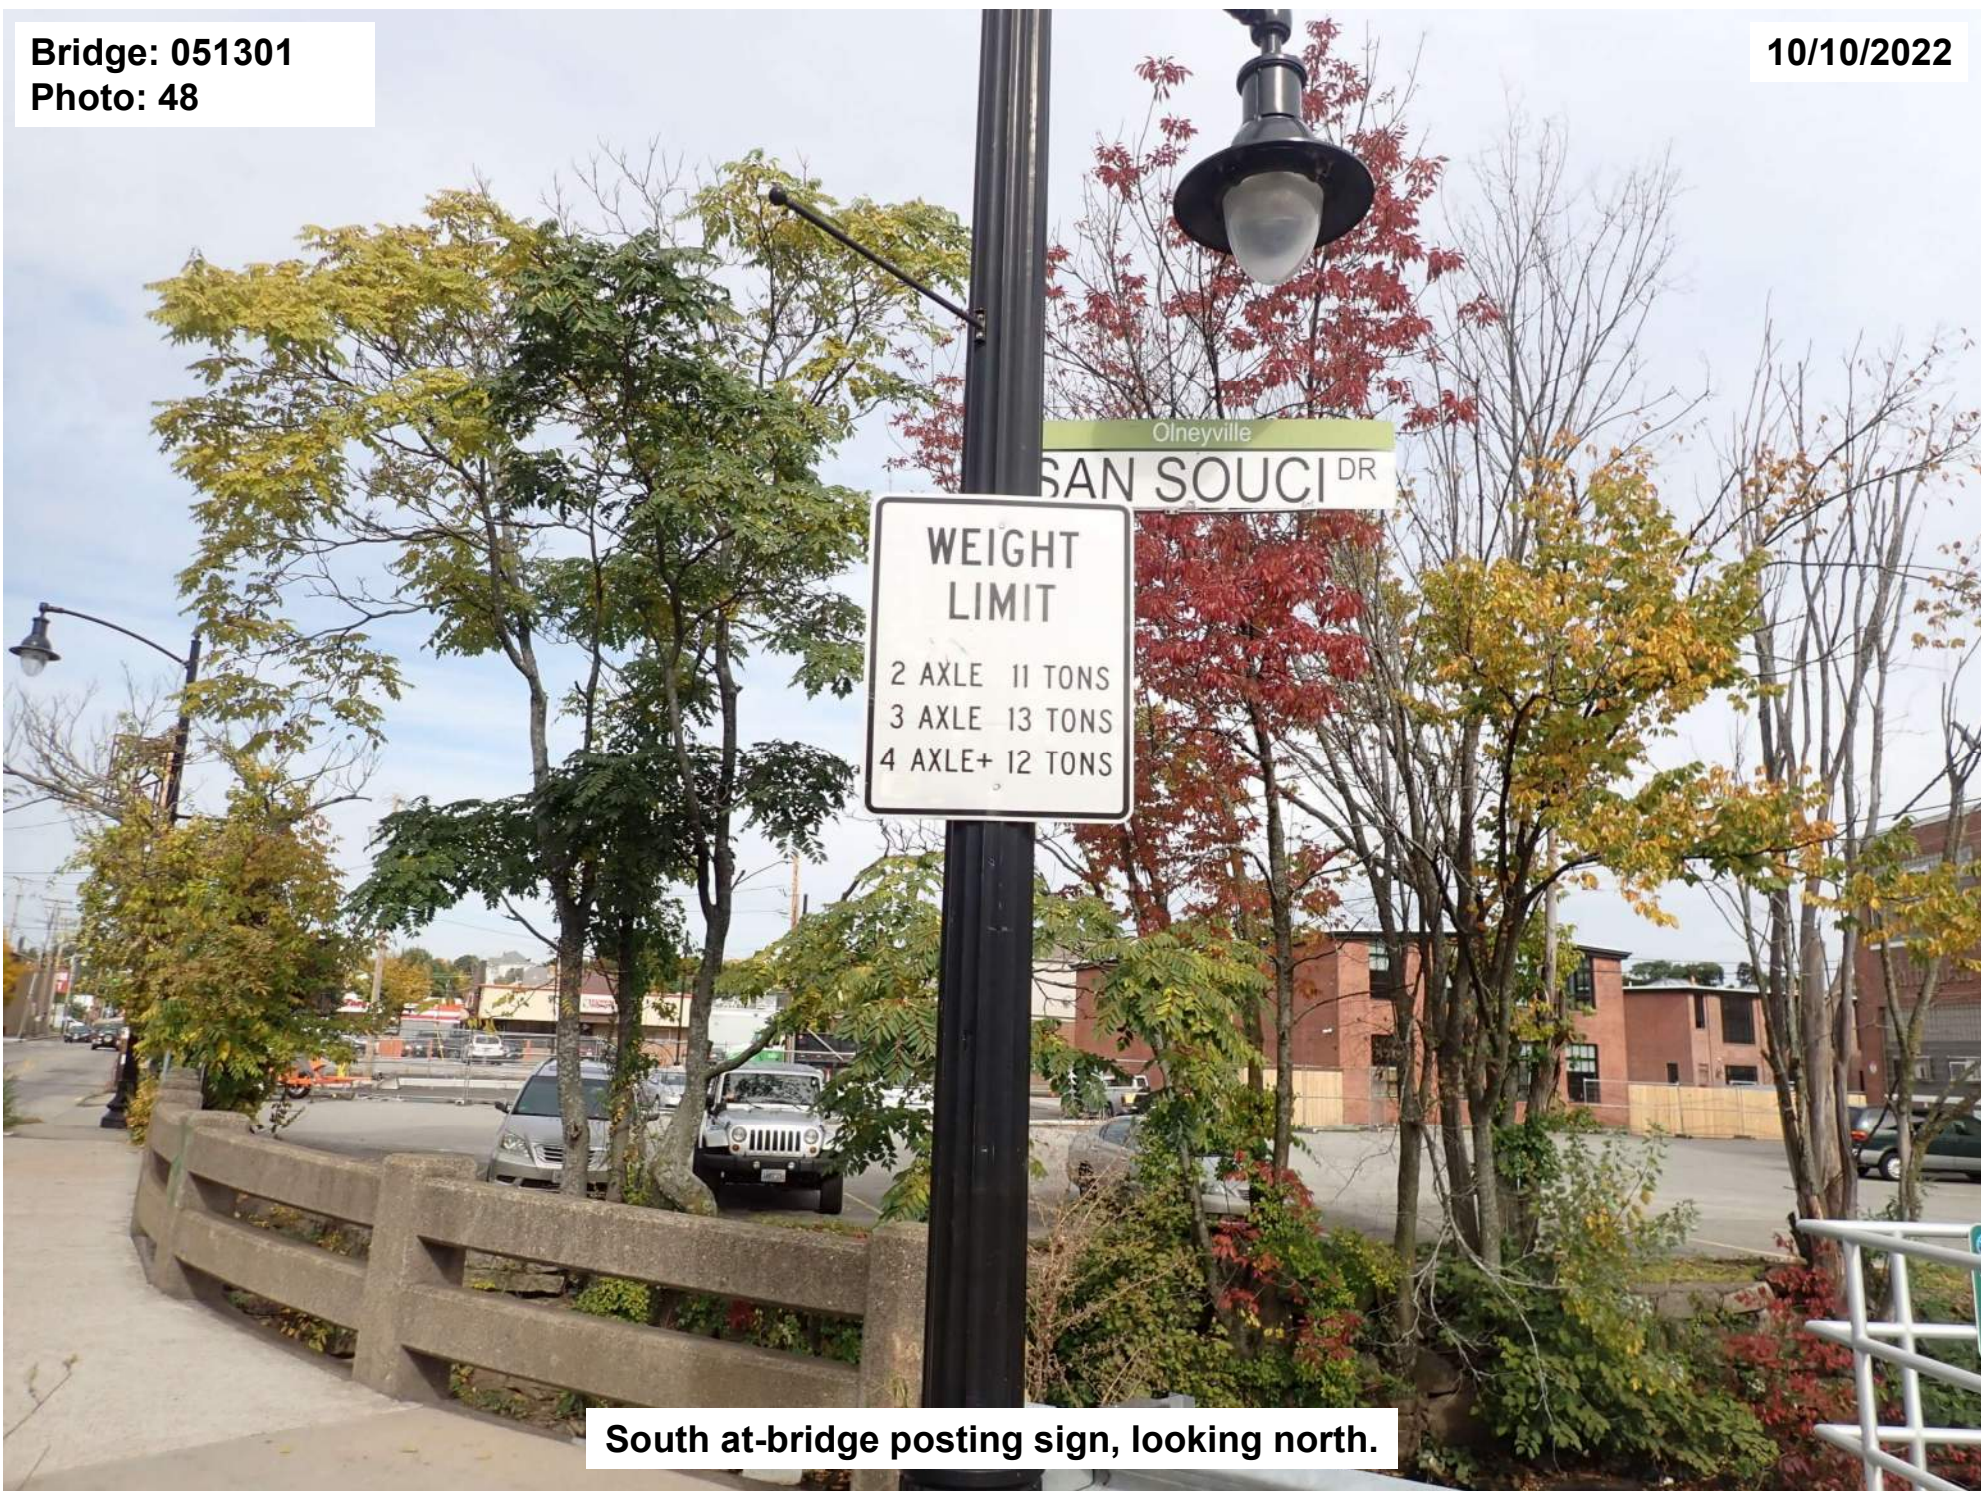
Bridge: 051301  
Photo: 49

There are four (4) advanced posting signs that are posted for "WEIGHT LIMIT: 2 AXLE 11 TONS; 3 AXLE 13 TONS; 4 AXLE+ 12 TONS". The south advance posting signs are located on Westminster Street at the intersection with Manton Avenue (Photo 49), Plainfield Street at the intersection with Dike Street (Photo 50), and Westminster just west of the intersection with Broadway (Photo 51). The north advance posting signs is located on Manton Avenue at the intersection with Delaine Street (Photo 52). The south advance posting sign located on Plainfield Street at the intersection with Dike Street has been vandalized partially obscuring the sign but the posted load restrictions are still legible (Photo 50).

South at-bridge posting sign, looking north.

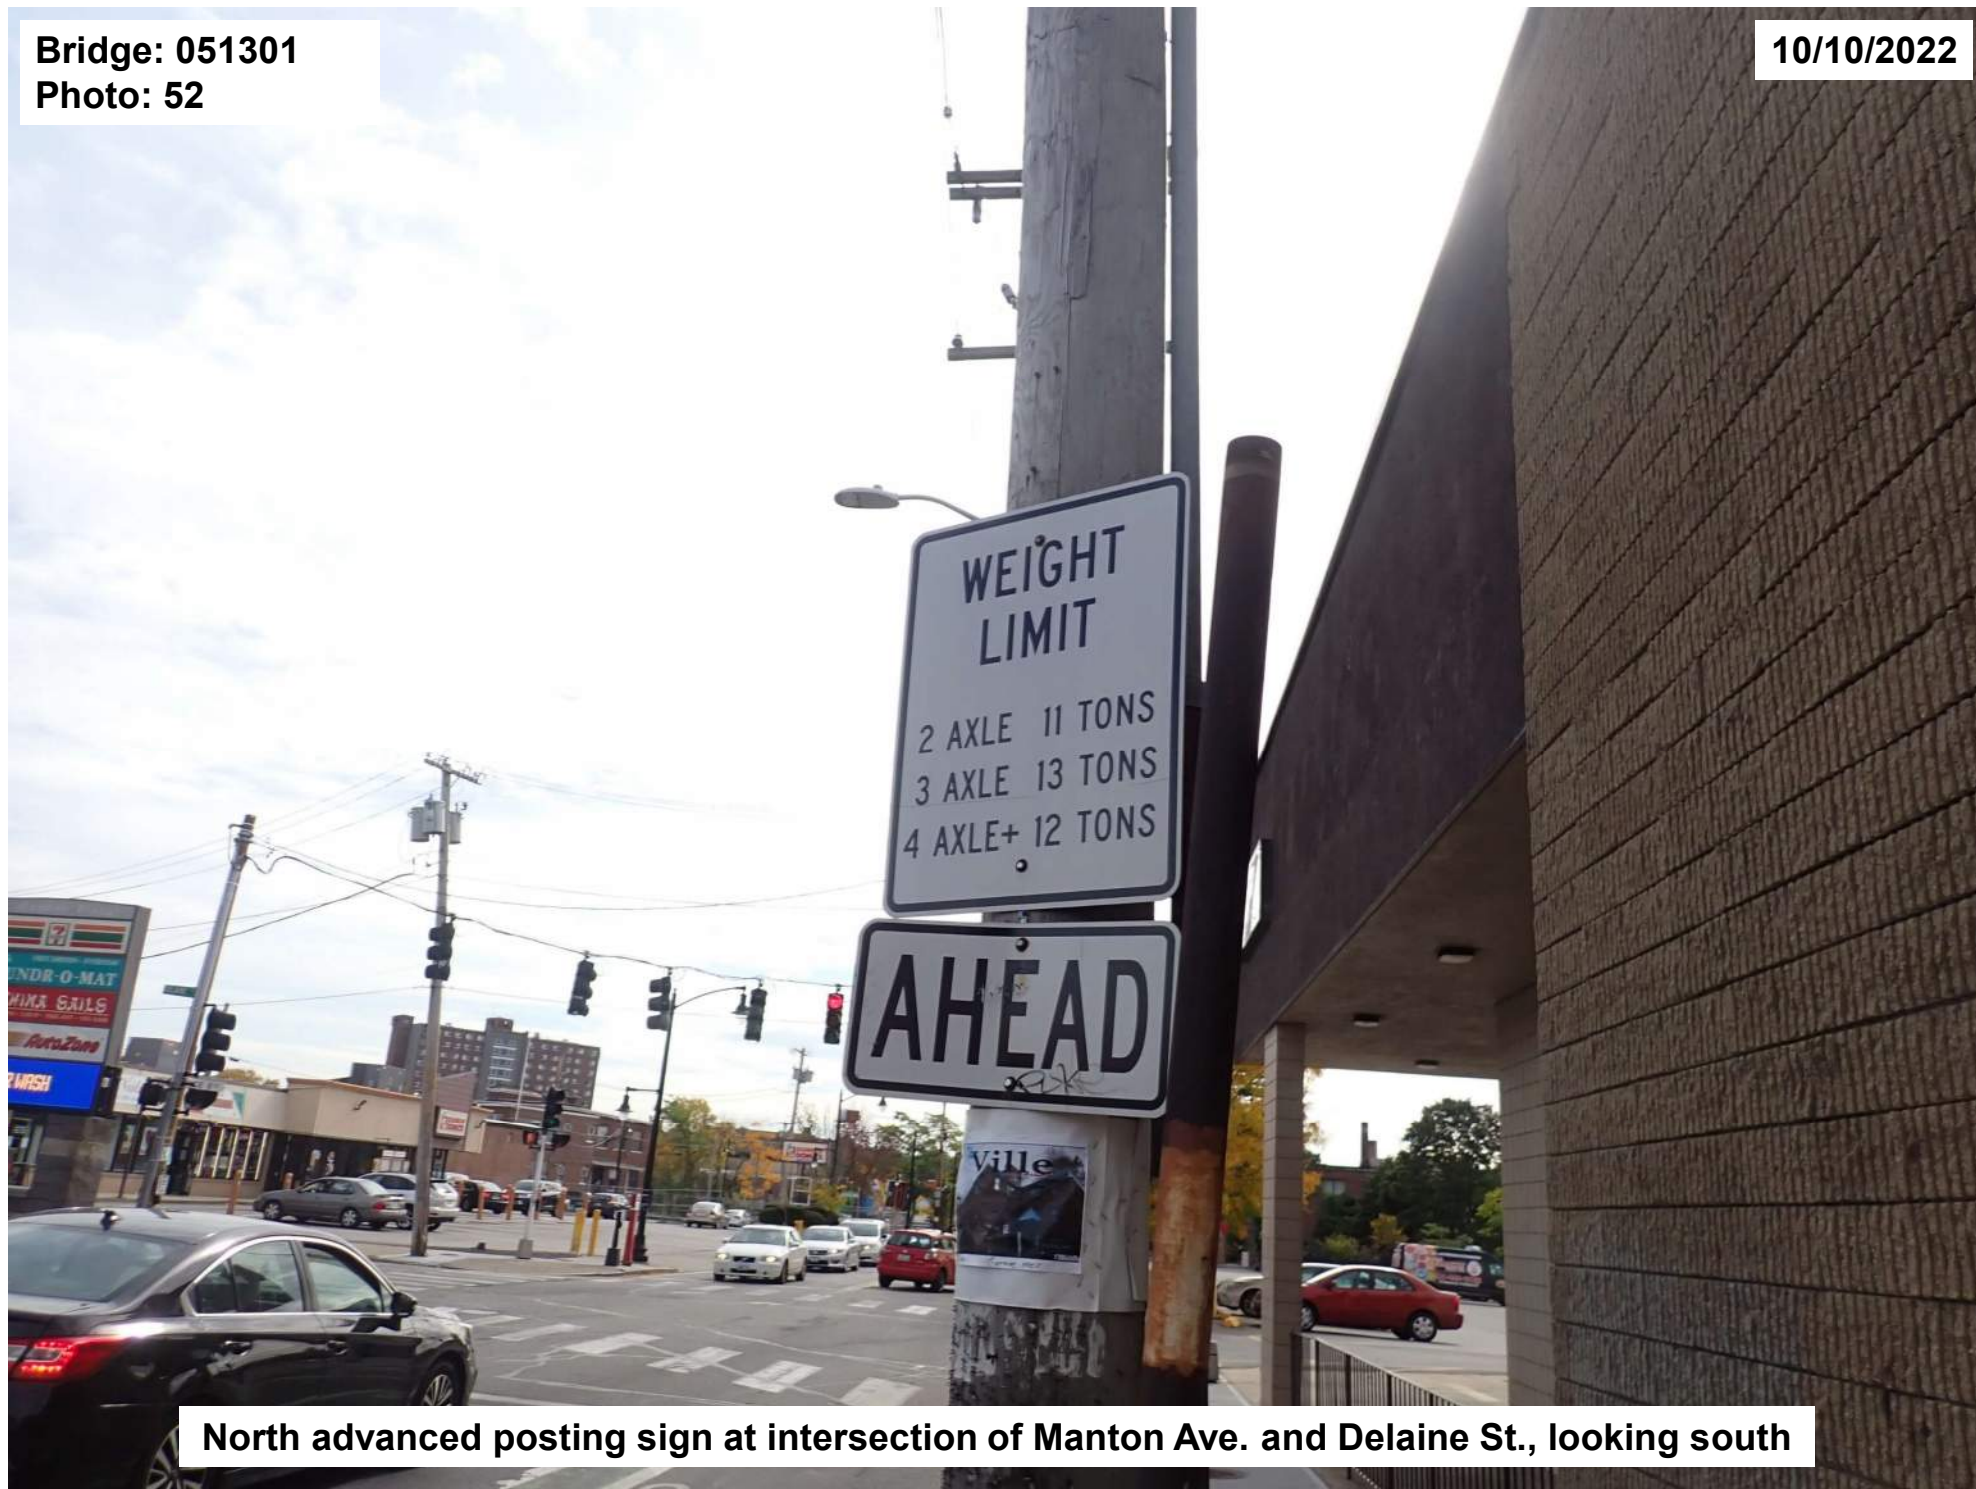
North advanced posting sign at intersection of Manton Ave. and Delaine St., looking south
