4. CASE 20.122, 20 JOHN STREET, Menzies Sweet and James Rhodes House, 1823 (COLLEGE HILL)

Federal; double house; 2-1/2 stories; clapboard; gable roof; 6 bay facade with double doorway flanked by pilasters and sidelights and carved fan decoration above; rear extension.

Proposal: The scope of work proposed consists of Major Alterations and includes:

- The applicant is requesting the removal of the of the existing dormer and the installation of a skylight, front (south) elevation.

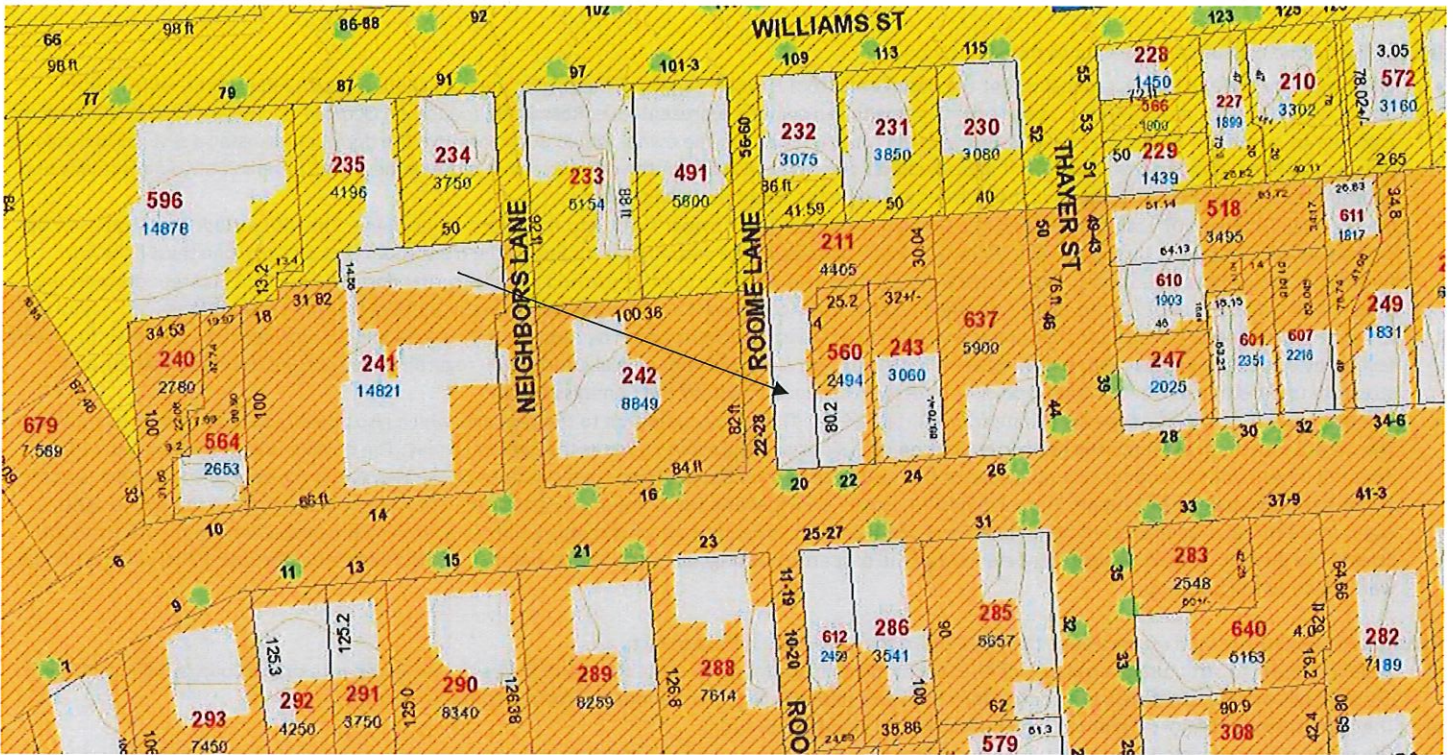
Arrow indicates 20 John Street.

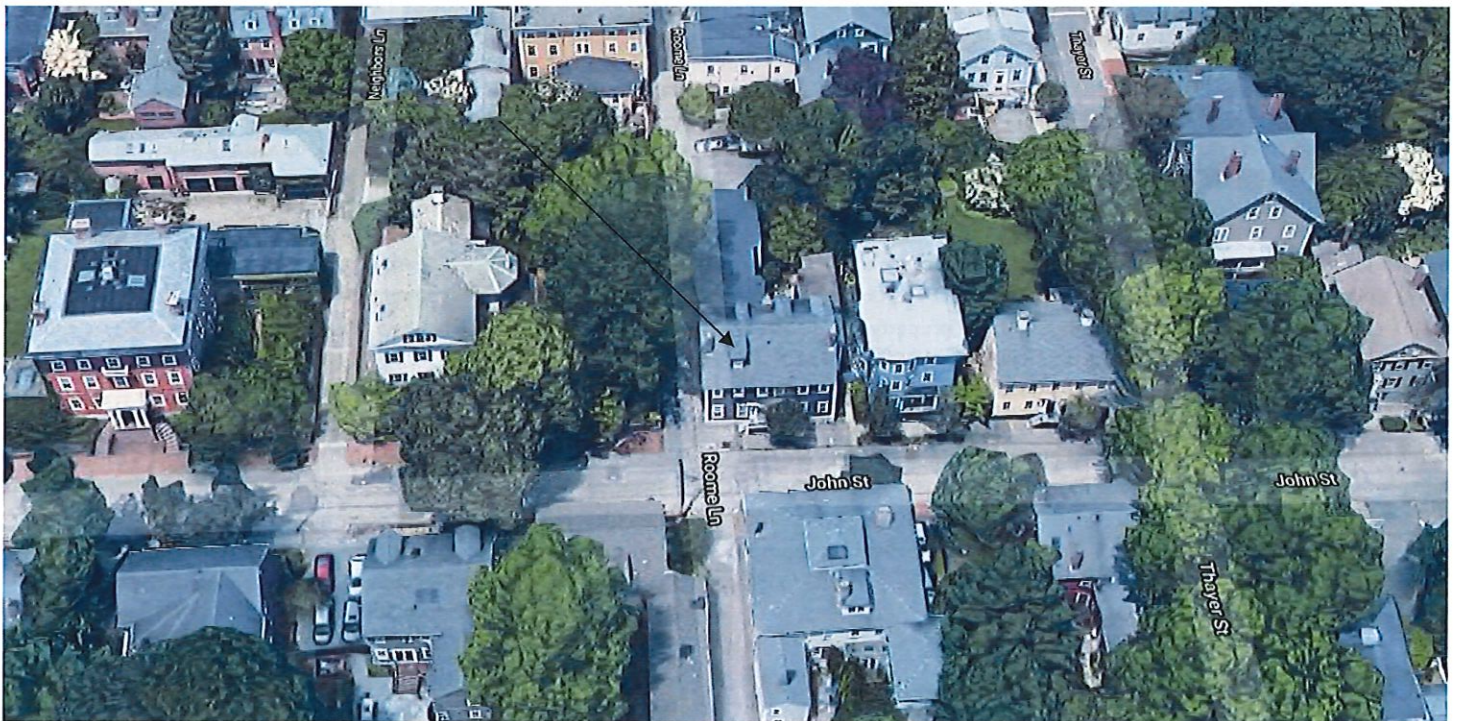
Arrow indicates project location, looking north.

- The reason for the applicant's request is that the dormer and roof is visibly sagging. The sagging appears confined to 20 John Street, with 22 John Street's roof showing no visible discrepancy. Staff met with the owner's representative, Ross Birch, initially on October 2nd and staff recommended an engineer be consulted to determine the issues with the roof and dormer. The owner would like to remove the dormer and install a skylight in its place, presumably in an effort to save costs. Staff explained that due to the visibility of the dormer, this is not a request the Commission would typically find appropriate and that repairing the roof and dormer would be the recommended option;

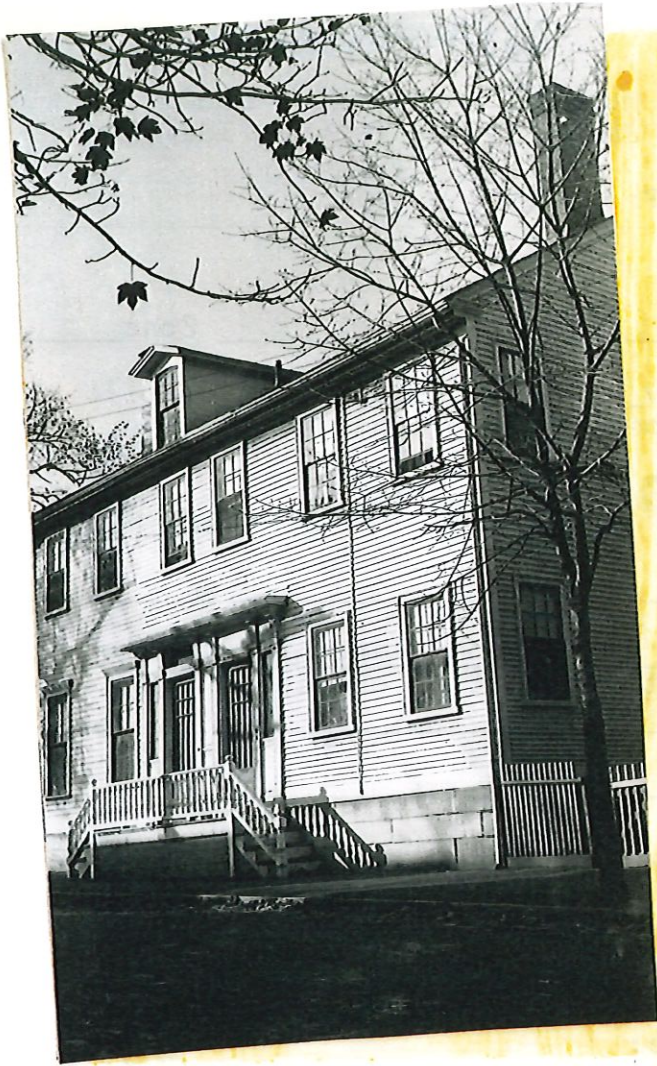
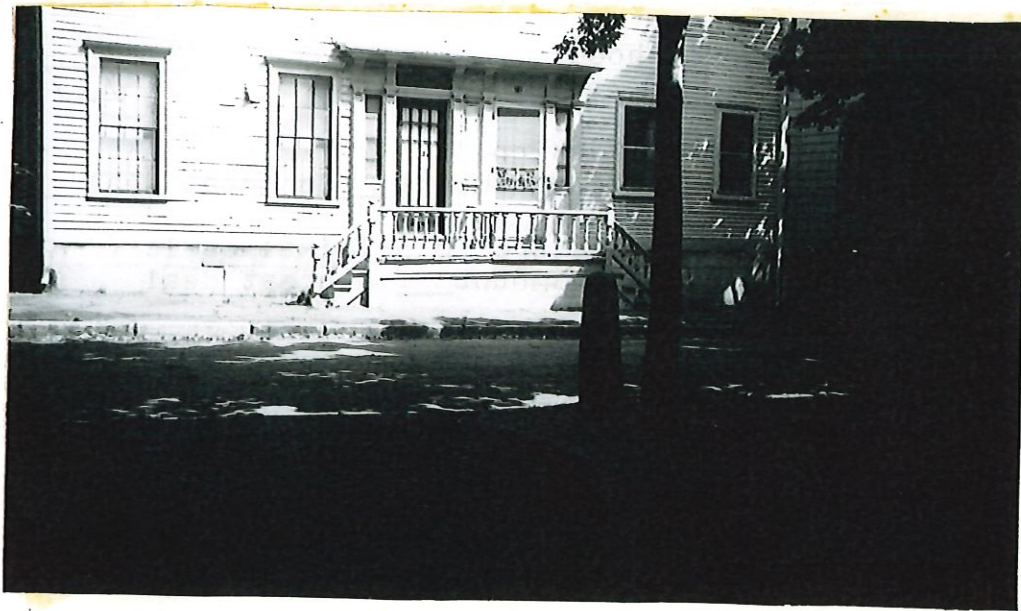
* 20-22 JOHN

Describe Rope molding across front cornice, Windows ^{caps} have dentel
course, ^{missing on right side} fret molding for gable eaves cornice, Stone basement, double
wooden steps, bracketed doorway forms both doors, doors have side-

Comments: (Notable features of building, grounds, etc.)
lights, end chimneys, long ell at rear has dentel cornice, Victorian

Side door way. one has a toplight (other removed?)
Original doors missing
set on side walk line
