**RFP Title: REDEVELOPMENT OF CITY BUILDING LOCATED AT 99 KENYON STREET,  
PROVIDENCE, RI 02903**

**Addendum #: 4**

# AHERA - ASBESTOS RE-INSPECTION OF ACBM & PACM

OVERALL ROOF PLAN  
**A-101**

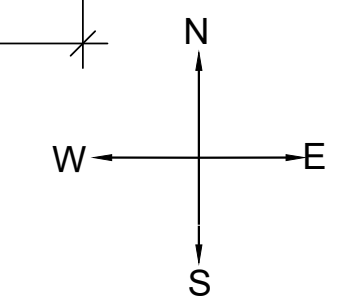
1 OVERALL ROOF PLAN  
A-1 SCALE: NTS

DEFICIENCY LIST	
1	DETERIORATED MEMBRANE
2	DEBRIS

MOISTURE SURVEY RESULTS				
ROOF SECTION	APPROX. SIZE (SF)	NUMBER OF WET AREAS	APPROX. WET AREAS (SF)	PERCENTAGE WET
ROOF 'A'	13,894	4	1,253	9%
ROOF 'B'	665	--	-	-
ROOF 'C'	689	--	-	-
ROOF 'D'	3,474	--	-	-
ROOF 'E'	5,452	1	5,452	100%
ROOF 'F'	2,272	2	786	35%
ROOF 'G'	13,600	4	234	2%
TOTAL	40,046	11	7,725	19%
