**1. CASE 25.128, 361 WEST FOUNTAIN STREET, United Transportation Company, 1910 (PLD-ICBD)
CONTRIBUTING**

361 West Fountain Street, Providence

RE: STRUCTURAL ASSESMENT
361 WEST FOUNTAIN STREET
PROVIDENCE, RI 02903
CE&C PROJECT NO. 25037.00

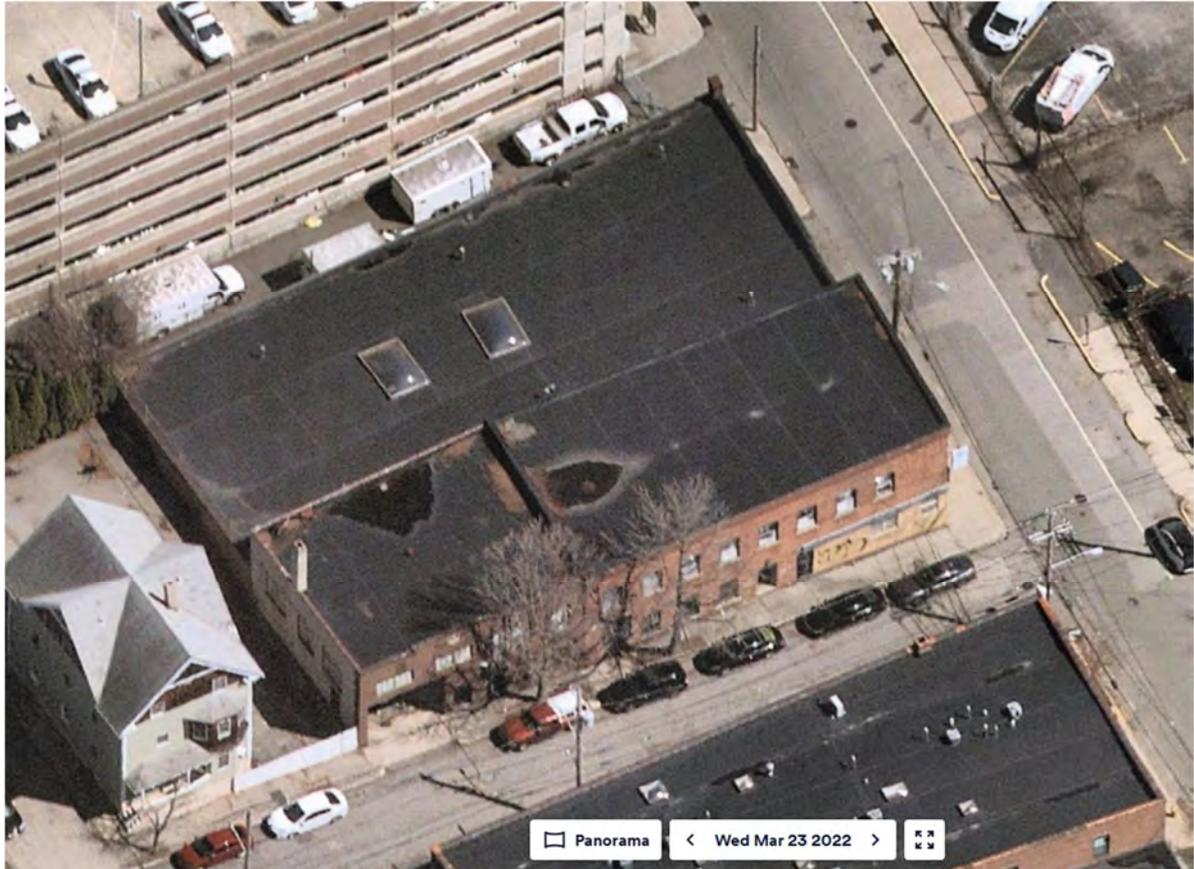
Photo 1 - 361 West Fountain Street aerial view from the west in March 2022 prior to collapse. The “front” portion is on the right and the “rear” portion is on the left. The adjacent 357 West Fountain Street is in the background (the roof with two large skylights). Note roof ponding due to clogged drainage scuppers in the area of collapse (rightmost large puddle). Also note ponding in the “rear” portion of the building (leftmost large puddle).

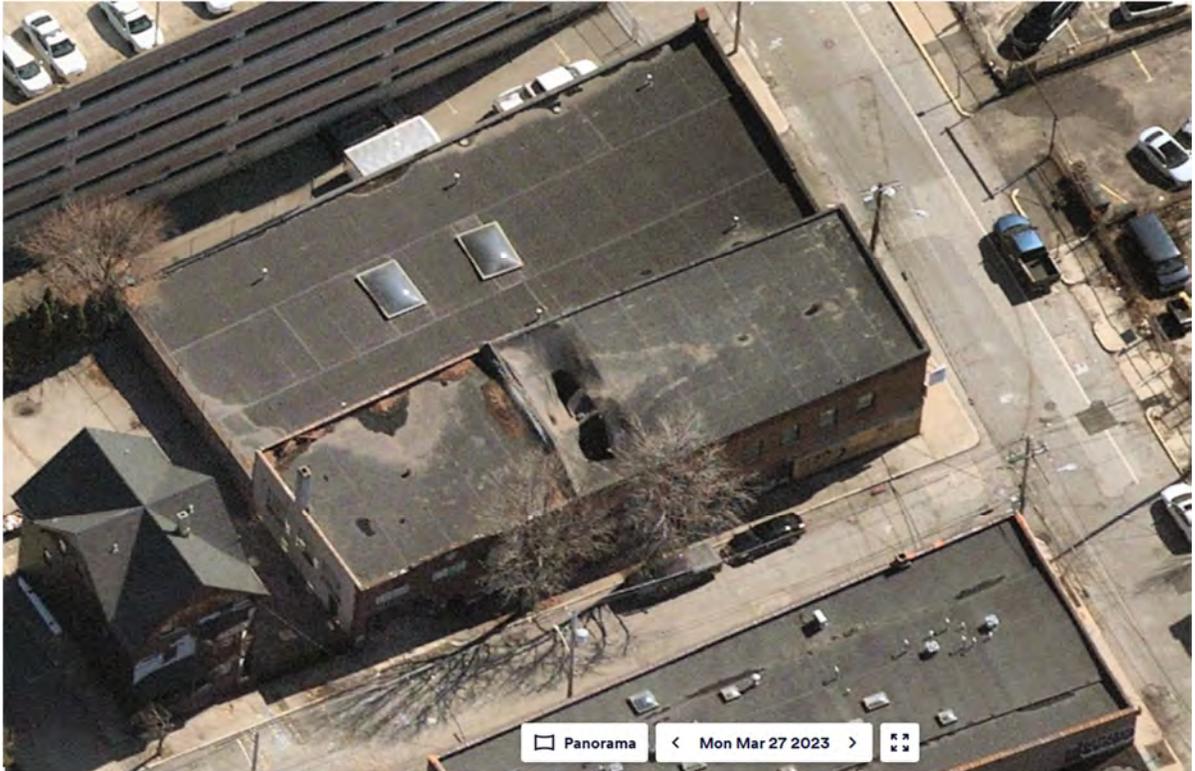
Photo 2 - 361 West Fountain Street aerial view from the west in March 2023 after collapse but before removal of debris. Note membrane roofing is still extant and is suspended from the side walls. Also note ponding in the "rear" portion of the building is still present.

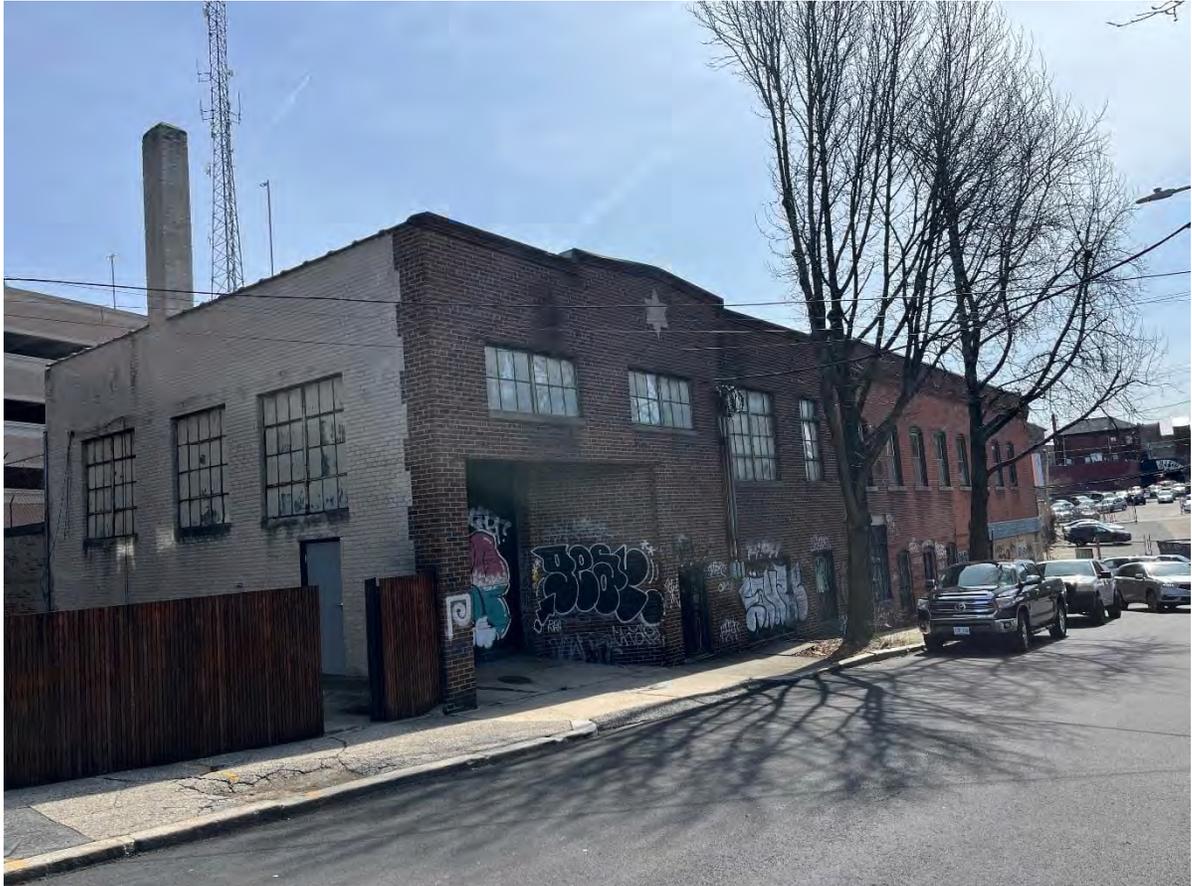
Photo 6 - 361 West Fountain Street view looking southeast along Cargill Street. The foreground is the "rear" portion of the building. Note that the detailing is different than the "front" portion of the building and matches that of the adjacent 357 West Fountain Street (the roof coping and 36" tall Star of David)

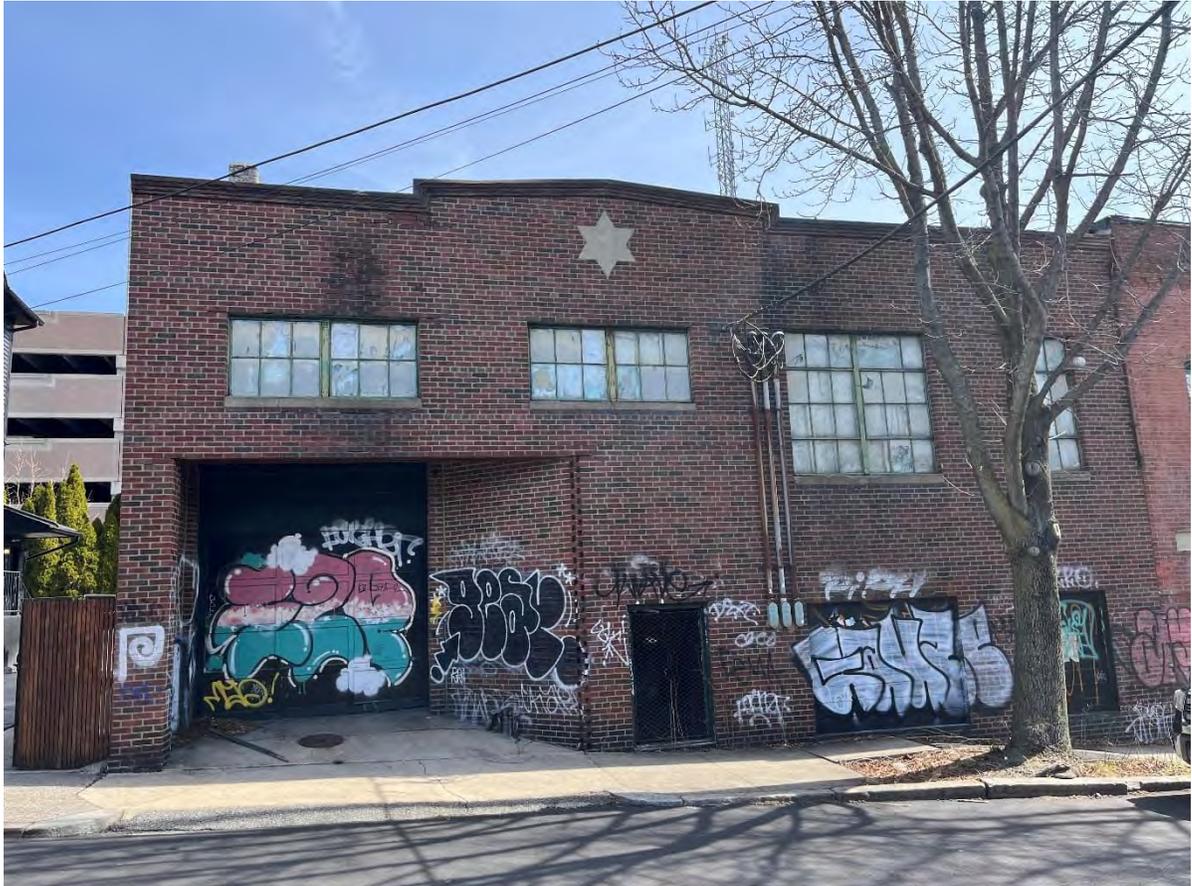
Photo 7 - 361 West Fountain Street view looking east at the "rear" portion of the building. Note that the detailing is different than the "front" portion of the building and matches that of the adjacent 357 West Fountain Street (the roof coping and 36" tall Star of David)

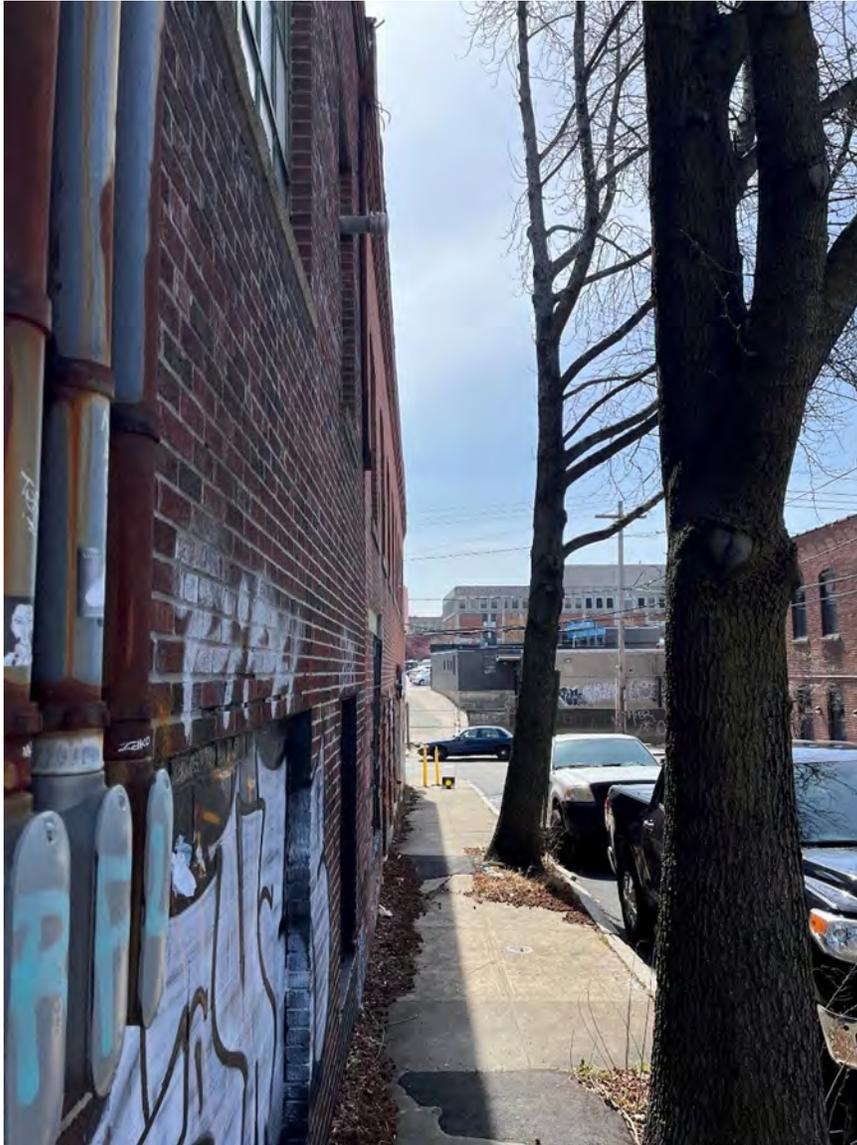
Since the ends of the steel rods do not penetrate deeply into the brick masonry, they were able to pull free during the collapse. A slight outward bulging of the west brick masonry wall was noted in this vicinity, due to the sudden elimination of lateral support provided by the floor and roof beams which no longer exist (photo 8). While lateral movement of the wall appears to have been fairly minimal, visually estimated at approximately one inch, the extents of resulting damage to internal coursing and mortar joints is unknown. Although perhaps to a lesser extent than the beams, the masonry walls have also been structurally compromised by the collapse.

Photo 8 - 361 West Fountain Street view looking south along Cargill Street. Note the apparent bulge to the wall just past the interface of "rear" and "front" portions (this is admittedly difficult to discern at photo-scale).

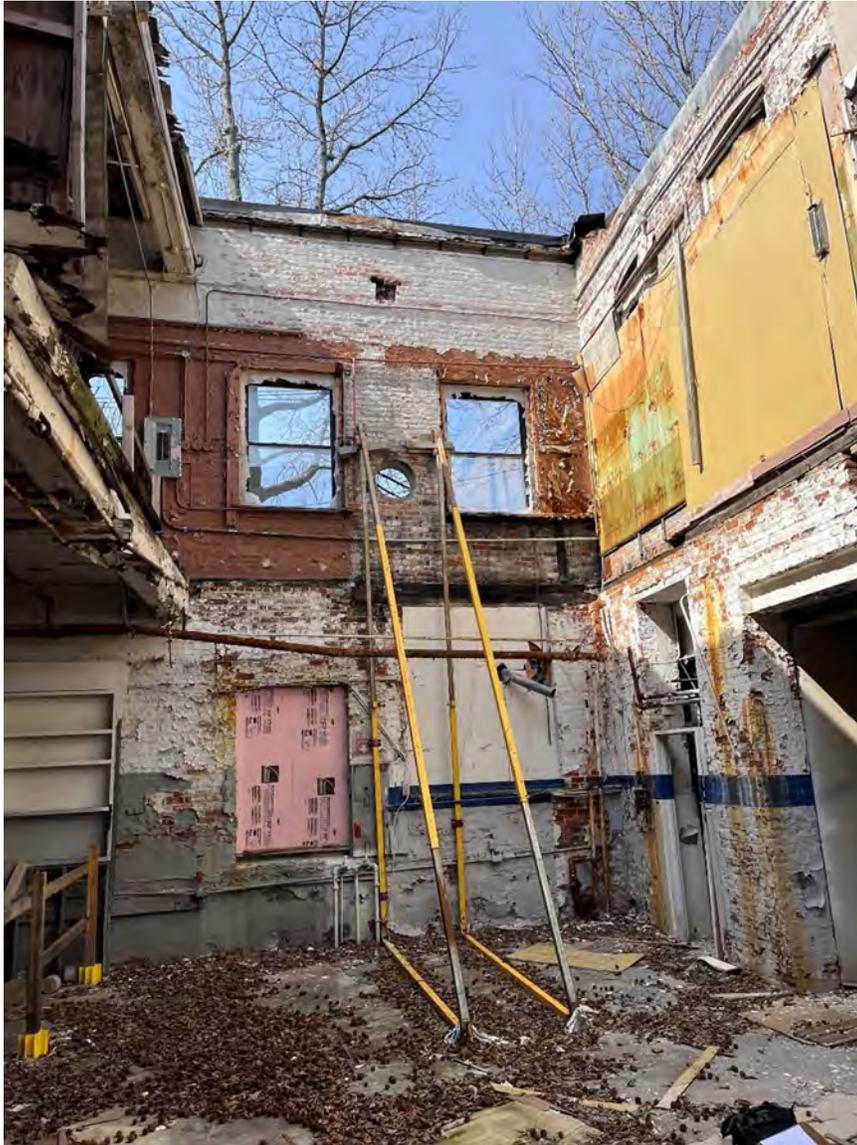
The previous owners installed temporary vertical shoring beneath the floor and roof beams immediately adjacent to the collapsed portions, and lateral bracing at the east and west walls at the locations of outward bulging (photos 9-13). By doing so the Building Department withdrew the condemnation order. However these shoring devices, the lateral ones in particular, appear to have been hastily installed, utilizing 2x wood blocks and plywood shims haphazardly stacked and fastened into the brick walls with masonry screws. The subsequent years of weathering has caused decay in the wood blocks & shims. Given the poor condition and inadequate method of attachment to the walls the devices appear to provide very little lateral resistance and should not be relied upon.

Photo 9 – Interior view “front” portion looking west in area of collapse (formerly bays 8 & 9). The wall on the right is the interface between the “front” and “rear” portions and is the original north wall of the “front” portion. Note the twin lateral bracing towers and the two square pockets which once housed the west ends of roof and floor beams #8. The top end of the lateral bracing is fastened into multiple layers of 2x blocks and plywood shims with masonry screws.

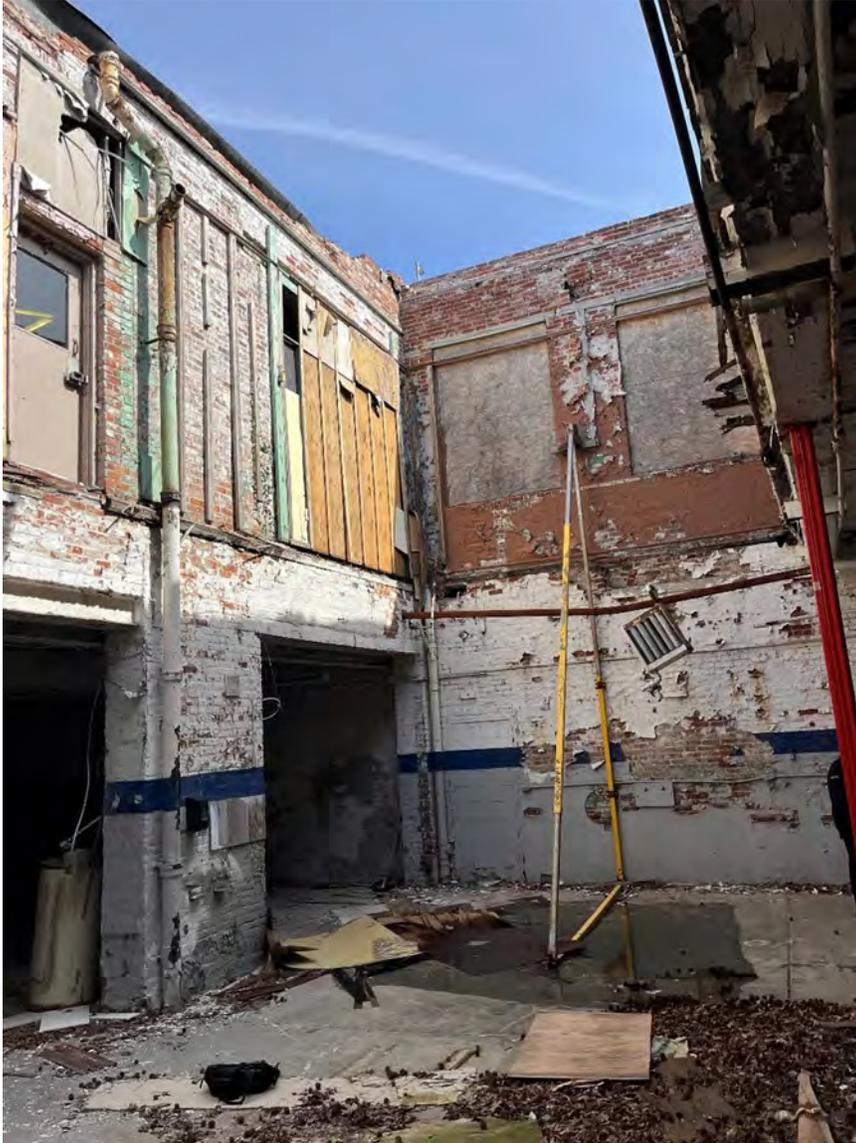
Photo 13 – Interior view “front” portion looking northeast in area of collapse (formerly bays 9 & 8). The wall on the left is the interface between the “front” and “rear” portions and is the original north wall of the “front” portion. Note the lateral bracing tower and the two square pockets which once housed the east ends of roof and floor beams #8. The top end of the lateral bracing is fastened into multiple layers of 2x blocks and plywood shims with masonry screws.

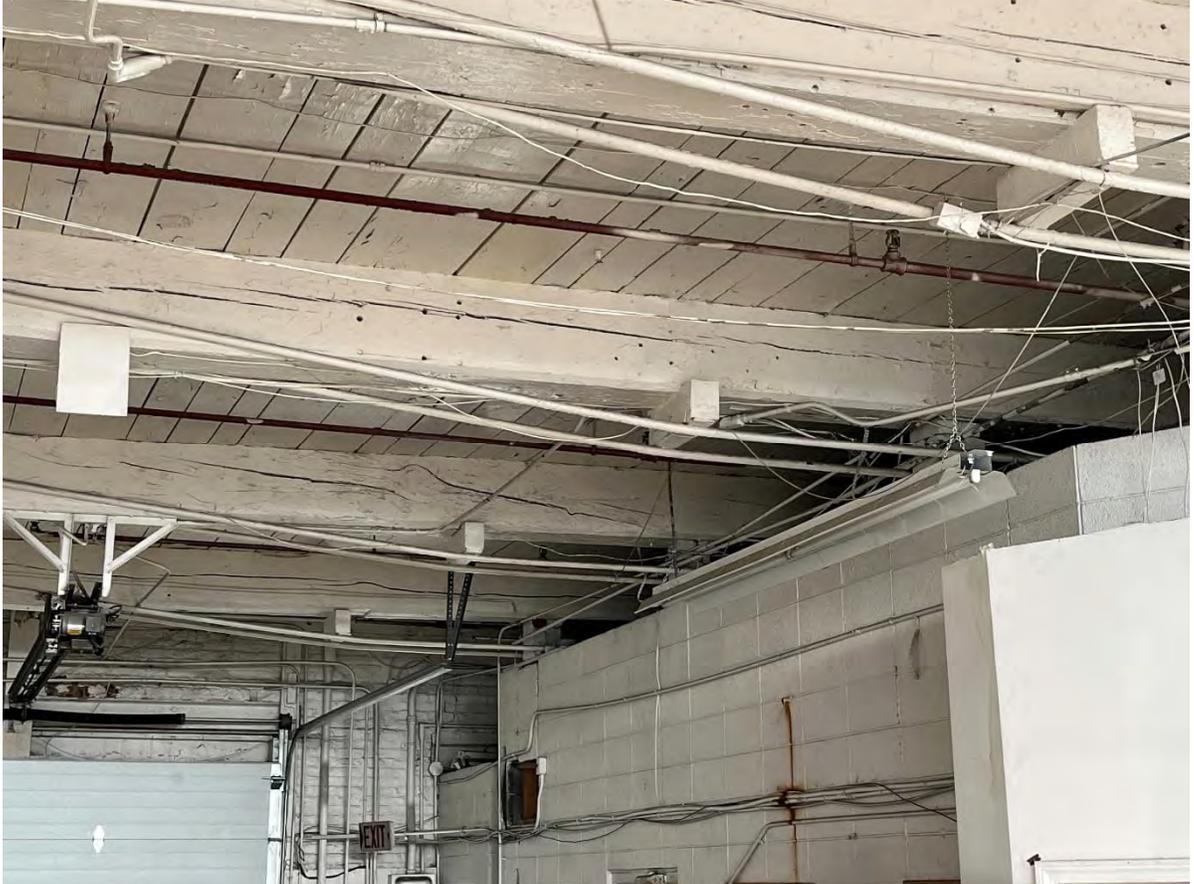
Photo 19 – Interior view “front” portion looking southwest at floor beams #4-1. Note longitudinal and diagonal splitting of wood beams.

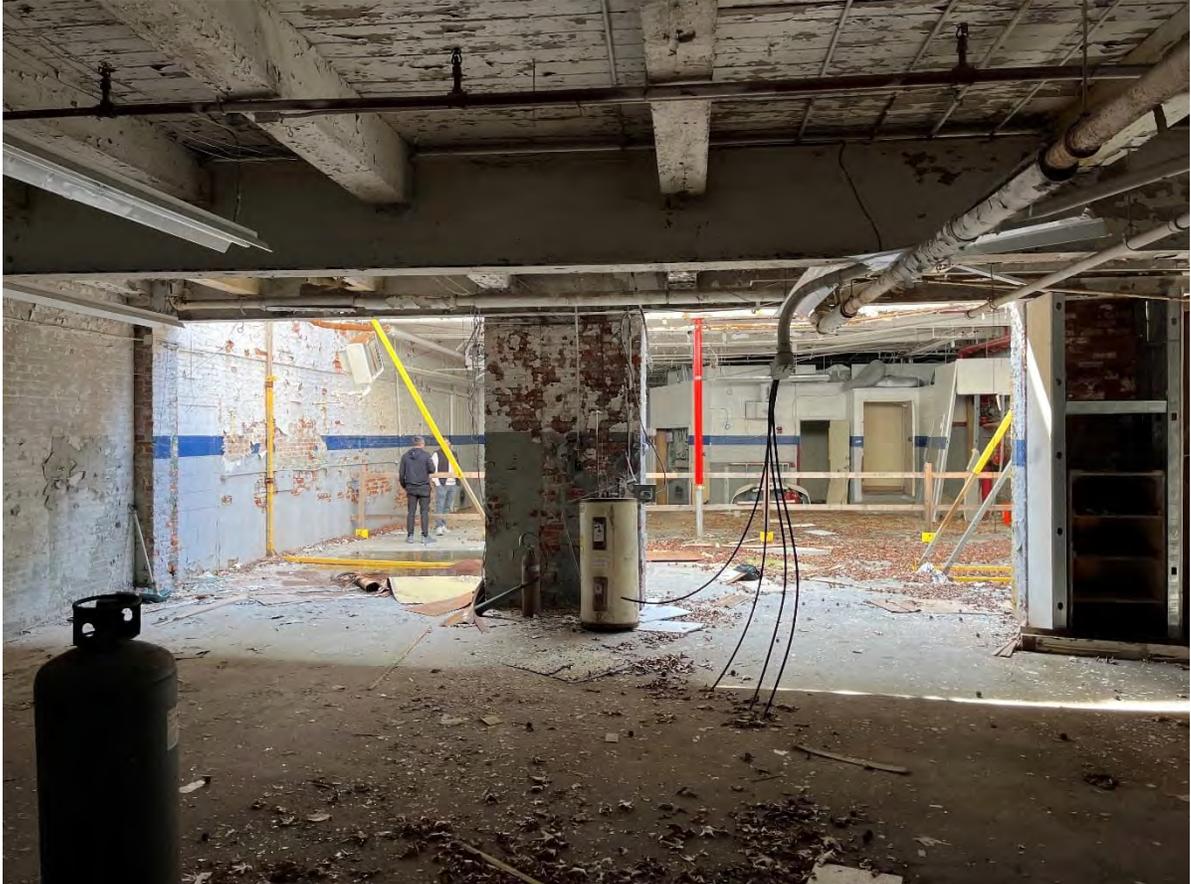
Photo 20 – Interior view “rear” portion looking south toward two of the three large openings into the “front” portion. Note the means of construction, which includes 24” deep steel girders supporting 8x12 wood floor beams that rest on steel clip angles that are riveted into the girder web. The wood floor beams support wood plank flooring.
