**2. CASE 26.105, 113 BROADWAY, Commercial Building, pre1875, 1921, 1956 (BROADWAY)**  
NON-CONTRIBUTING

RE: STRUCTURAL ASSESSMENT  
113 BROADWAY  
PROVIDENCE, RI 02903  
CE&C PROJECT NO. 25087.00

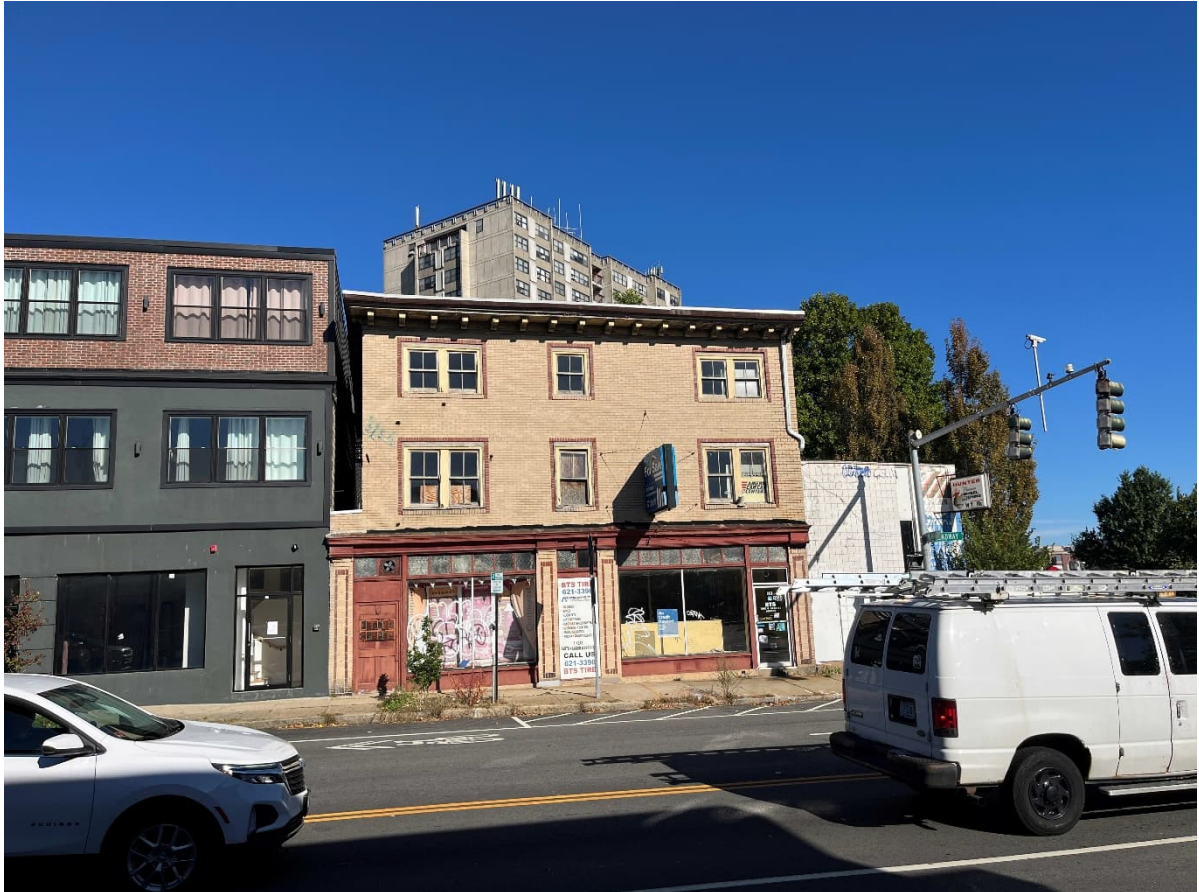
Photo 5 – 113 Broadway South Elevation looking North. The Southern Portion of the building is center, the Eastern Portion of the building is to the right, and 117 Broadway is to the left.

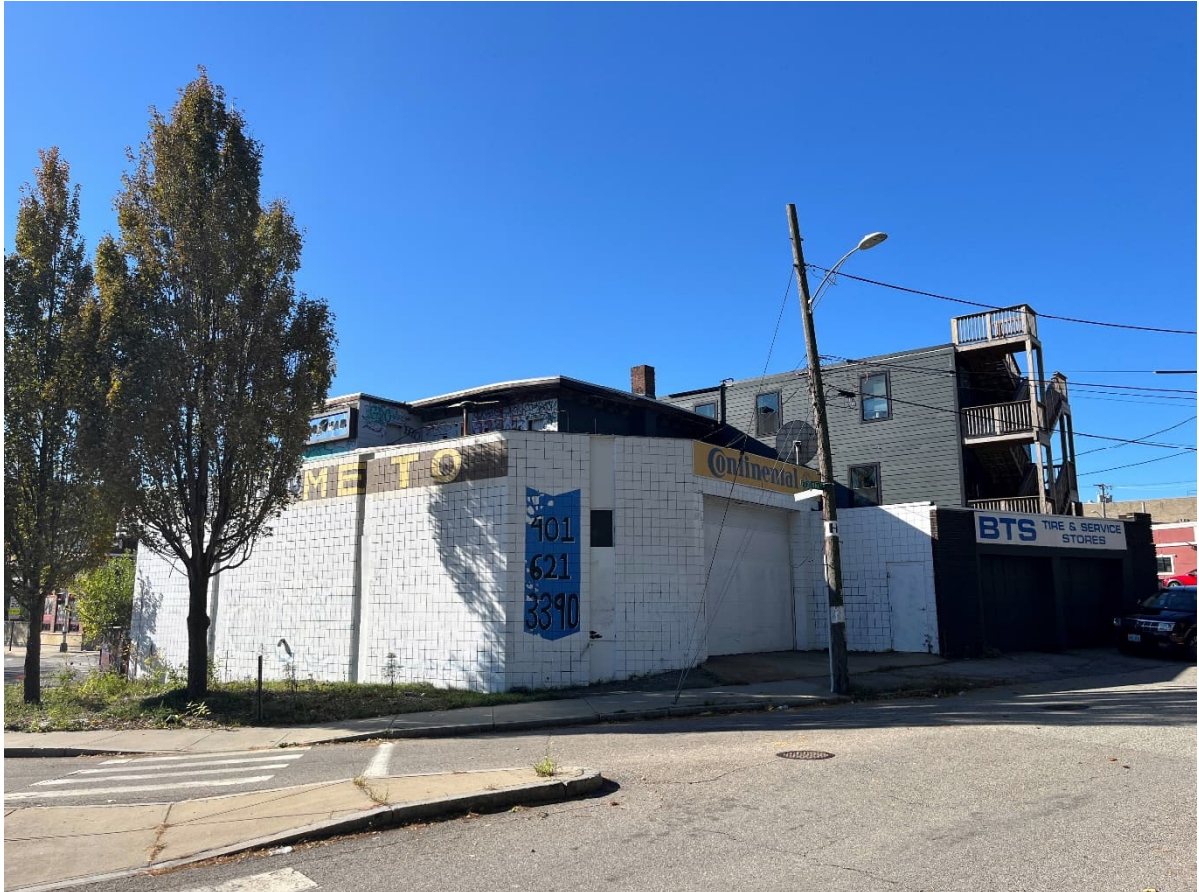
along the entirety of the first story east wall, as viewed from within the eastern portion of the building (photos 25 & 26). The remainder of the second and third stories of the east façade and north facade are clad in what appears to be asbestos siding (Photos 8 & 10). The second and third stories of the west façade, immediately adjacent to 117 Broadway, retains the original wood clapboard and decorative diamond pattern frieze detailing (photo 6, note this is difficult to see in the photo due to shadowing).

Photo 8 - 113 Broadway looking Southwest. The Eastern Portion of the building is in the foreground constructed of white CMU block, the Northern Portion is to the right (with the BTS sign), and the Southern portion is in the background. 117 Broadway is the green building with multiple wood decks in the background.

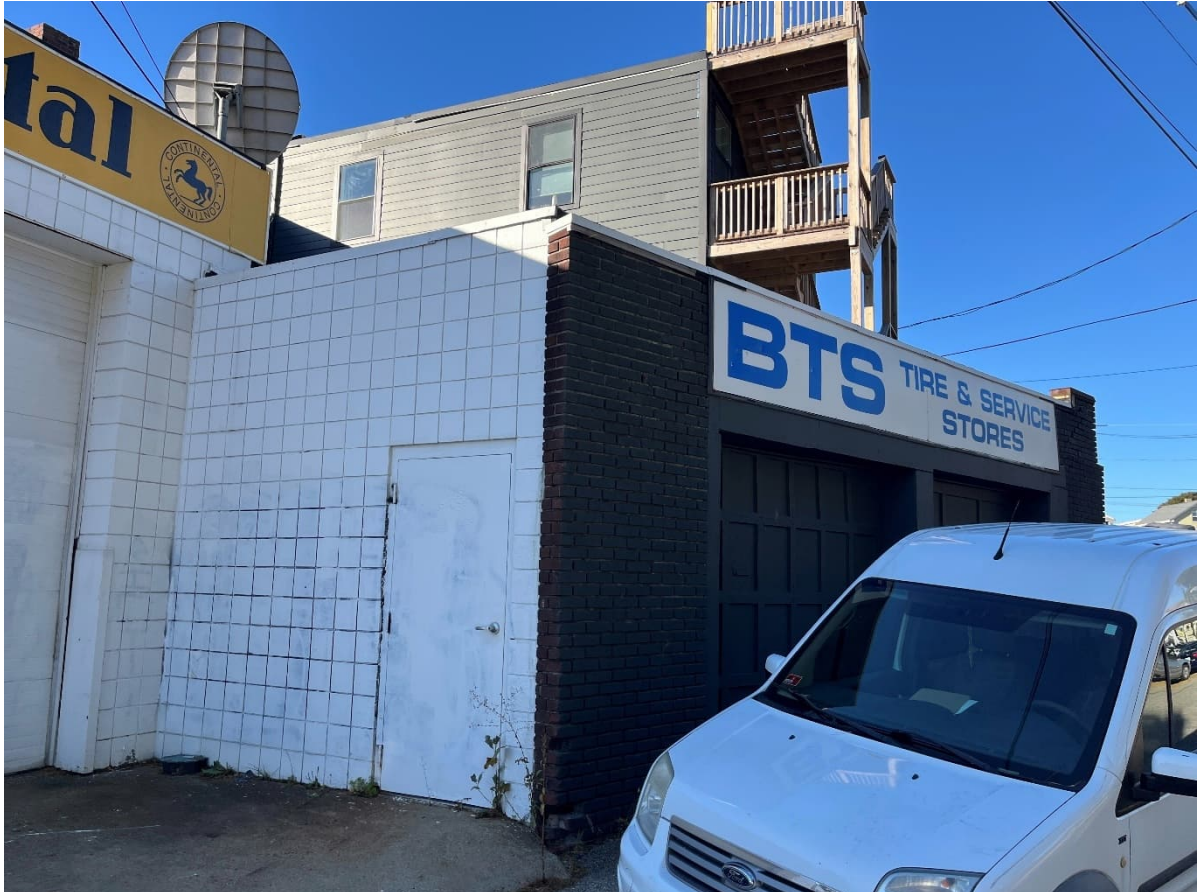
which is composed of two-wythe brick (Photos 9-11). The walls support a roof structure consisting of 8x12 timber beams spaced at 6' on center which span the full width of the building (Photo 23). The timbers support wood plank roof sheathing and membrane roofing (Photo 24). The CMU wall block is visually identical to that used in the east side wall of the south portion of the building which indicates that its construction likely coincides with the conversion of the Southern portion from residential to commercial use. The foundation sizes and composition are unknown. There are two garage doors along the north wall and the floor is covered by a thick concrete slab which is capable of supporting vehicular loading.

Photo 9 - 113 Broadway looking Southwest. Interface of the Eastern Portion of the building (left) and Northern Portion (right). 117 Broadway is the green building with multiple wood decks in the background.

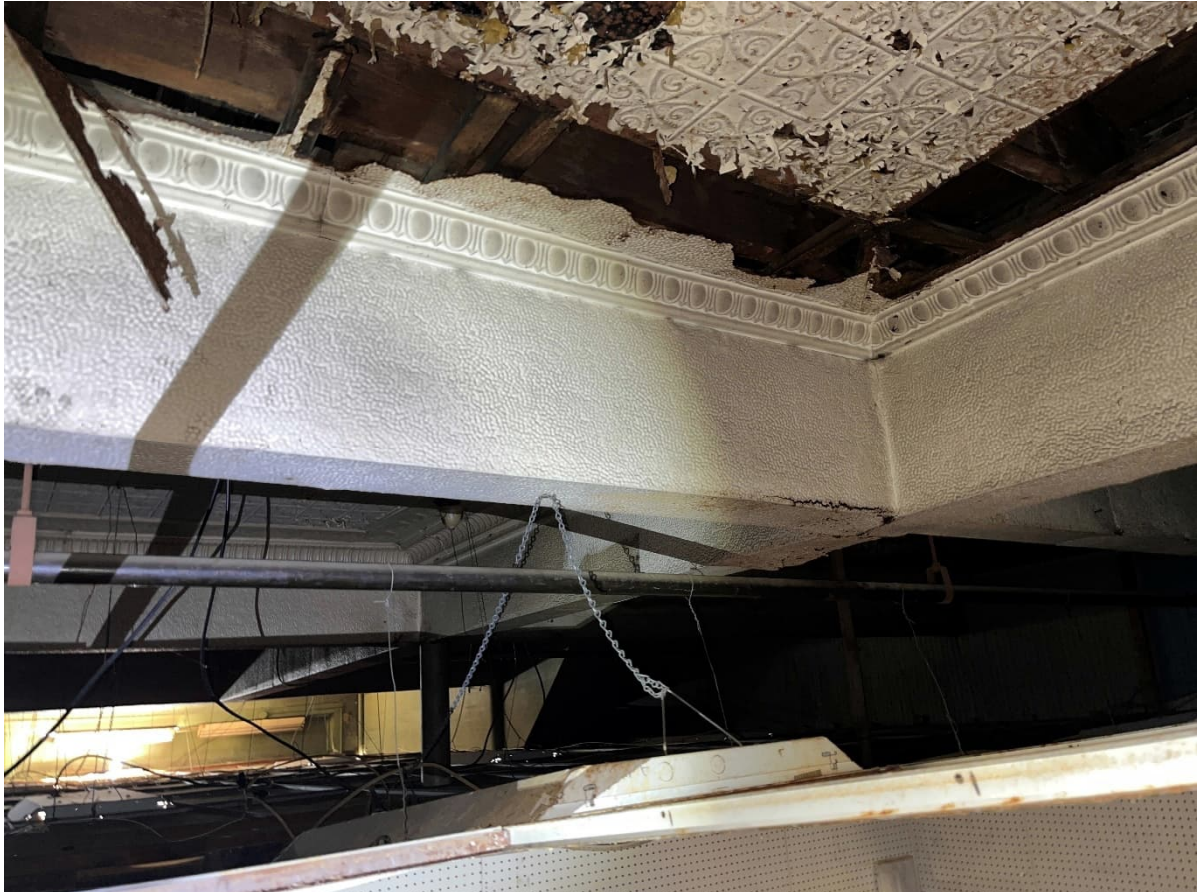
The first story provides mostly-open store space, with a trabeated support system consisting of metal (steel or iron) columns which support large ceiling beams which are concealed from view by a decorative tin ceiling finish, but are presumably composed of steel given their long span lengths (Photos 12 & 13). Wood floor joists rest on top of these beams and provide support for the second story. The metal pipe columns penetrate through the first story wood floor framing and are supported upon unreinforced CMU piers located in the basement, the blocks of which are identical to those utilized on the east façade which suggests that the conversion of the first story to open store space and masonry cladding coincides with the ~1921 construction of the southeastern protrusion (Photos 14 & 15).

Photo 12 – Southern Portion, first story eastern half looking southwest. View of the typical structural beams and columns which support the wood framing of the second and third stories. This view is from above the existing drop ceiling. The column located in the center left provides support for the southeastern chambers above. Note the second story wood floor joists are visible through the deteriorated tin ceiling finish. Also note the deflection in the header beam above the eastern storefront window (background left – not easily discernable at this scale).

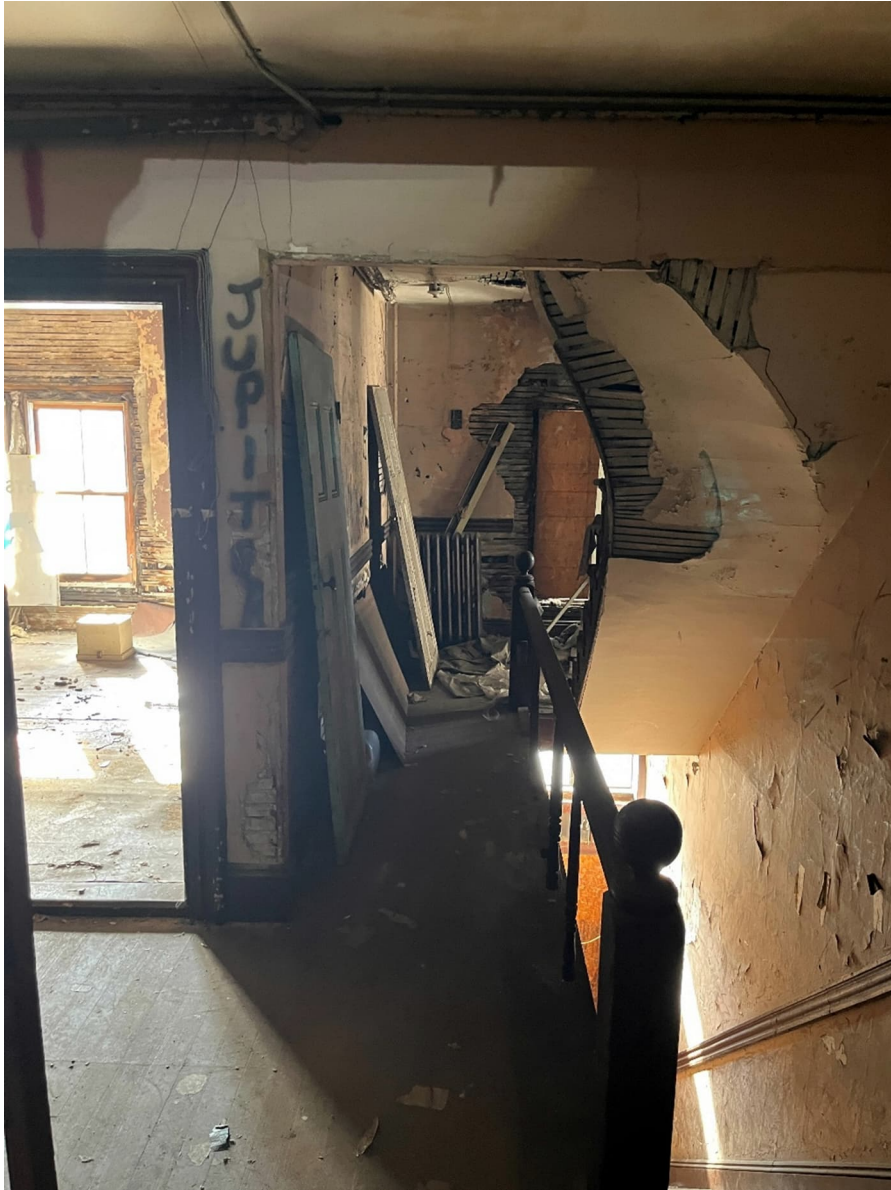
Photo 16 – Southern Portion, second story looking south. The stairway in the foreground leads down to the first story, between the two store spaces. The curved stairway in the background leads to the third story. The wall on the left side of the hallway is the location of the most significant floor deflections ( $\sim 2'' \pm$ ). The metal column & CMU pier shown in the previous photos are located directly beneath this point. The southeast chamber is through the doorway on the left.

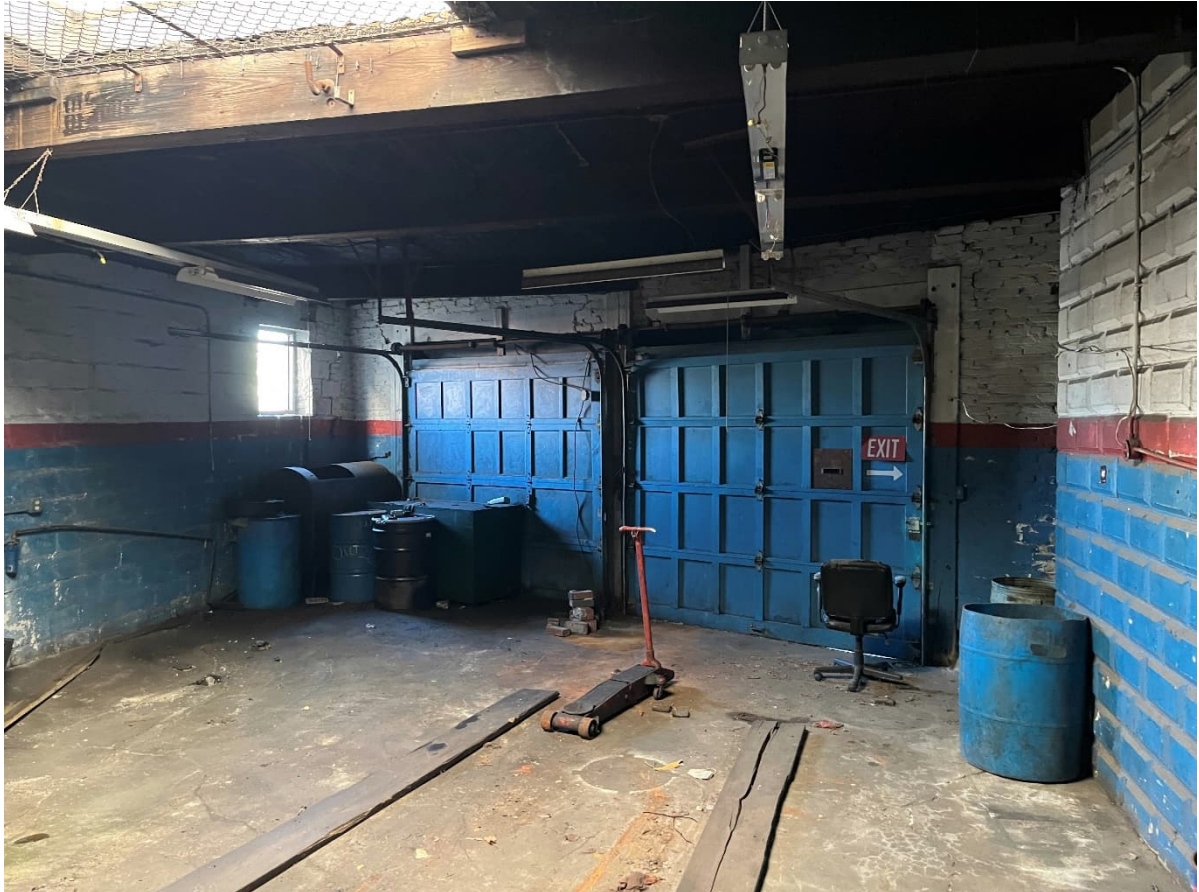
Photo 23 – Northern Portion, typical interior view looking north. The vehicle-damaged wall is located in the background left corner. Note the typical construction – CMU block walls with heavy wood timber rafters.

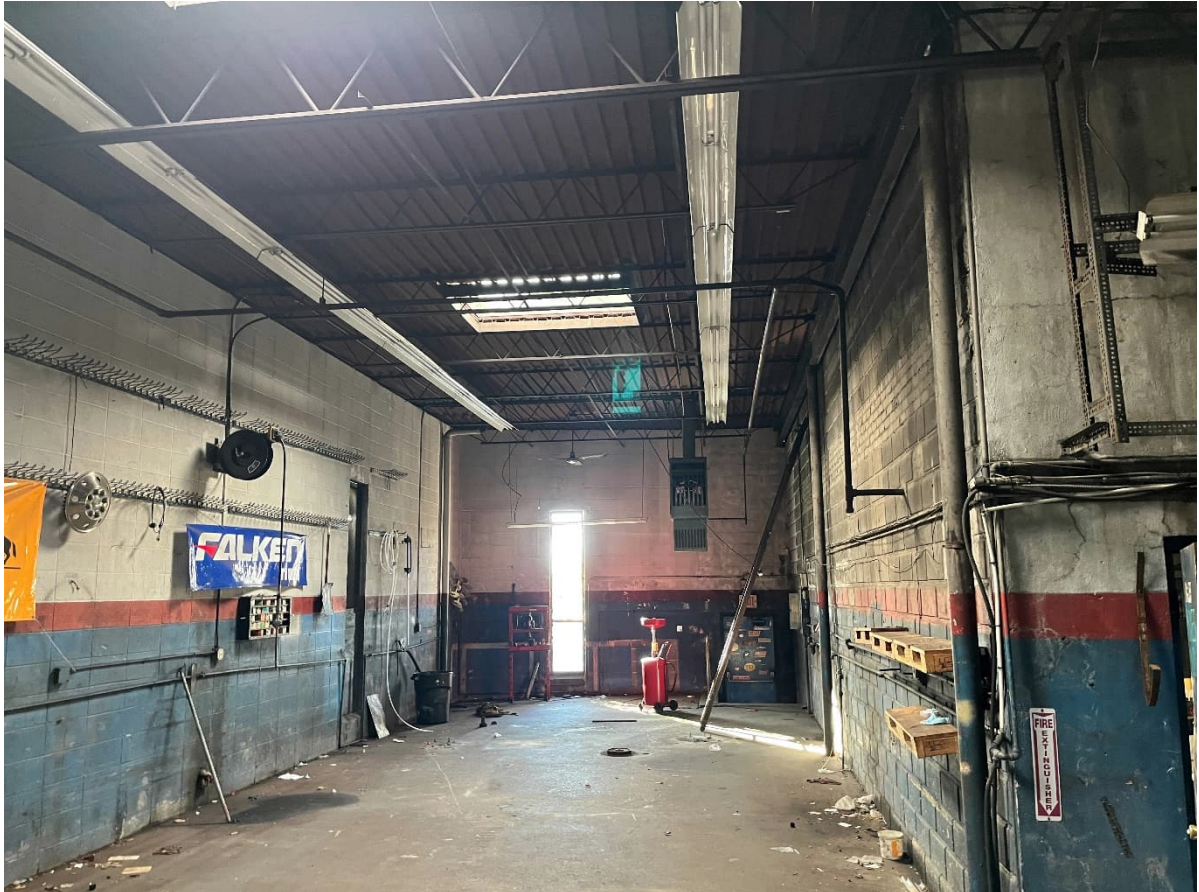
Photo 25 – Eastern Portion, typical interior view looking south. Note the typical construction – CMU block walls with open web steel joists spaced at 4' on center which support corrugated metal roof panels and membrane roofing. The CMU wall on the right side was constructed as part of the "southeast protrusion" - note the open web joists are supported on a steel header beam and steel columns which are completely independent of this older CMU wall.
