#### 3. CASE 23.027, 40 STIMSON AVENUE, Edward S. Clark House, 1892 (STIMSON)

Shingle Style, 2 ½ stories, faced in brick on the first floor and shingles on the second, carrying a cross-gabled slate roof; gabled entrance porch with bargeboards; varying treatment of window paning (some casement-hung). CONTRIBUTING

[EXTERNAL] Slate roof inspection

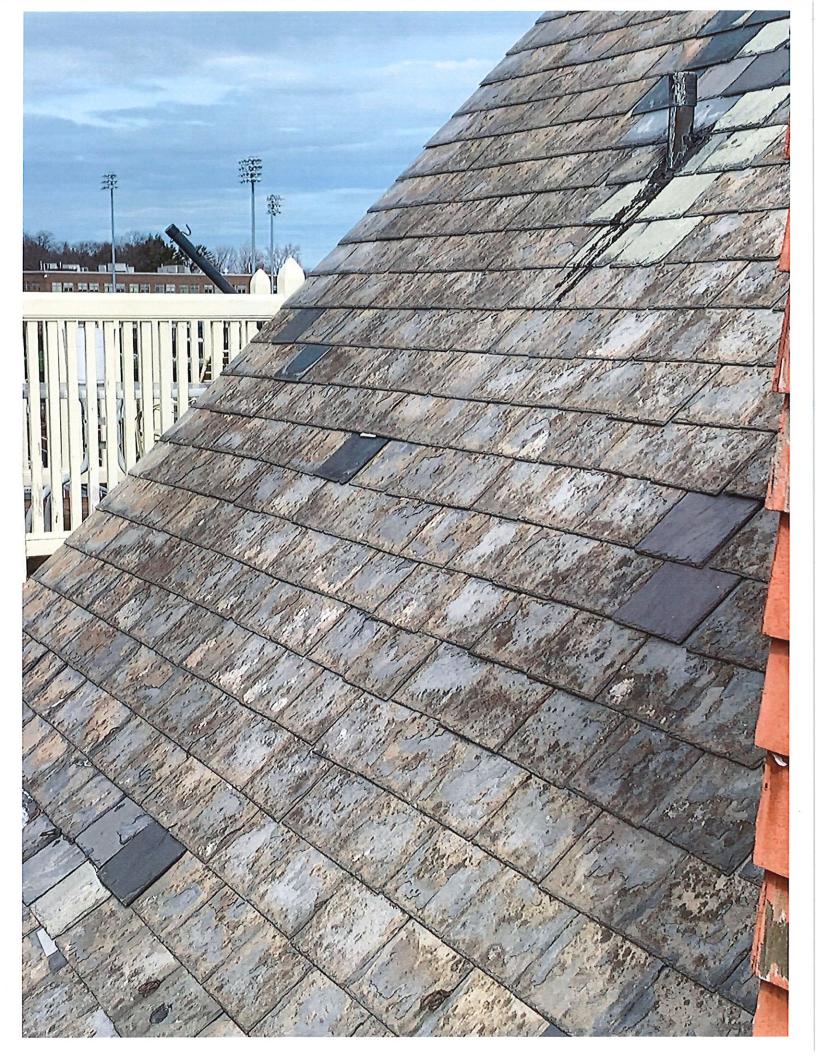
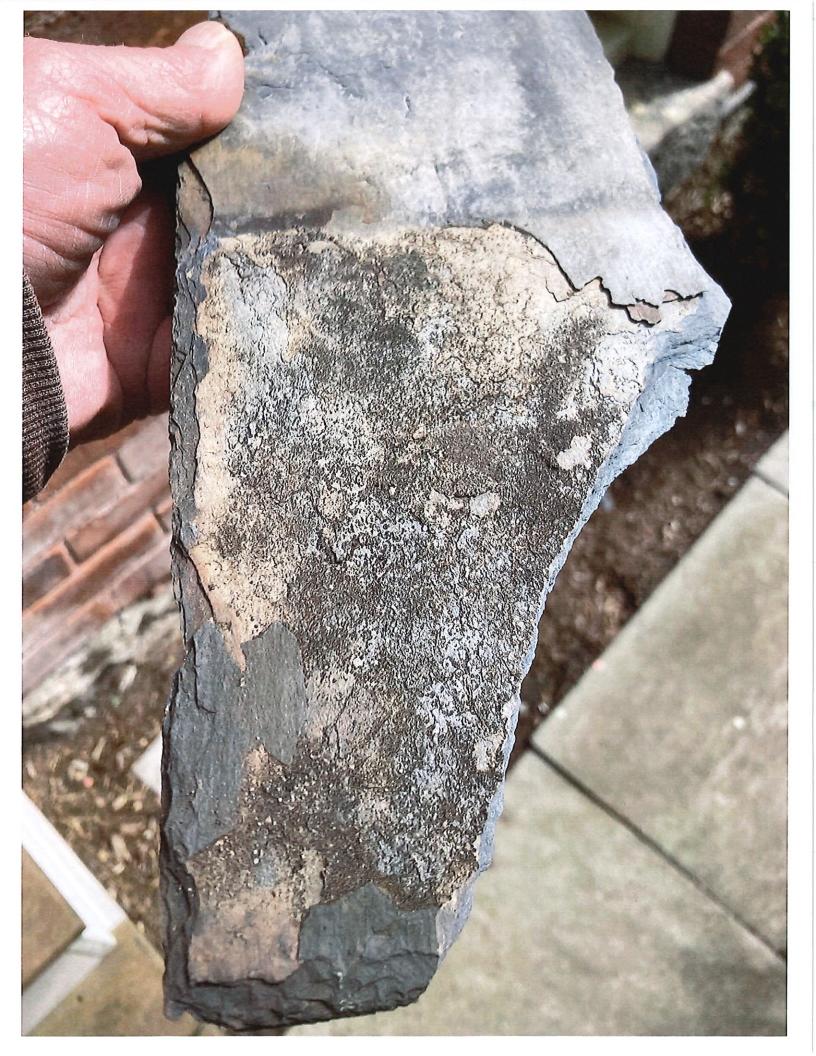
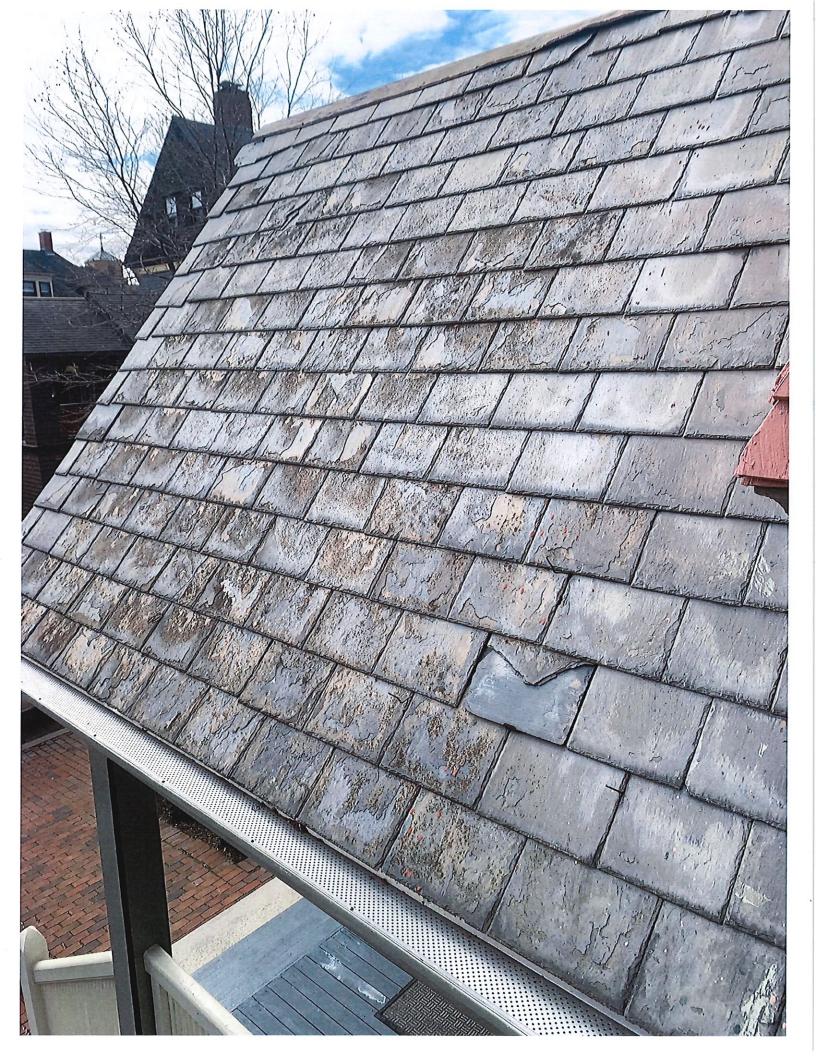
Gentlemen, I have inspected the slate roof at 40 Stimpson Street as requested. I have attached only a few photographs. It was obvious that the existing slate should be removed as soon as possible. Typically, Sea Green slate has a life expectancy of 100 years so has now failed with age. Unfortunately, the slates are soft, delaminating and shedding its layers. I found numerous pieces scattered on the ground. Please review the attached photos and feel free to call if you have any questions.
